# Diagnosis report of 2022 TOYOTA C-HR Active

# Preparation and repair report of 2022 TOYOTA C-HR Active

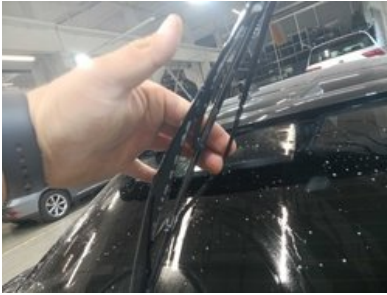
- ✔ **1. Front:** Window Wiper Rubber and Handle (Front and Rear) - Condition

- ✓ 1. Engine Oil & Filter Change
- ✓ 2. Change Rear Wiper (Mechanical)
- ✓ 3. Charge Battery

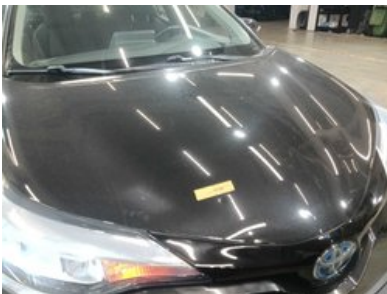
- ✔ **1. Front:** Hood - Visual Damage

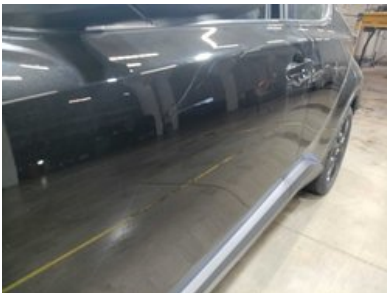
- ✔ **2. Other:** Additional Polishing Tasks

- ✓ 1. Body wet wash
- ✓ 2. Full interior deep clean using only hypoallergenic cleaning products
- ✓ 3. Post cleaning body polish

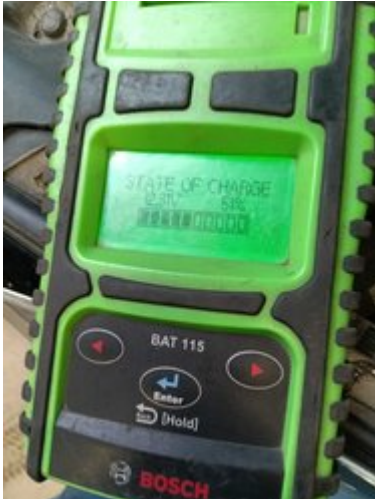
### ✓ 1. OTHER: Charge Battery
