# Diagnosis report of 2018 KIA SPORTAGE DynamicLine

# Preparation and repair report of 2018 KIA SPORTAGE DynamicLine

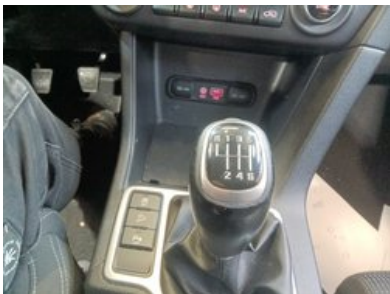
- ✔ **1. Inside:** Gear Shift Boot and Gear Shift Knob - Condition

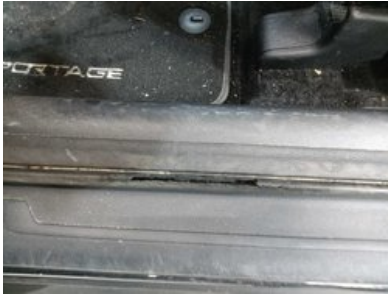
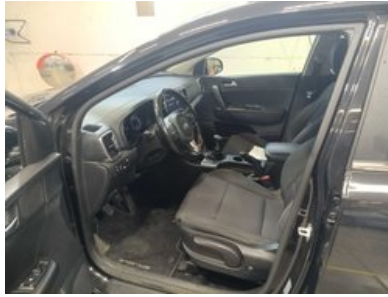
✓ **2. Doors:** Door Rubber Seals

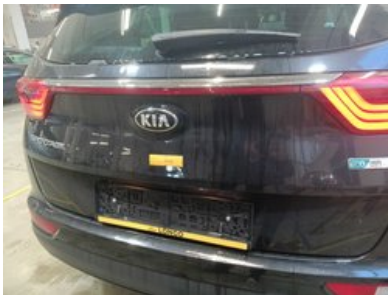
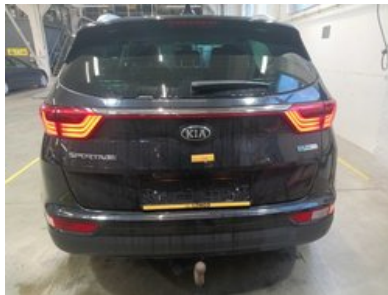
✓ **1. Rear:** Trunk - Visual Damage

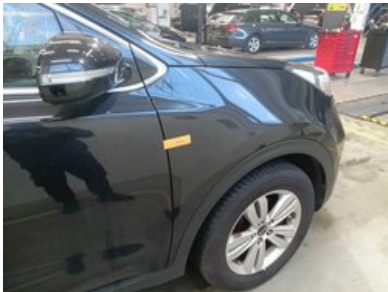
✓ **2. Side:** Left and Right Side - Visual Damage and Scratches

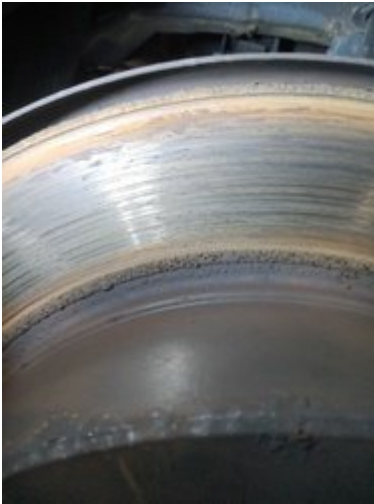
✓ **3. OTHER:** Rear Brake Disc and Pads

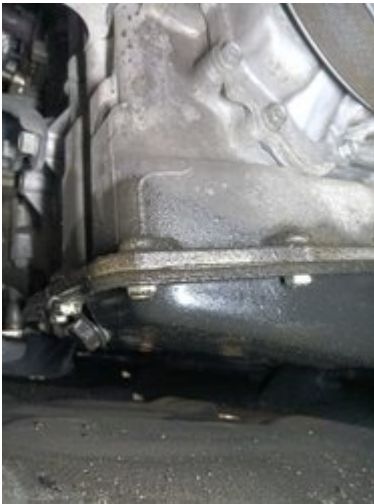
✓ **4. OTHER:** Oil Pan

- ✓ 1. Oil Pan
- ✓ 2. Charge Battery
- ✓ 3. Engine Oil and Filter

- 1. Engine Oil (5W30)
- 2. Oil Filter (OP617/1)
- 3. Oil Pan Seal (85932456)
