# Diagnosis report of 2018 PEUGEOT 5008 GT-Line

During the comprehensive diagnosis conducted by Longo, 7 issues were identified in the vehicle.

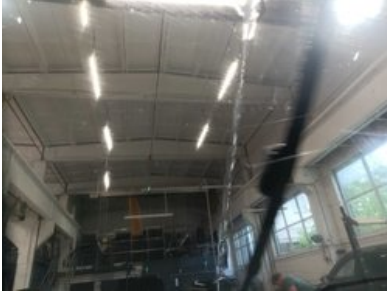
- ✓ **1. Front:** Window Wiper Rubber and Handle (Front and Rear) - Condition

- ✓ 1. Suspension Lower Arm (Both)
- ✓ 2. Engine Oil & Filter Change
- ✓ 3. Charge Battery
- ✓ 4. Change Front Wiper (Mechanical)

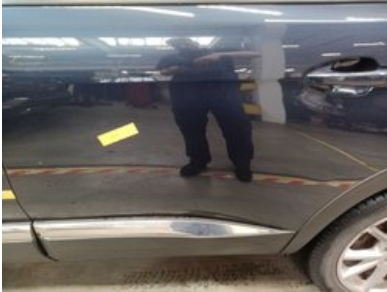
- ✓ **1. Other:** Additional Polishing Tasks

- ✓ 1. Body wet wash
- ✓ 2. Post cleaning body polish

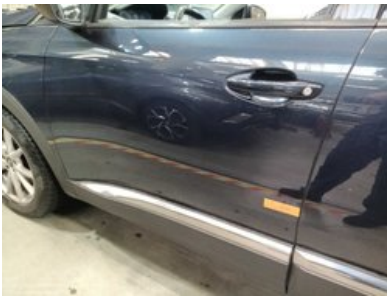
- ✓ **2. Side:** Left and Right Side - Visual Damage and Scratches

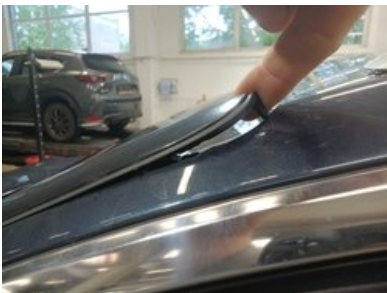
- ✓ **3. Front:** Windscreen Integrity - Free from MOT-Excluding Damage

- ✓ 1. Left Windshield Trim

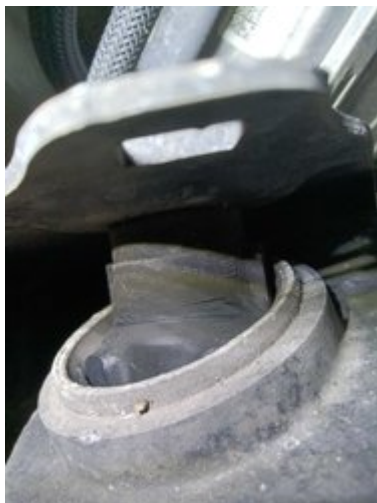
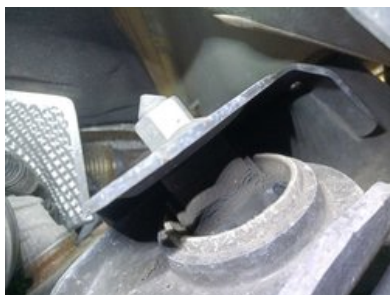
- ✓ 1. **OTHER:** Charge Battery
- ✓ 2. **OTHER:** Engine Oil & Filter Change
- ✓ 3. **SUSPENSION:** Suspension Lower Arm Both

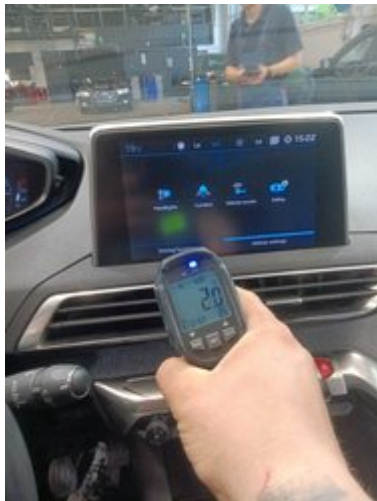
✓ 3. Air-Conditioning Measurement
