# Diagnosis report of 2021 PEUGEOT 2008 Active

## Summary of diagnosed issues

During the comprehensive diagnosis conducted by Longo, 5 issues were identified in the vehicle.

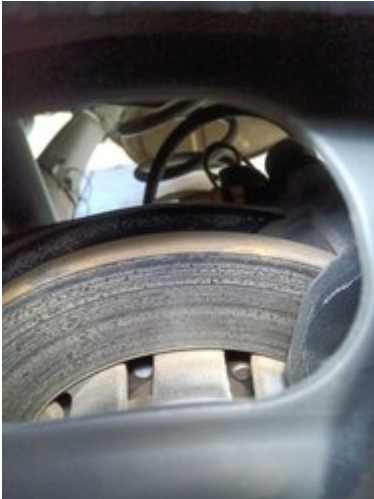
### ✓ 1. BRAKES: Rear Brake Disc (Both)

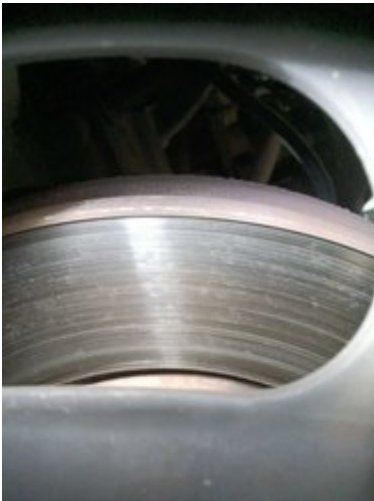
### ✓ 2. BRAKES: Front Brake Discs Both

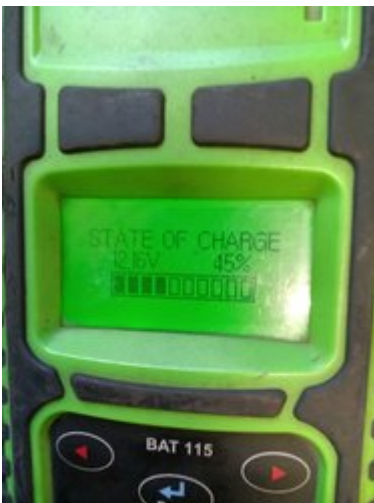
### ✓ 3. OTHER: Charge Battery

- ✓ 1. Engine Oil & Filter Change
- ✓ 2. Charge Battery
