# Diagnosis report of 2018 MAZDA CX-3 Dynamic

## Diagnosis details

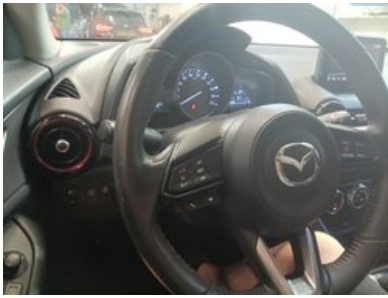
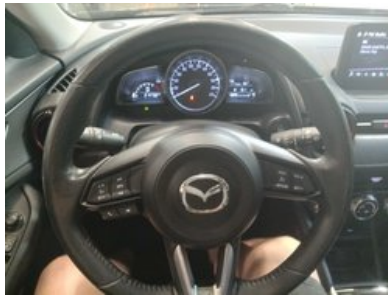
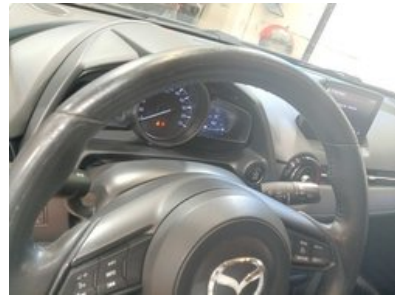
### ✓ 1. Front: Steering Wheel - Condition

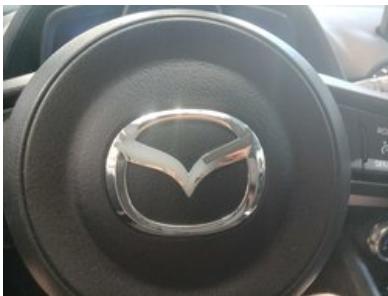
### ✓ 2. Front: Steering Wheel - Condition

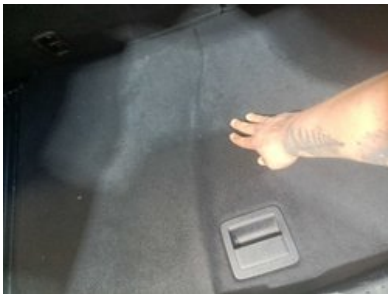
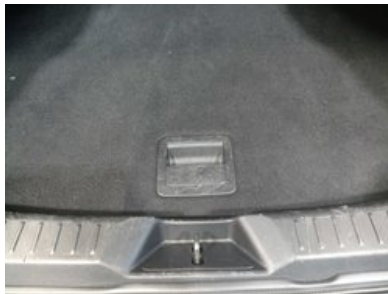
### ✓ 3. Inside: Carpets - Condition

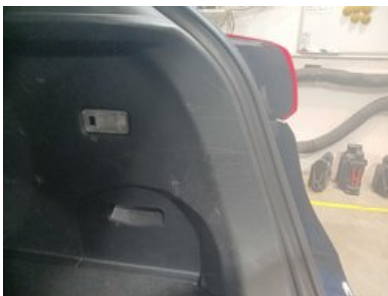
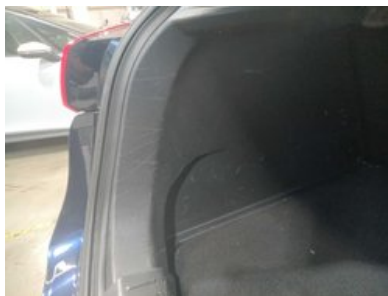
### ✓ 4. Inside: Trims - Condition

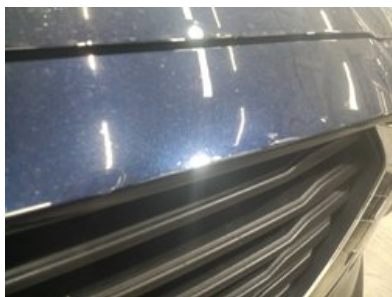
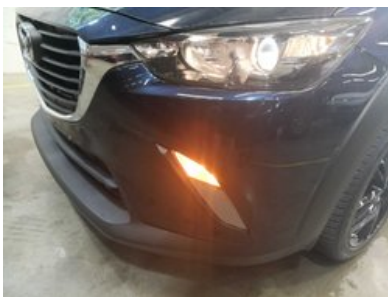
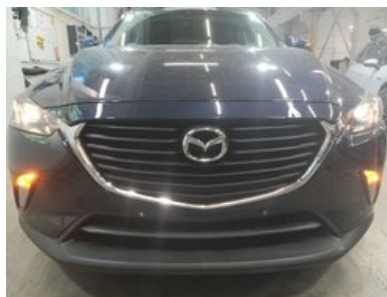
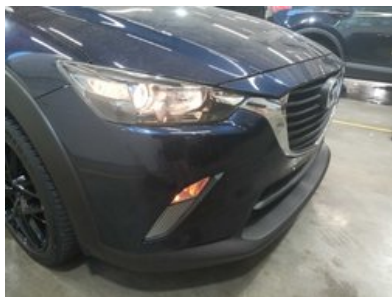
### ✔ 1. Front: Front Bumper - Condition and Alignment

- ✓ 1. Change Bumper Grills
- ✓ 2. Number Plate Holder
- ✓ 3. Headlamp Alignment

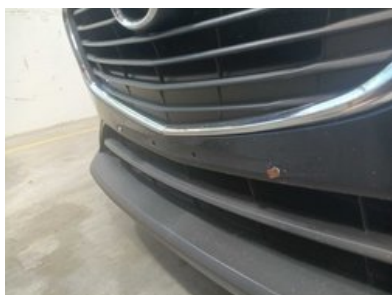
### ✔ 2. Front: Front Bumper - Condition and Alignment

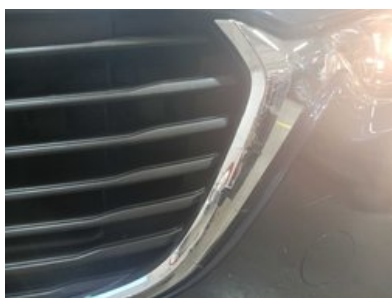
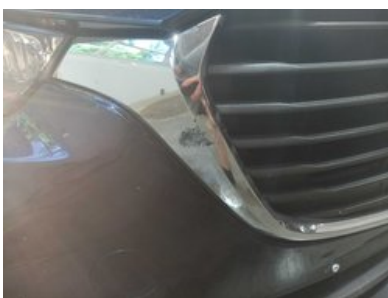
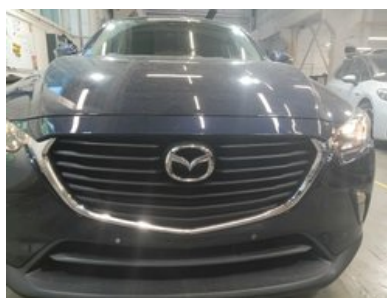
### ✔ 3. Front: Front Grille - Condition

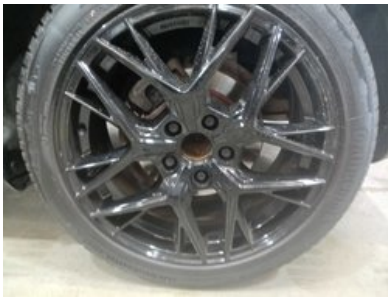
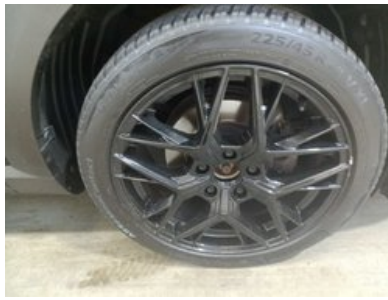
✓ **4. Side:** Wheels - Condition

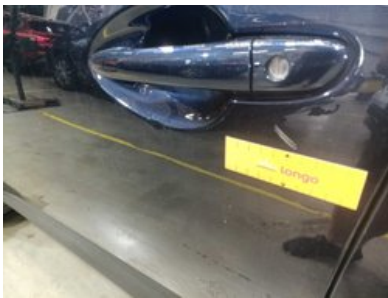
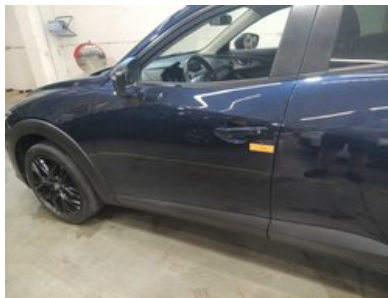
✓ **5. Side:** Left and Right Side - Visual Damage and Scratches

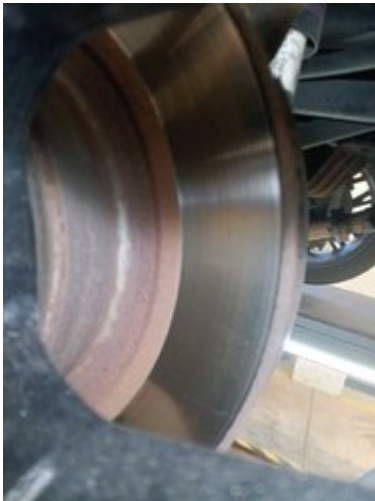
✓ **1. BRAKES:** Rear Brake Disc (Both)

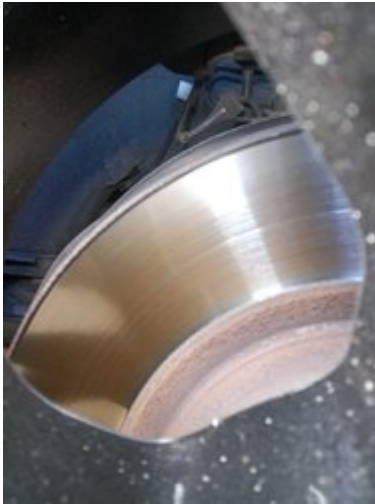
✓ **2. BRAKES:** Front Brake Discs Both

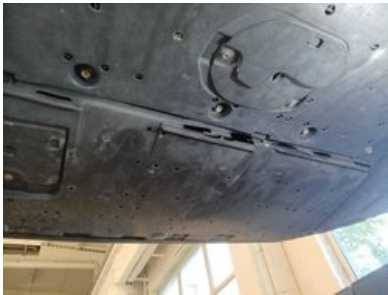
✓ **4. BODY - FRONT SECTION:** Damage
