# Diagnosis report of 2014 KIA CARENS ComfortLine

# Preparation and repair report of 2014 KIA CARENS ComfortLine

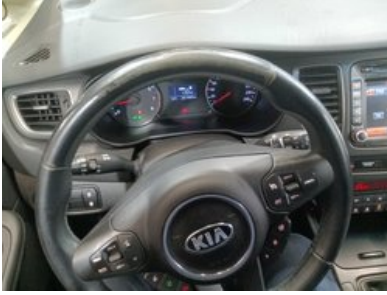
### ✓ 1. Front: Steering Wheel - Condition

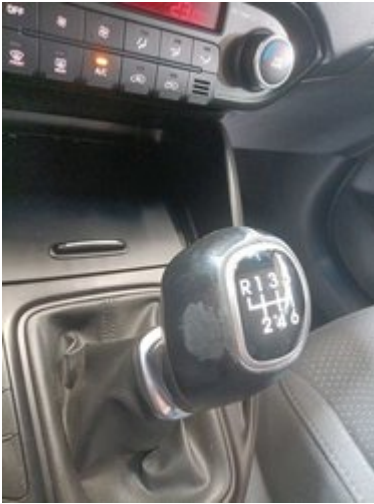
### ✓ 2. Inside: Gear Shift Boot and Gear Shift Knob - Condition

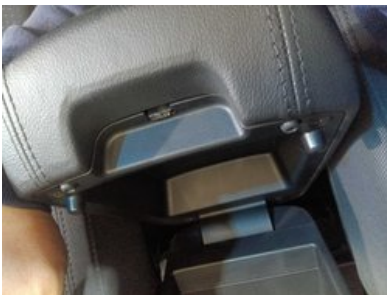
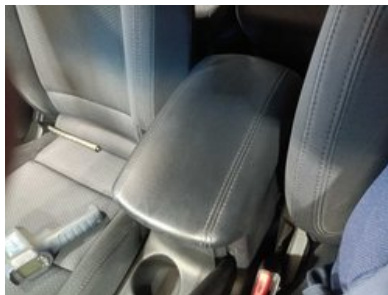
### ✓ 3. Inside: Armrest - Operation and Condition

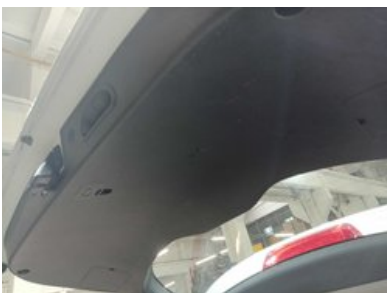
### ✓ 4. Inside: Trims - Condition

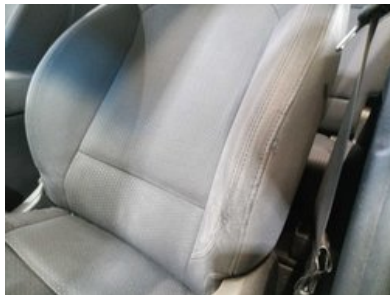
✓ **5. Seats:** All Seats - Condition

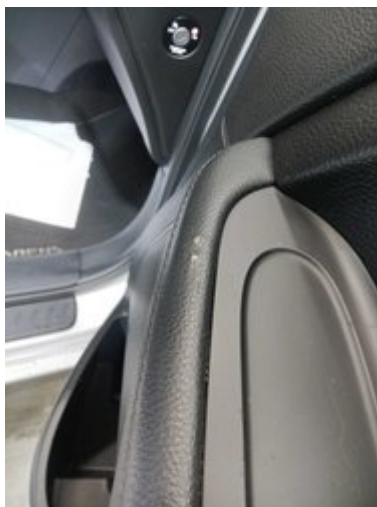
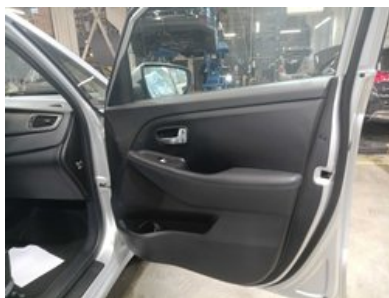
✓ **6. Doors:** Trims - Condition

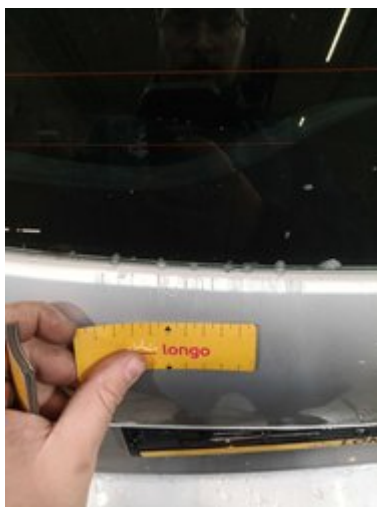
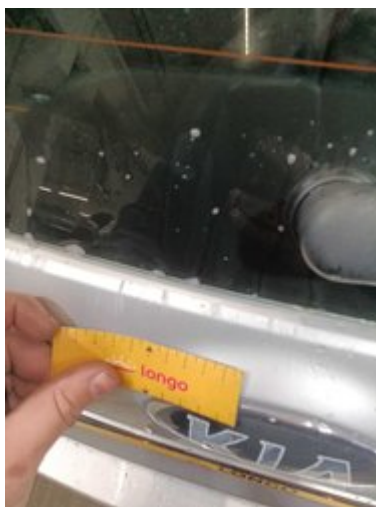
✓ **1. Rear:** Trunk - Visual Damage

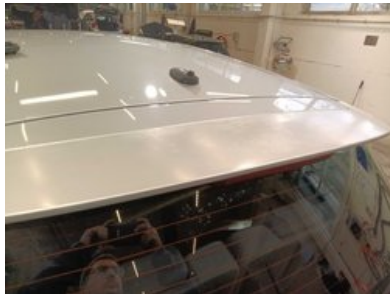
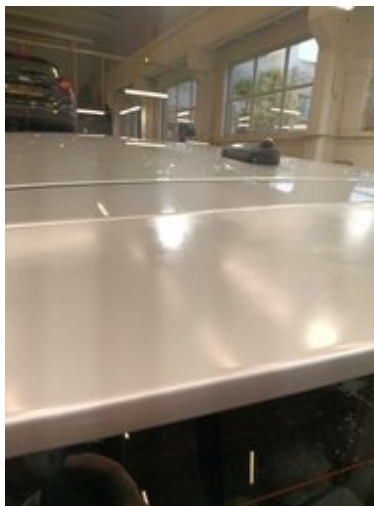
✓ **2. Rear:** Trunk - Visual Damage

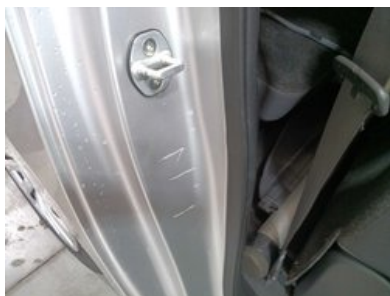
✓ **3. Side:** Left and Right Side - Visual Damage and Scratches

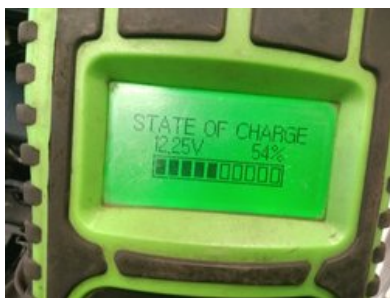
✓ **2. OTHER:** Charge Battery

- ✓ 1. Charge Battery
- ✓ 2. Engine Oil & Filter Change
