Diagnosis report of

2022 CITROEN C5 Aircross Business Plus

Diagnosis details

Summary of diagnosed issues

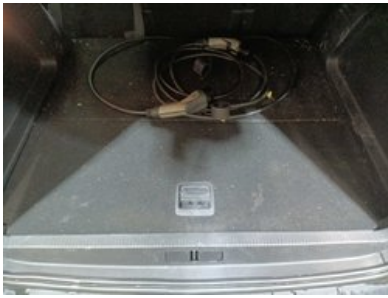
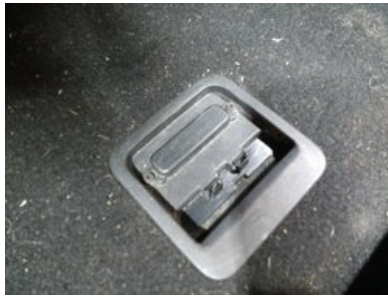
### ✓ 1. Inside: Carpets - Condition

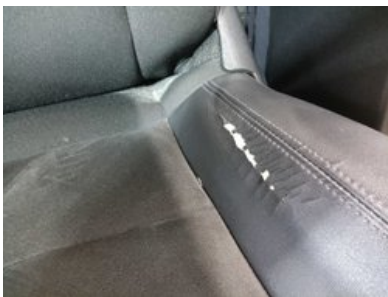
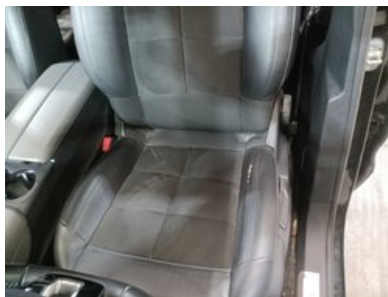
### ✓ 2. Seats: All Seats - Condition

- ✓ 1. Sew Front Seat

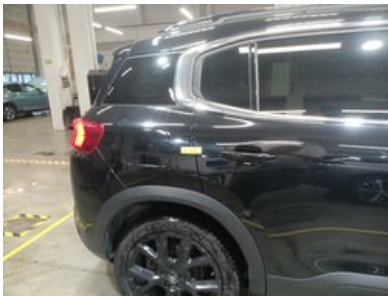
### ✓ 1. Side: Left and Right Side - Visual Damage and Scratches

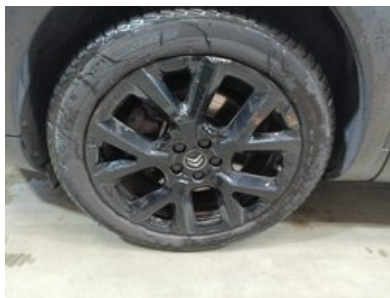
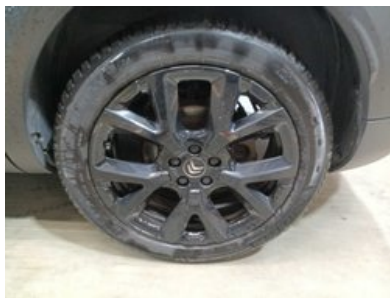
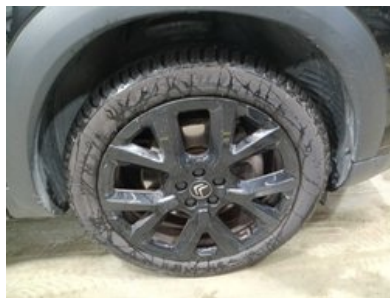
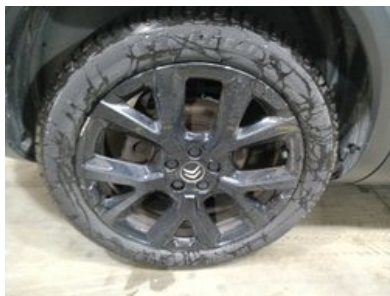
✓ **2. Side:** Wheels - Condition

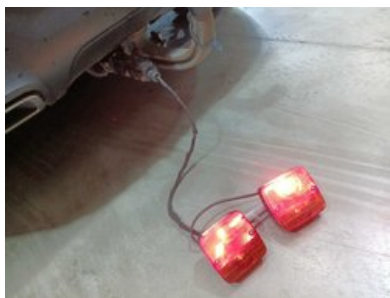
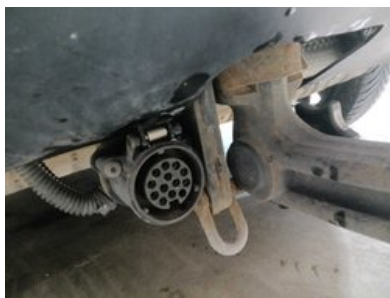
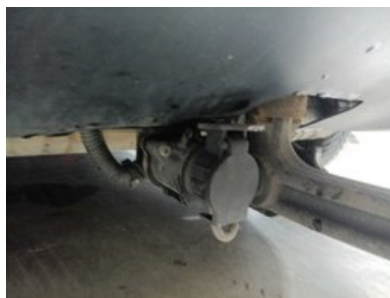
✓ **3. Rear:** Tow Hitch (Attachment, Removal Mechanism, External Light Connector, Connector Thickness)

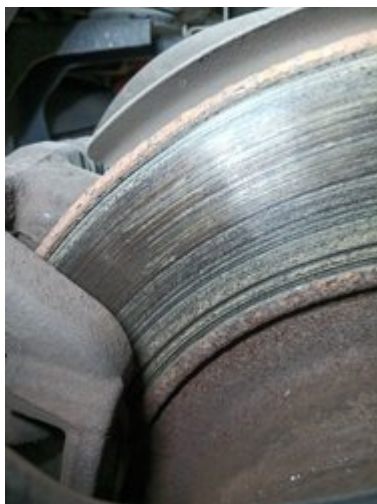
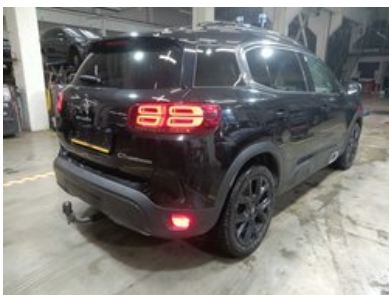
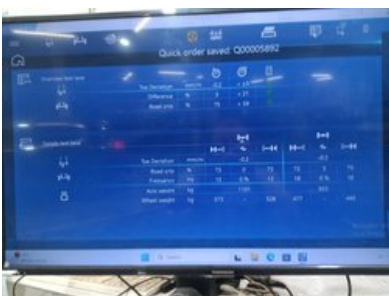
✓ **2. BRAKES:** Rear Brake Disc (Both)
