# Diagnosis report of 2018 PEUGEOT 5008 GT-Line

# Preparation and repair report of 2018 PEUGEOT 5008 GT-Line

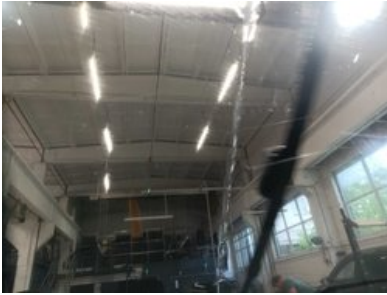
- ✓ **1. Front:** Window Wiper Rubber and Handle (Front and Rear) - Condition

- ✓ 1. Suspension Lower Arm (Both)
- ✓ 2. Engine Oil & Filter Change
- ✓ 3. Charge Battery
- ✓ 4. Change Front Wiper (Mechanical)

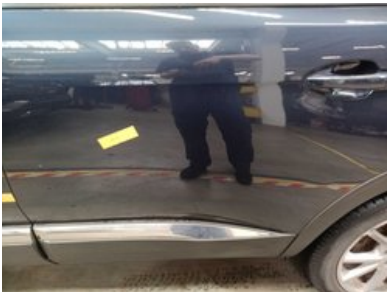
- ✓ **1. Other:** Additional Polishing Tasks

- ✓ 1. Body wet wash
- ✓ 2. Post cleaning body polish

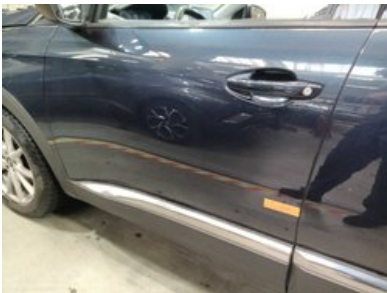
- ✓ **2. Side:** Left and Right Side - Visual Damage and Scratches
