# Diagnosis report of 2018 PEUGEOT 3008 Allure

# Preparation and repair report of 2018 PEUGEOT 3008 Allure

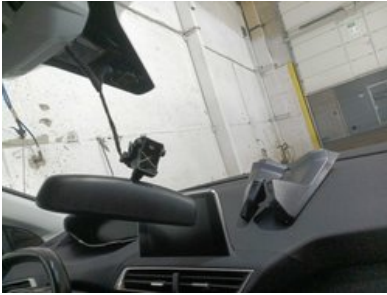
- ✔ **1. Front:** Rearview Mirror - Operation and Attachment Integrity

- ✓ 1. Repair Rearview Mirror
- ✓ 2. Plastics
- ✓ 3. Repair Washer Mechanism

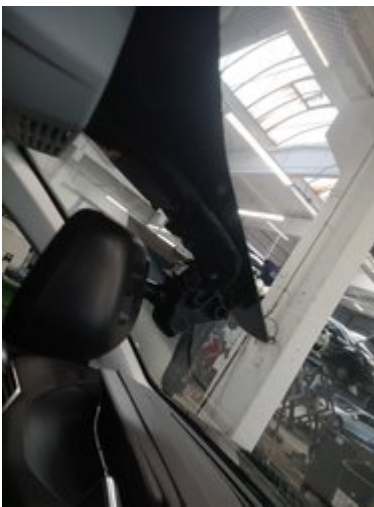
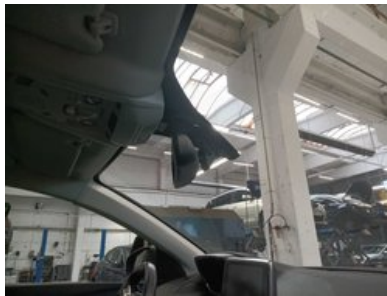
- ✔ **2. Front:** Headlining - Condition

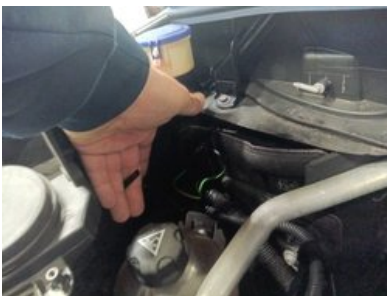
- ✔ **3. Front:** Window Wash System - Functioning (Front and Rear)

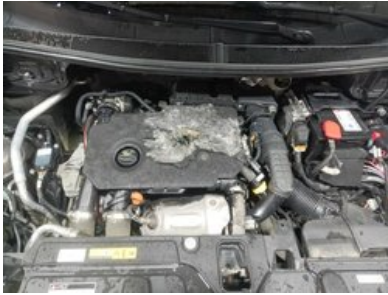
### ✓ 1. Front: Engine Cover Integrity

- ✓ 1. Engine Oil & Filter Change
- ✓ 2. Charge Battery
- ✓ 3. Change Engine Cover
- ✓ 4. Check Fuses

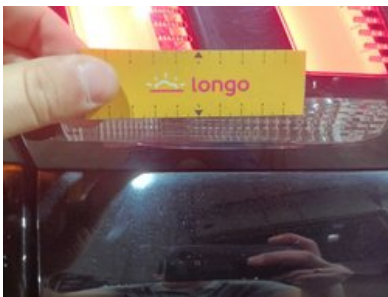
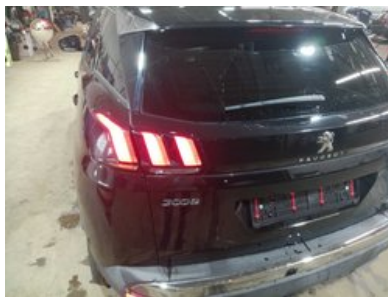
### ✓ 2. Lights: Rear Lights (Brake, Fog, Indicator) - Basic Functioning, Damage, and Color

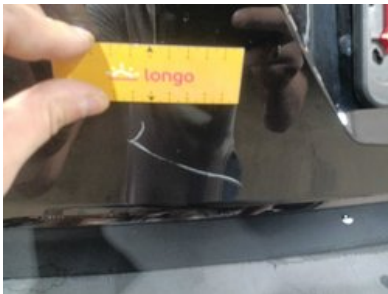
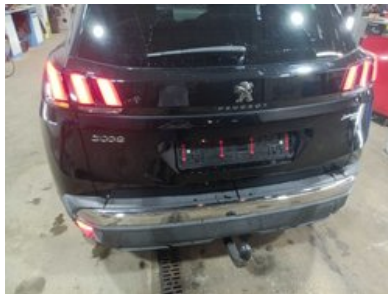
### ✓ 3. Rear: Trunk - Visual Damage

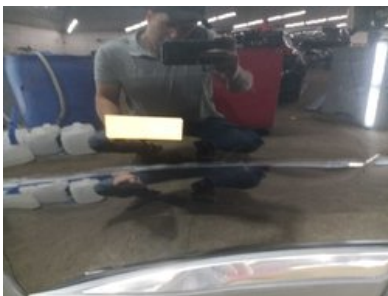
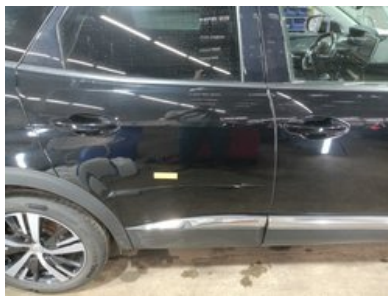
### ✓ 4. Side: Left and Right Side - Visual Damage and Scratches

- ✓ 1. Paint Door

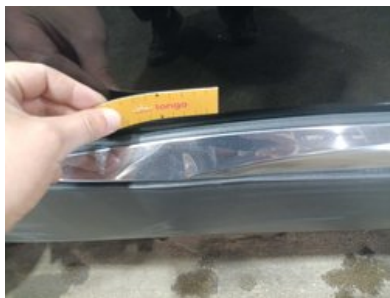
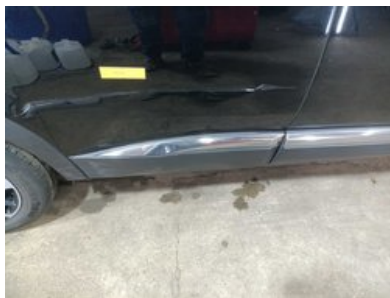
✓ **5. Side:** Left and Right Side - Visual Damage and Scratches

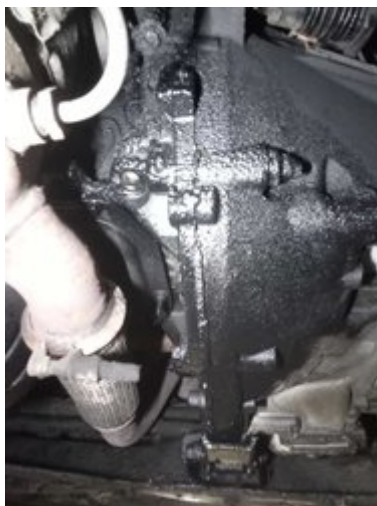
✓ **3. OTHER:** Engine Camshaft Repair "Sandwich"

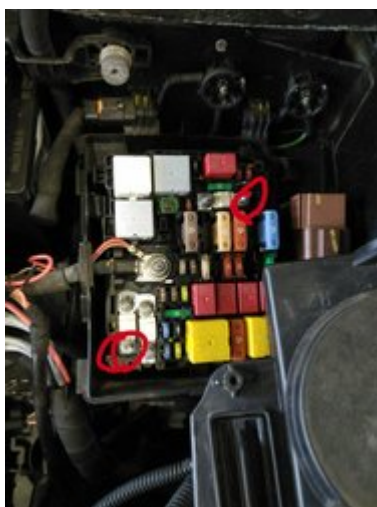
✓ **4. GENERAL ELECTRICS:** Tighten Fuses

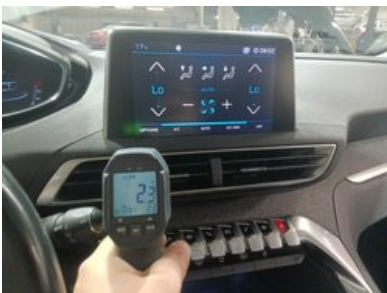
### ✓ 3. Air-Conditioning Measurement
