# Diagnosis report of 2021 OPEL GRANDLAND X Business Eleg

Diagnosis report of

2021 OPEL GRANDLAND X Business Eleg

# Preparation and repair report of 2021 OPEL GRANDLAND X Business Eleg

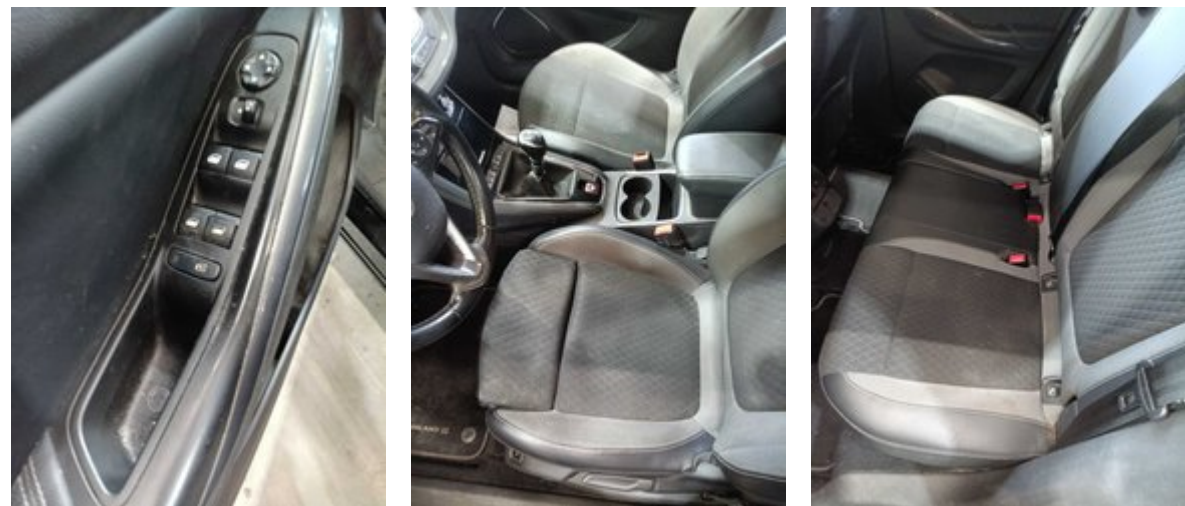
- ✔ 1. Inside: Additional Cleaning Tasks

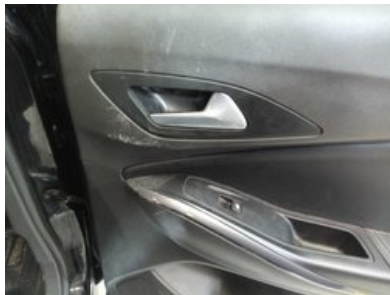
✓ **2. Doors:** Trims - Condition

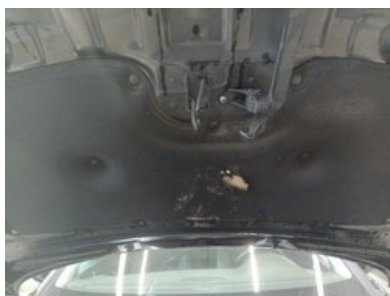
✓ **1. Front:** Hood Sound Insulation - Condition

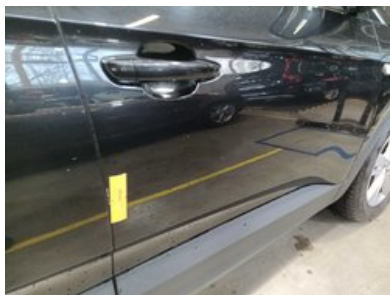
✓ **2. Side:** Left and Right Side - Visual Damage and Scratches

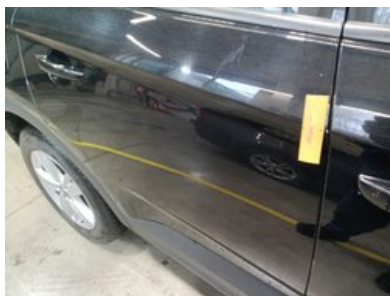
✓ **3. Side:** Left and Right Side - Visual Damage and Scratches

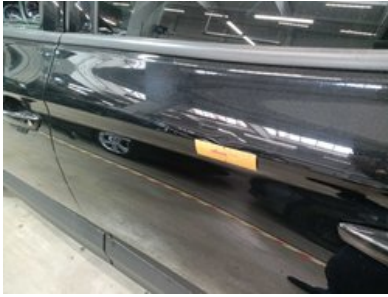
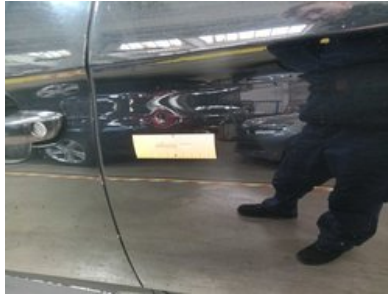
✓ **4. Side:** Left and Right Side - Visual Damage and Scratches

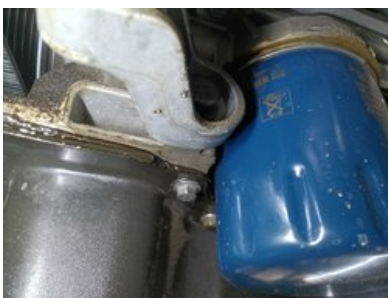
✓ **3. OTHER:** Oil Pan

- ✓ 1. Alternator Belt
- ✓ 2. Drive Belt
- ✓ 3. Engine Oil and Filter
- ✓ 4. Oil Pan
- ✓ 5. Charge Battery

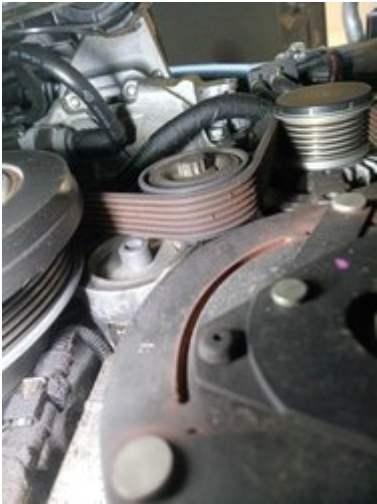
✓ 4. OTHER: Alternator Belt
