Diagnosis report of 2014 BMW 320 High Executive

Preparation and repair report of 2014 BMW 320 High Executive

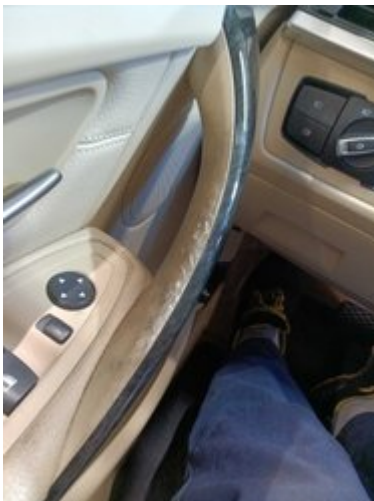
- ✔ **1. Doors:** Door Handles - Operation and Condition

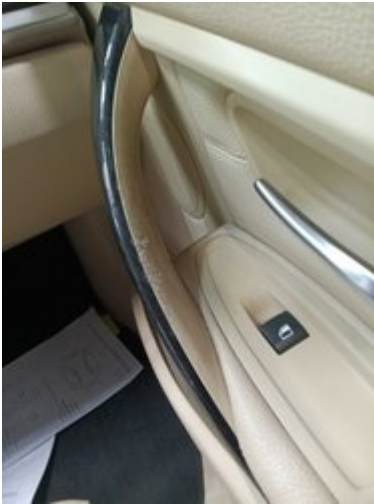
✔ **2. Doors:** Door Handles - Operation and Condition

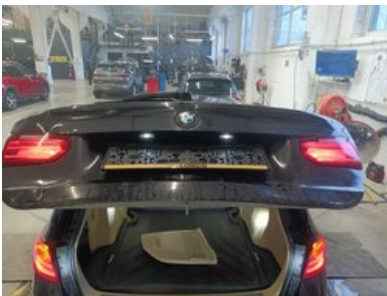
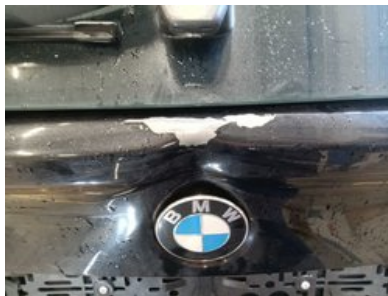
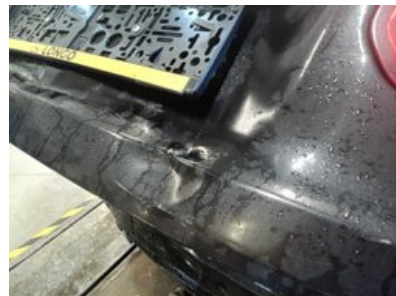
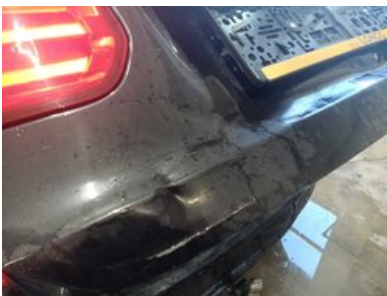
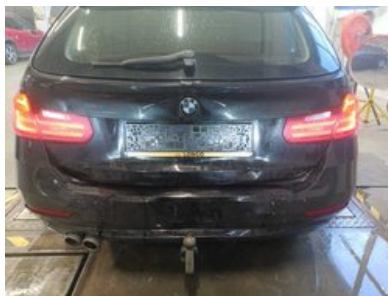
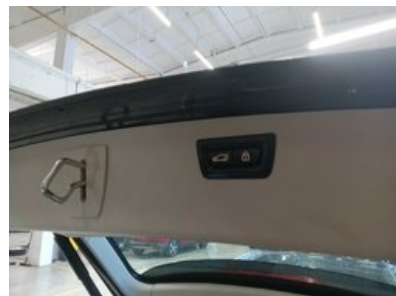
✔ **1. Rear:** Trunk - Visual Damage

- ✓ 1. Paint Boot
- ✓ 2. Paint Rear Bumper

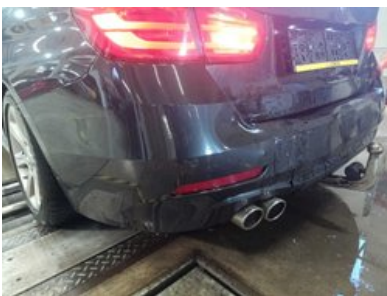
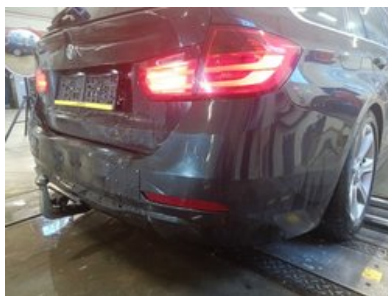
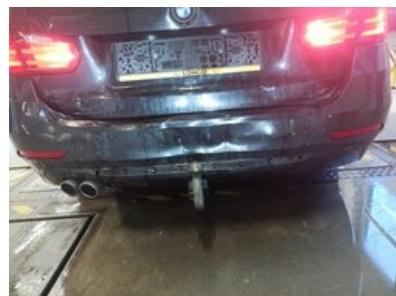
✔ **2. Rear:** Rear Bumper - Condition and Alignment

- ✓ 1. Other: Rear Bumper Holder

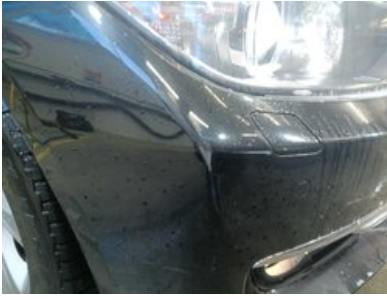
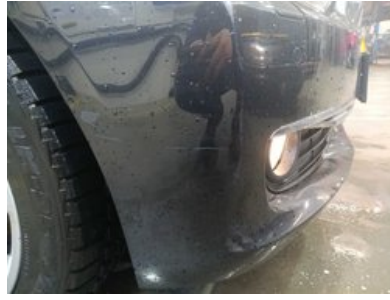
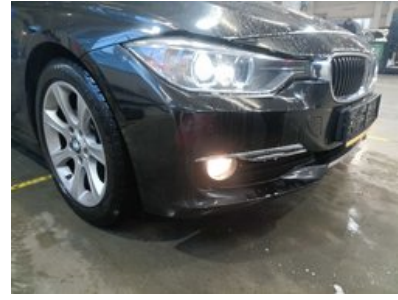
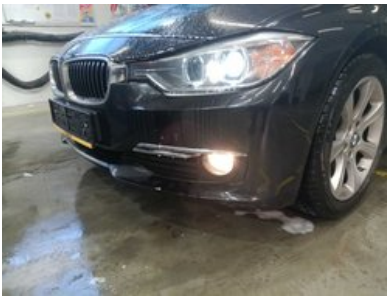
✔ **3. Front:** Front Bumper - Condition and Alignment

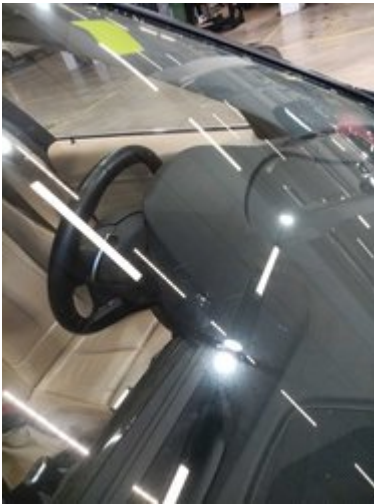
✔ **4. Front:** Windscreen Integrity - Free from MOT-Excluding Damage

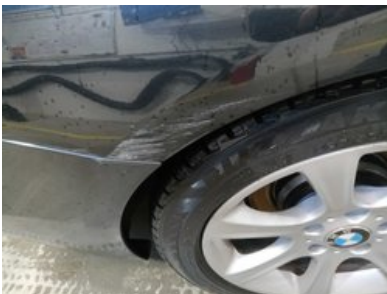
✔ **5. Other:** Additional Polishing Tasks

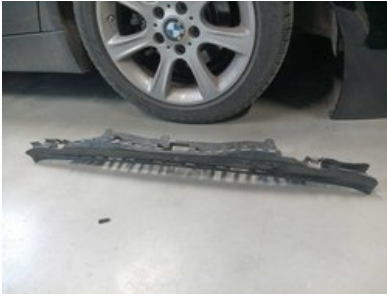
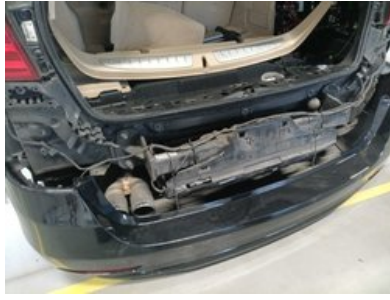
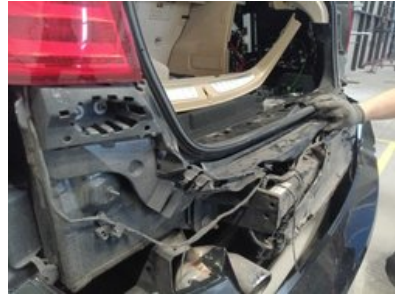
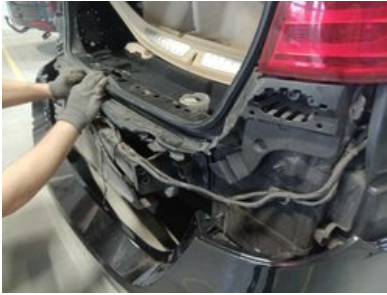
✔ **6. Other:** Audible Signs (Loose Parts, Rattling, Etc.)

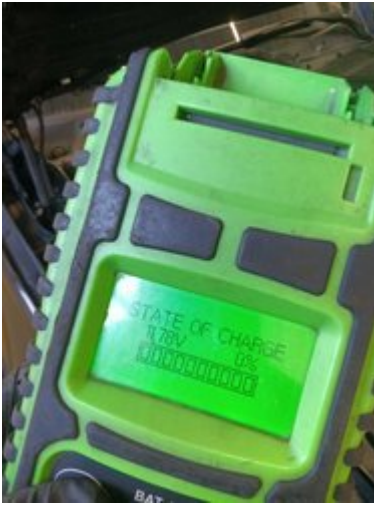
✔ **1. OTHER:** Charge Battery

- ✓ 1. Charge Battery

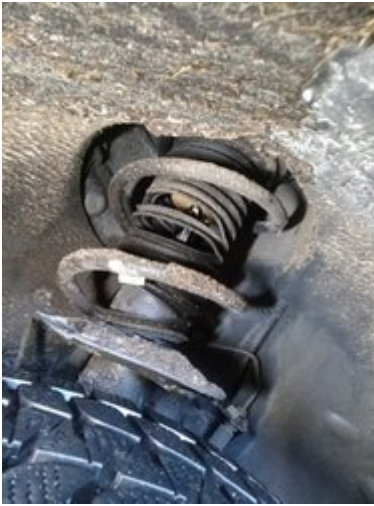
✔ **3. SUSPENSION:** Strut Assembly (Both)

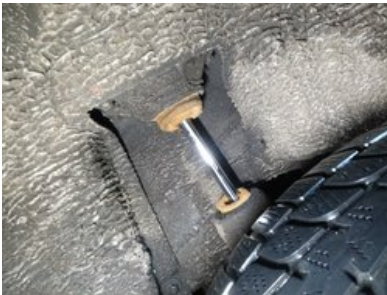
✔ **4. SUSPENSION:** Shock Absorbers (Pair)

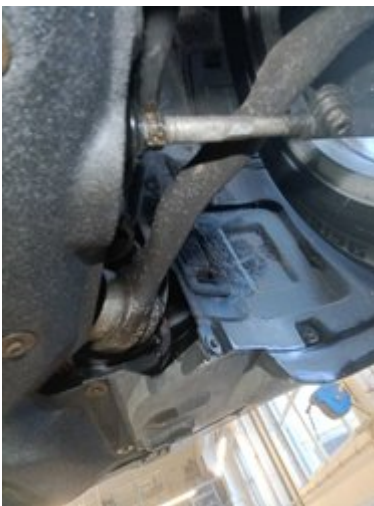
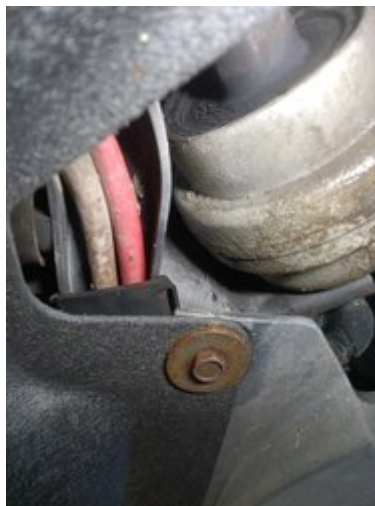
✔ **5. SUSPENSION:** Suspension Lower Arm Both
