# Diagnosis report of 2015 CITROEN C4 CACTUS Business Plus

Diagnosis report of

2015 CITROEN C4 CACTUS Business Plus

# Preparation and repair report of 2015 CITROEN C4 CACTUS Business Plus

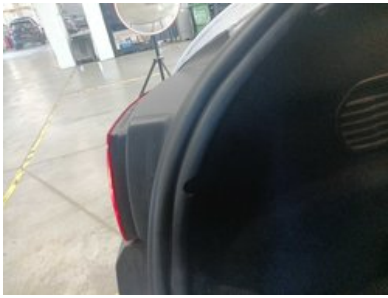
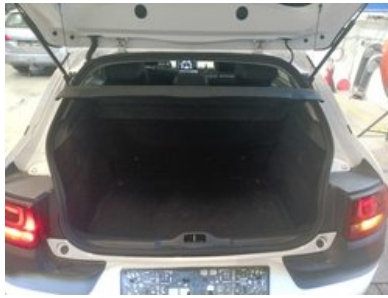
### ✓ 1. Doors: Door Rubber Seals

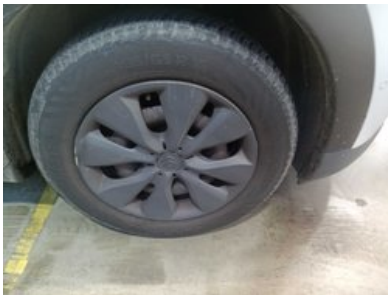
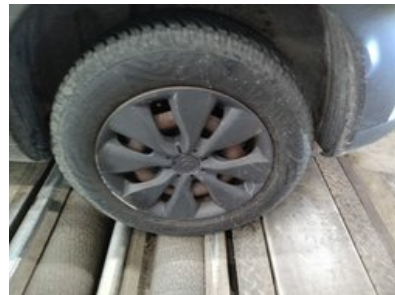
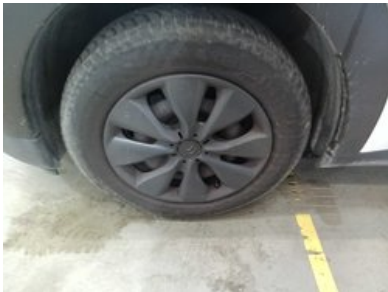
### ✓ 1. Side: Wheels - Condition

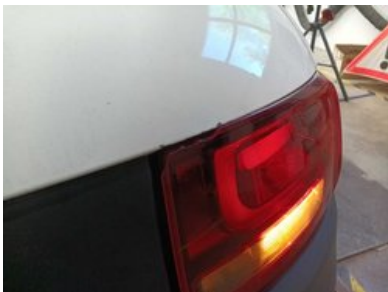
### ✓ 2. Lights: Rear Lights (Brake, Fog, Indicator) - Basic Functioning, Damage, and Color

- ✓ 1. Change Rear Lights
