# Diagnosis report of

## 2015 CITROEN DS3 So Chic

# Diagnosis report of 2015 CITROEN DS3 So Chic

During the comprehensive diagnosis conducted by Longo, 10 issues were identified in the vehicle.

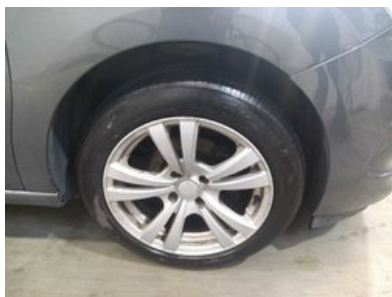
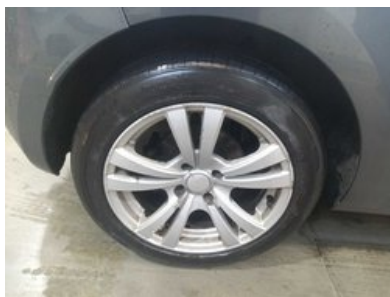
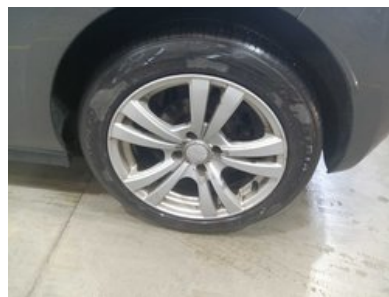
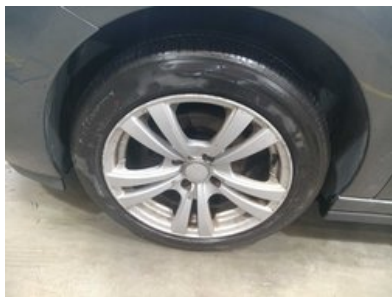
### ✓ 1. Side: Wheels - Condition

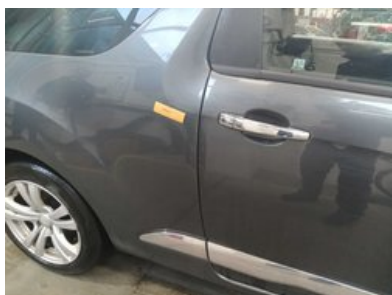
### ✓ 2. Side: Left and Right Side - Visual Damage and Scratches

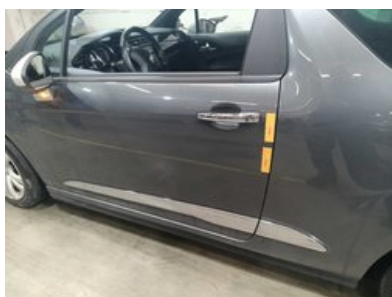
### ✓ 3. Side: Left and Right Side - Visual Damage and Scratches

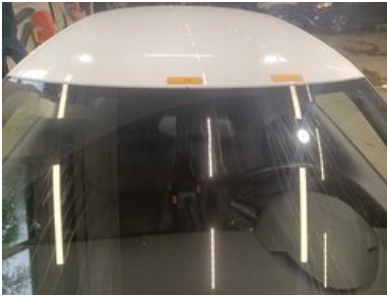
✓ **4. Other:** Roof - Visual Damage (e.g., Hail Damage)

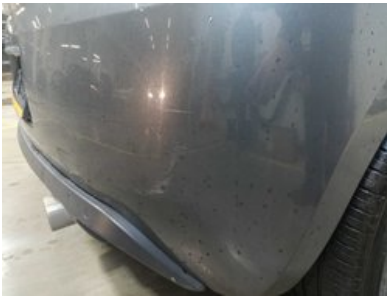
✓ **5. Other:** Additional Polishing Tasks

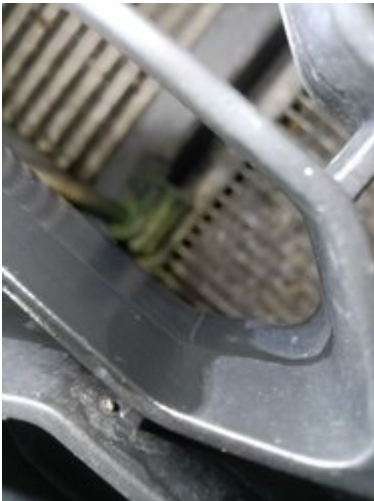
✓ **1. AIR CONDITIONING AND HEATING:** Condenser

- ✓ 1. Suspension Lower Arm
- ✓ 2. System Evacuation/Recharging
- ✓ 3. Engine Oil & Filter Change
- ✓ 4. Condenser

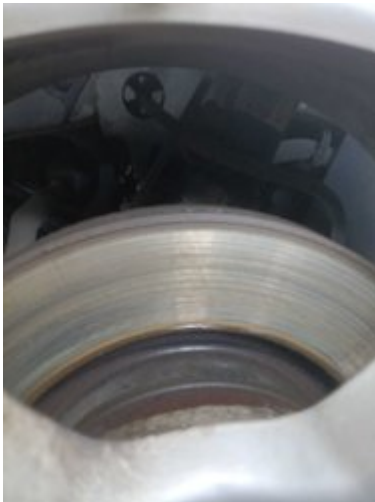
✓ **4. BRAKES:** Front Brake Discs Both with Pads

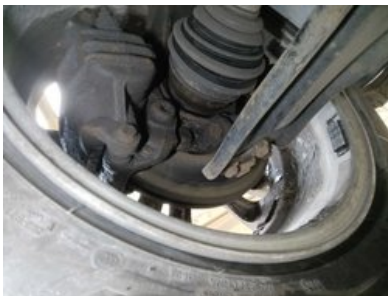
✓ **5. SUSPENSION:** Suspension Lower Arm
