# Diagnosis report of 2016 PEUGEOT 2008 Executive

During the comprehensive diagnosis conducted by Longo, 12 issues were identified in the vehicle.

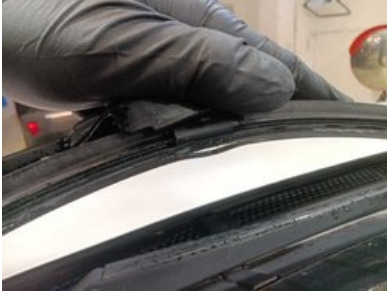
- ✓ **1. Front:** Window Wiper Rubber and Handle (Front and Rear) - Condition

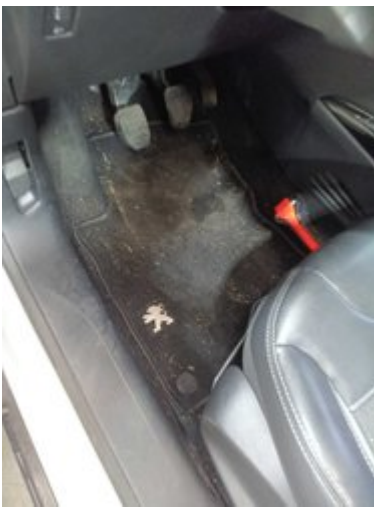
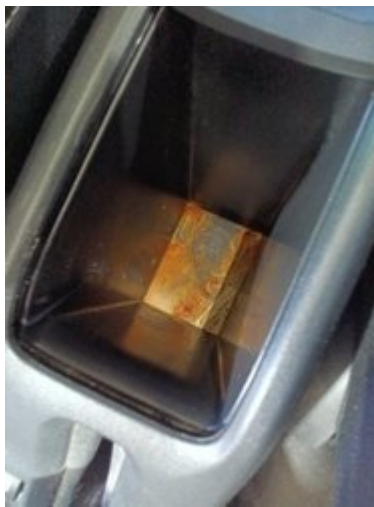
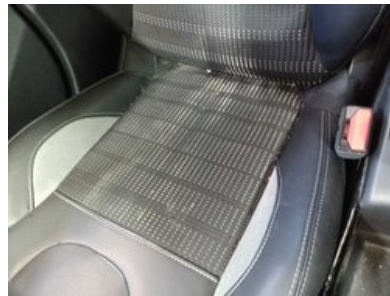
- ✓ **2. Inside:** Additional Cleaning Tasks

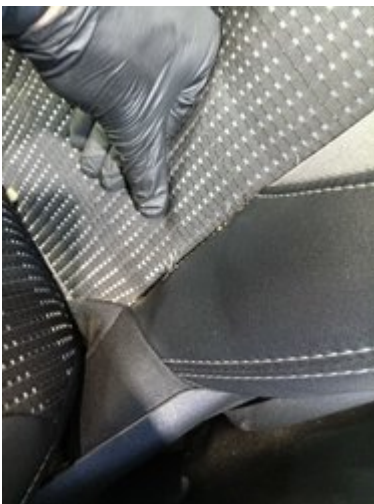
- ✓ **3. Seats:** All Seats - Condition

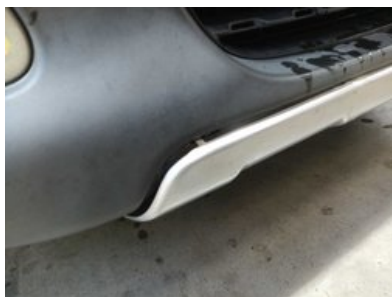
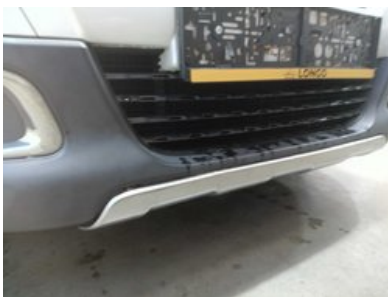
### ✔ 1. Front: Front Bumper - Condition and Alignment

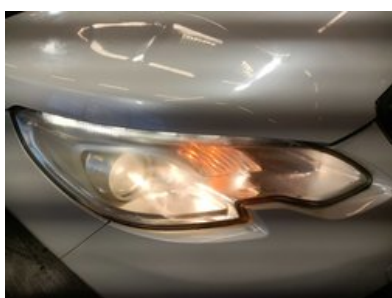
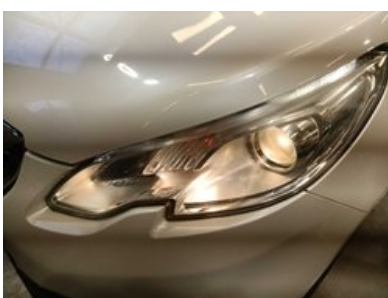
### ✔ 2. Other: Additional Polishing Tasks

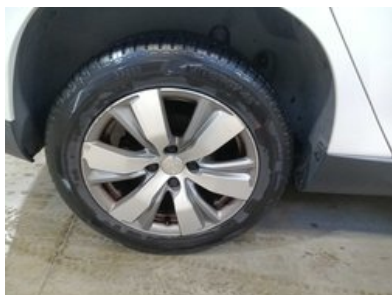
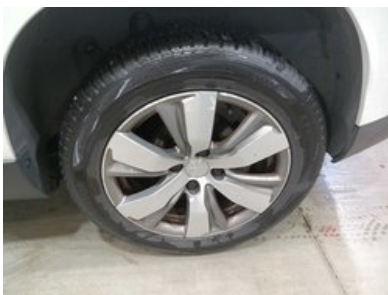
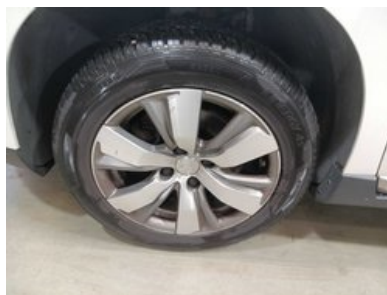
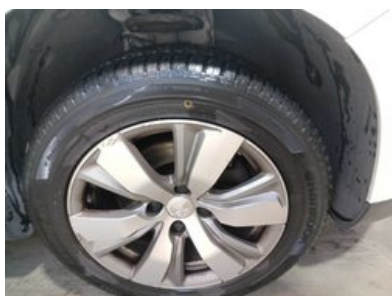
### ✔ 3. Side: Wheels - Condition

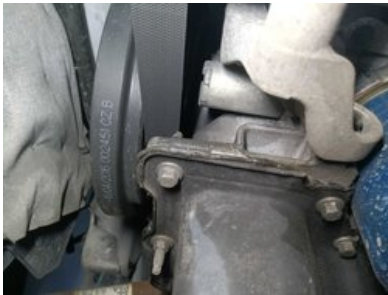
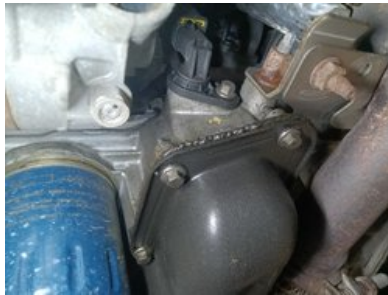
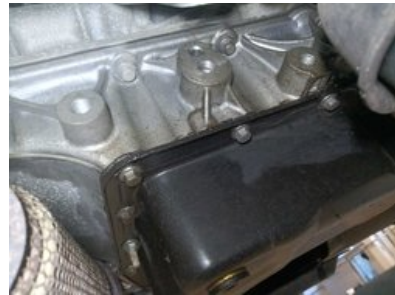
### ✓ 1. OTHER: Oil Pan

- ✓ 1. Oil Pan
- ✓ 2. Suspension Lower Arm
- ✓ 3. Charge Battery
- ✓ 4. Change Front Wiper (Mechanical)
- ✓ 5. Engine Oil and Filter

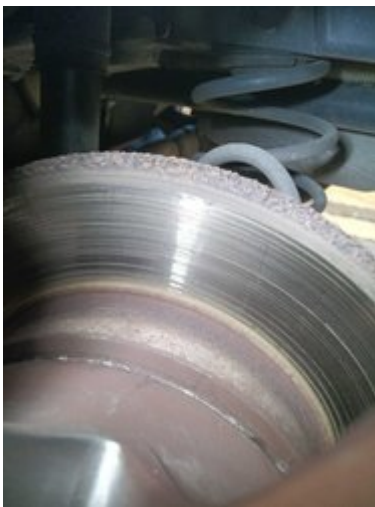
### ✓ 3. OTHER: Rear Brake Discs Including Pads

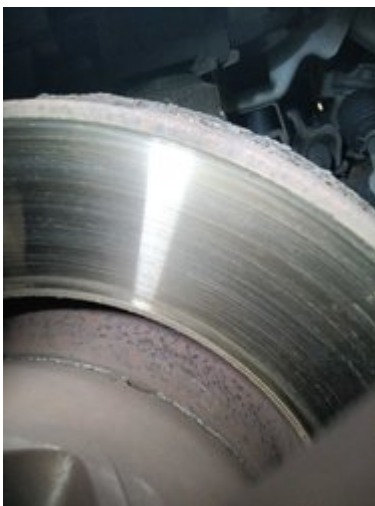
### ✓ 4. OTHER: Front Brake Discs Including Pads
