# Diagnosis report of 2019 TOYOTA C-HR i-Hybrid

# Preparation and repair report of 2019 TOYOTA C-HR i-Hybrid

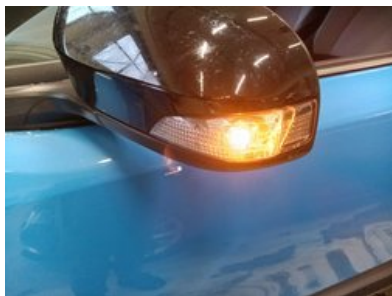
- ✓ **1. Lights:** Car Side Lights - Basic Functioning, Damage, and Color

- ✓ 1. Change Lights on Car Side
- ✓ 2. Rear Bumper Damage

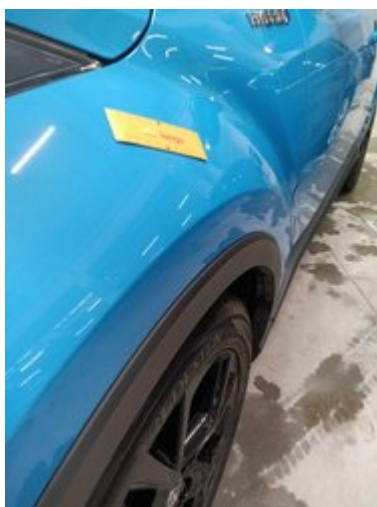
- 
- ✓ **2. Side:** Left and Right Side - Visual Damage and Scratches

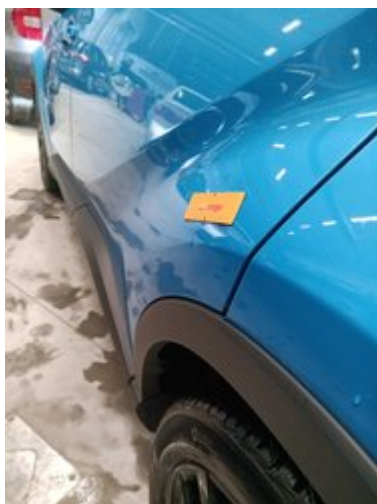
- 
- ✓ **3. Side:** Left and Right Side - Visual Damage and Scratches

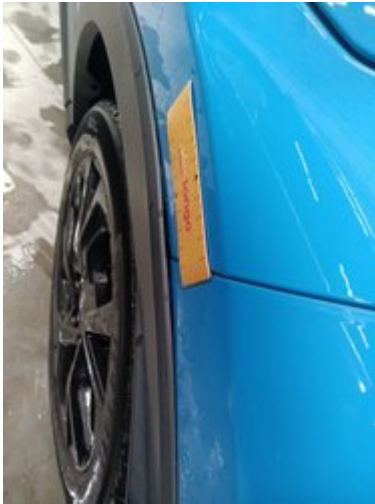
✓ **4. Side:** Left and Right Side - Visual Damage and Scratches

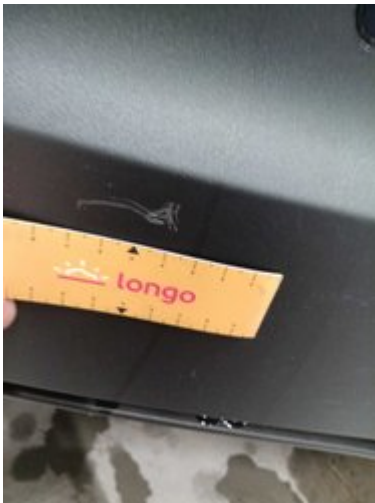
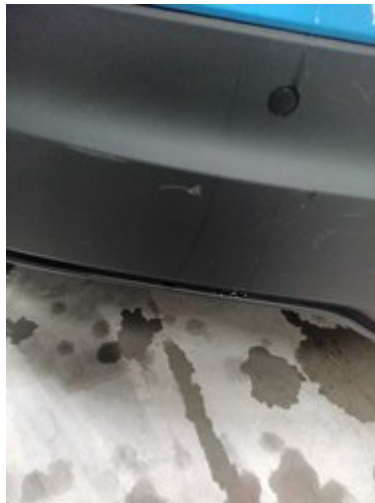
✓ **5. Rear:** Rear Bumper - Condition and Alignment

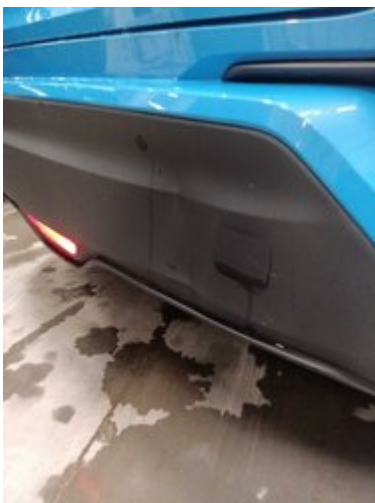
✓ **6. Rear:** Rear Bumper - Condition and Alignment
