# Diagnosis report of 2014 TOYOTA AURIS Aspiration

During the comprehensive diagnosis conducted by Longo, 10 issues were identified in the vehicle.

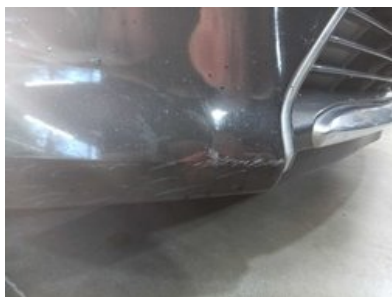
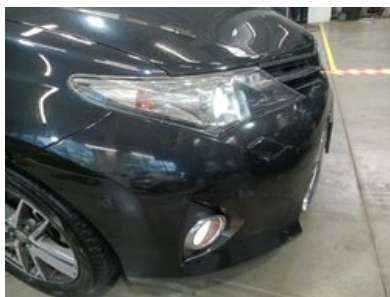
### ✔ 1. Front: Front Bumper - Condition and Alignment

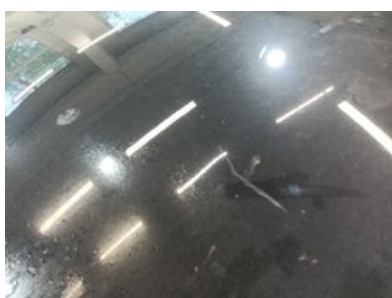
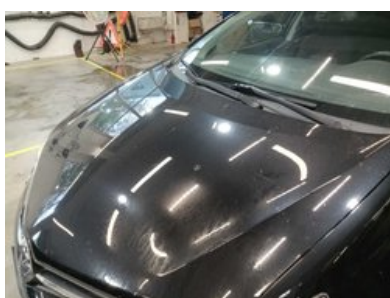
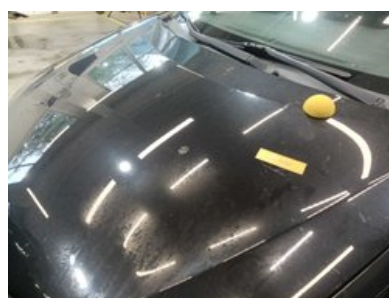
### ✔ 2. Front: Hood - Visual Damage

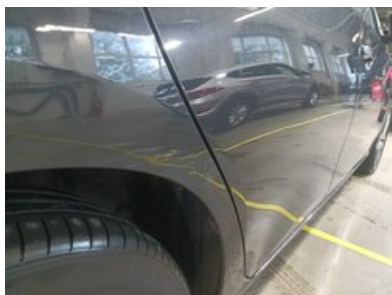
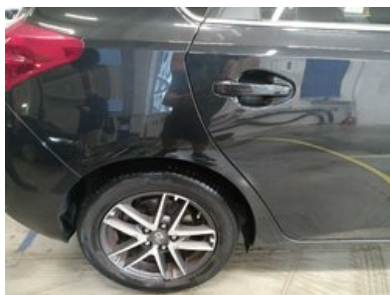
### ✔ 3. Side: Left and Right Side - Visual Damage and Scratches

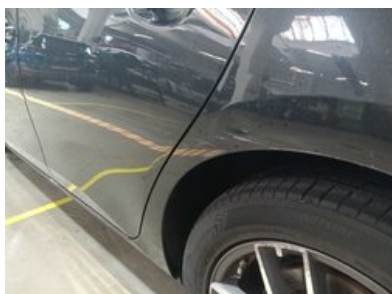
### ✔ 4. Side: Left and Right Side - Visual Damage and Scratches

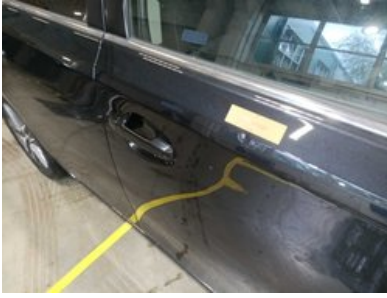
✓ **5. Side:** Left and Right Side - Visual Damage and Scratches

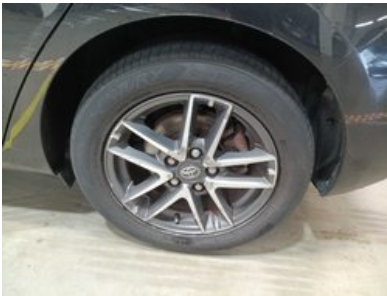
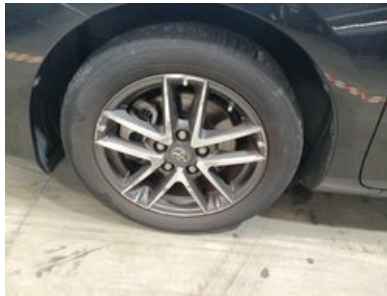
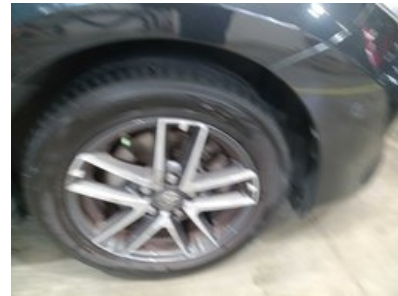
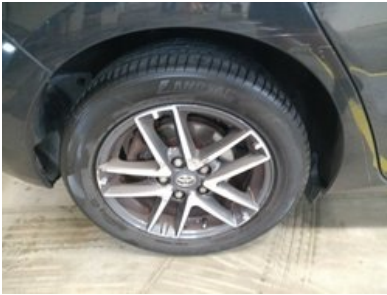
✓ **6. Side:** Wheels - Condition

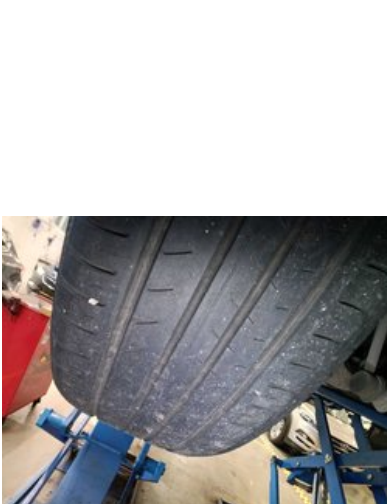
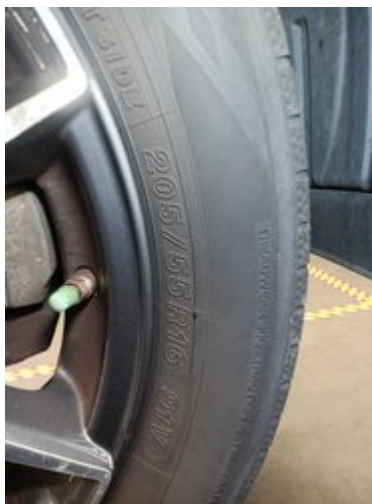
✓ **2. OTHER:** Change Tires

- ✓ 1. Engine Oil & Filter Change
- ✓ 2. Change Tires

- 1. Oil Filter (OE685/2)
- 2. Quartz Ineo Xtra EC6 0W20 208L 4.2L
- 3. Maxtrek 205/55R16 91V Maximus M2 C B 71 Summer (MXT00428)
- 4. Oil Pan Gasket (81930263)

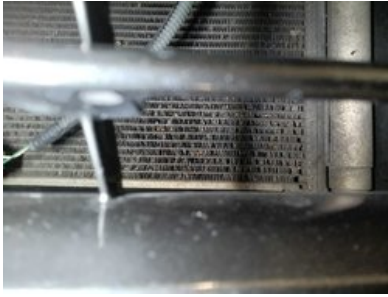
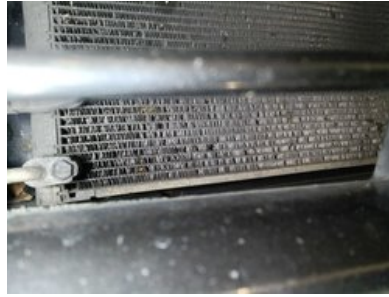
✓ 3. AIR CONDITIONING AND HEATING: Condenser

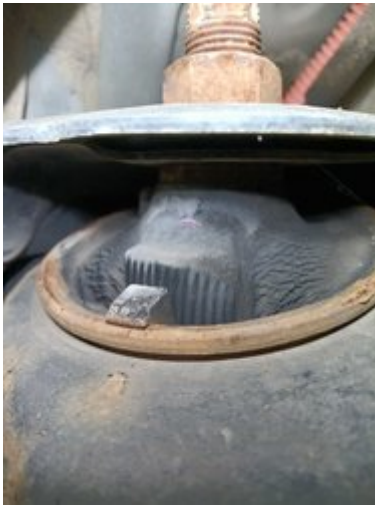
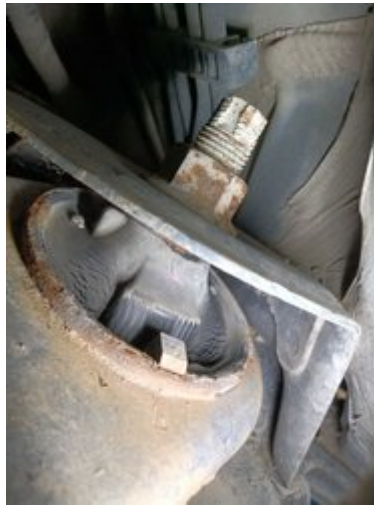
✓ 4. SUSPENSION: Suspension Lower Arm
