# Diagnosis report of 2022 PEUGEOT 2008 Allure

# Preparation and repair report of 2022 PEUGEOT 2008 Allure

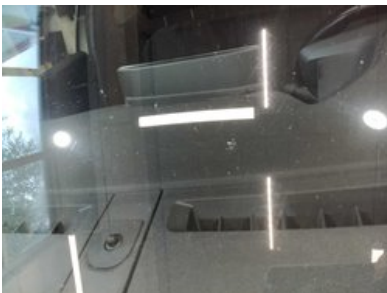
- ✓ **2. Front:** Windscreen Integrity - Free from MOT-Excluding Damage
