# Diagnosis report of 2020 TOYOTA YARIS Active

# Preparation and repair report of 2020 TOYOTA YARIS Active

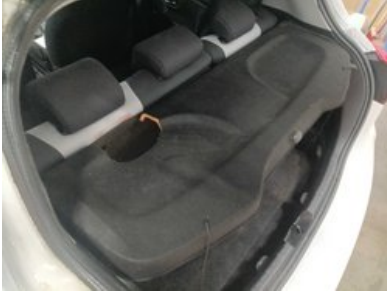
- ✓ **1. Inside:** Parcel Shelf - Operation and Condition

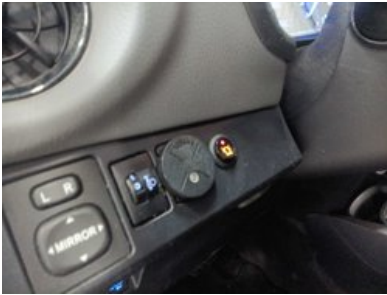
- ✓ **2. Front:** Trims - Condition

- ✓ 1. Change Element in Front Panel
- ✓ 2. Change Mirror Cover

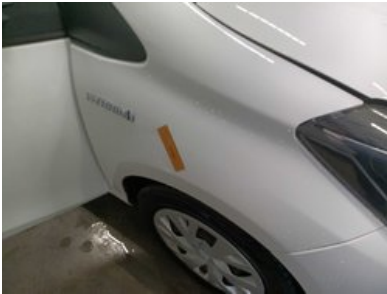
- ✓ **1. Side:** Left and Right Side - Visual Damage and Scratches

- ✓ 1. Paint Front Fender
- ✓ 2. Paint Sill
- ✓ 3. Paint Rear Fender
- ✓ 4. Paint Roof

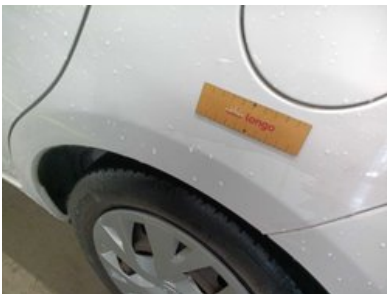
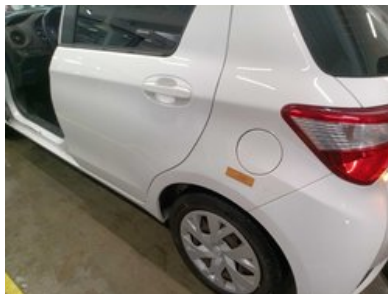
- ✓ **2. Side:** Left and Right Side - Visual Damage and Scratches

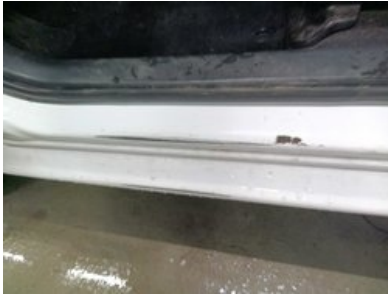
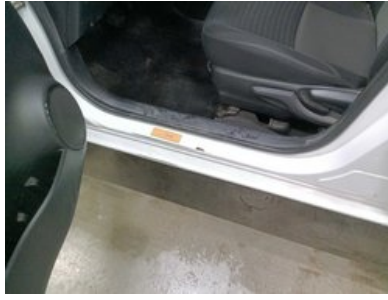
✔ **3. Side:** Left and Right Side - Visual Damage and Scratches

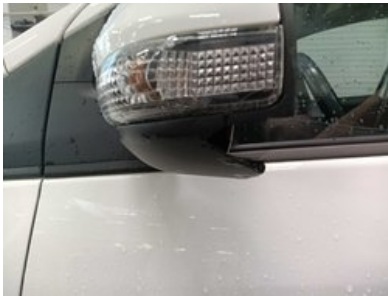
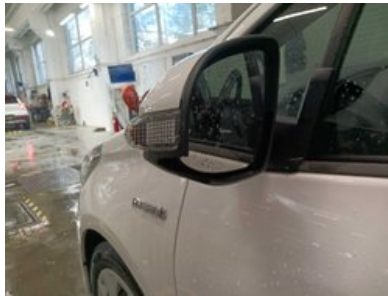
✔ **4. Side:** Exterior Mirrors - Mirror Integrity and Car Attachment

- 1. Side Mirror Left Hand (5402-19-1491318P)

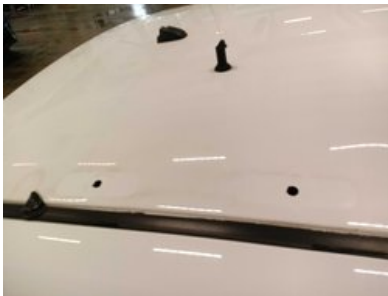
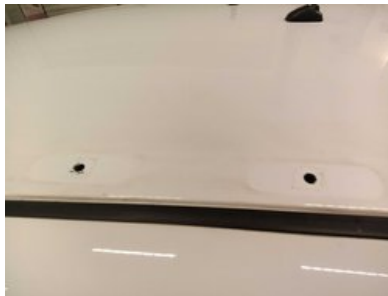
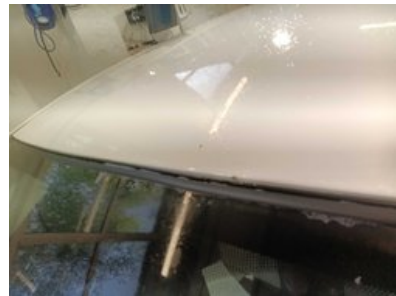
✔ **5. Other:** Roof - Visual Damage (e.g., Hail Damage)
