# Diagnosis report of 2016 FORD MONDEO Titanium

During the comprehensive diagnosis conducted by Longo, 23 issues were identified in the vehicle.

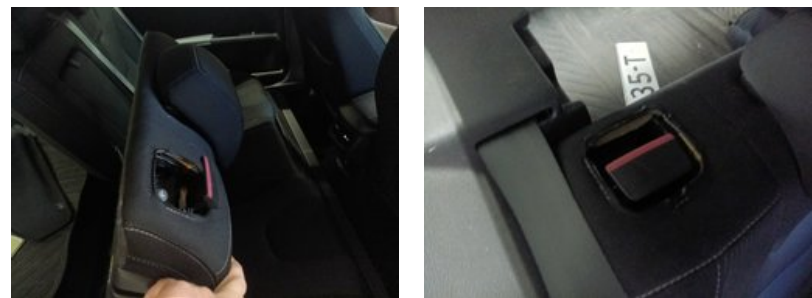
- ✔ 1. Seats: Seat Adjustment Mechanisms - Functioning

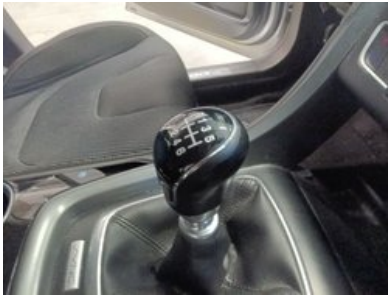
✔ **2. Inside:** Gear Shift Boot and Gear Shift Knob - Condition

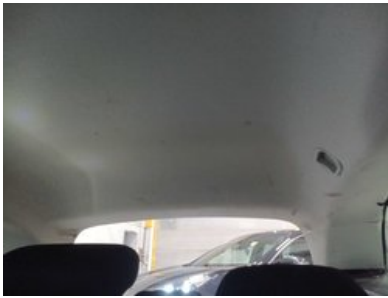
✔ **3. Inside:** Additional Cleaning Tasks

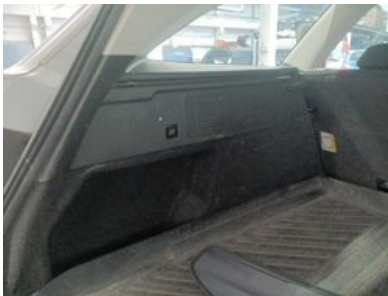
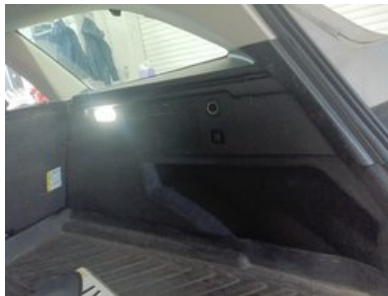
✔ **4. Inside:** Trims - Condition

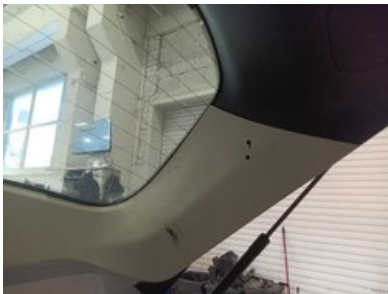
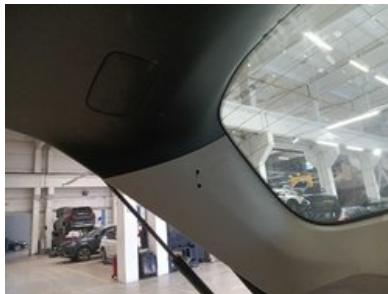
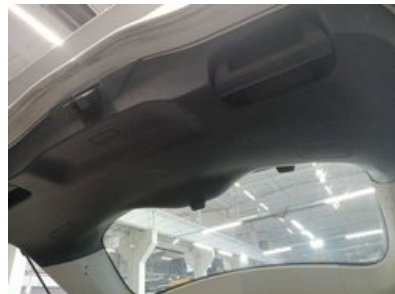
✔ **5. Inside:** Trims - Condition

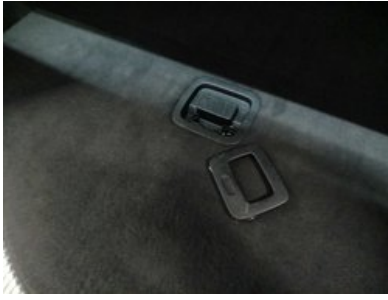
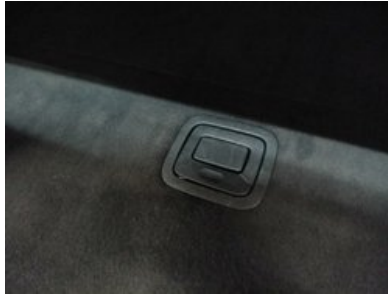
✔ **6. Inside:** Carpets - Condition

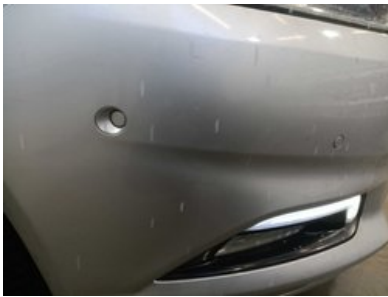
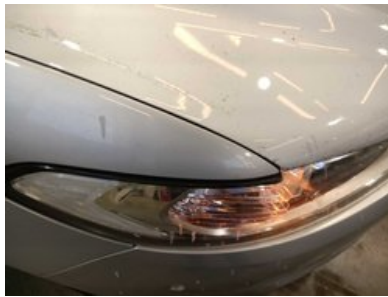
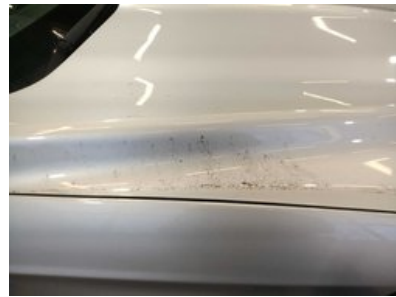
✔ **1. Other:** Additional Polishing Tasks

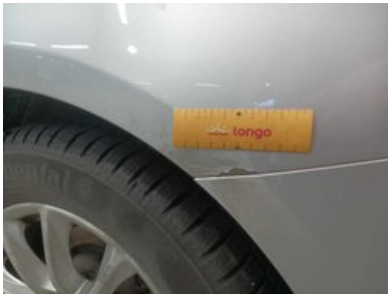
✔ **2. Other:** Additional Polishing Tasks

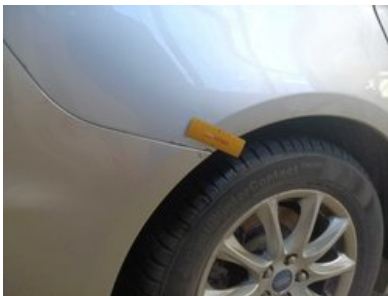
✔ **3. Other:** Additional Polishing Tasks

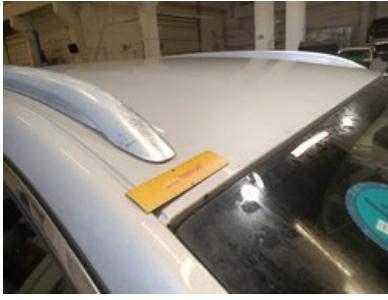
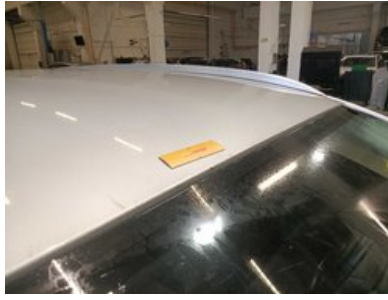
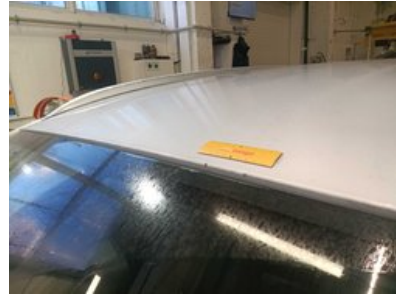
✓ **4. Other:** Roof - Visual Damage (e.g., Hail Damage)

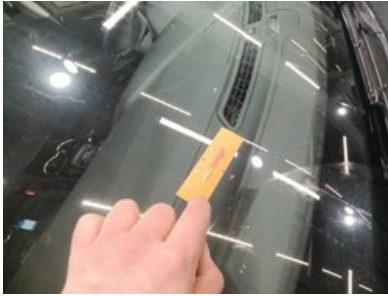
✓ **5. Front:** Windscreen Integrity - Free from MOT-Excluding Damage

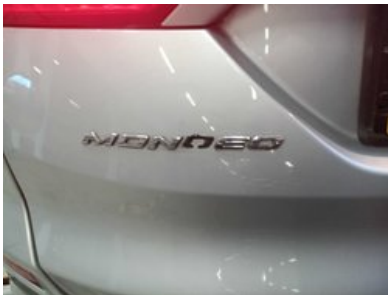
✓ **6. Rear:** Trunk - Visual Damage

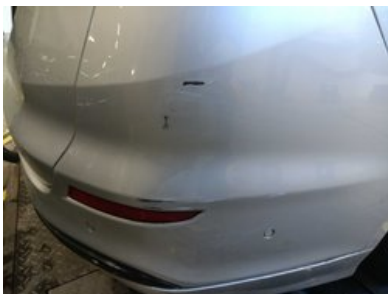
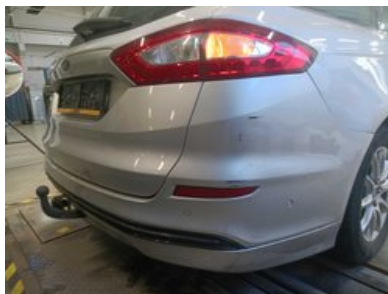
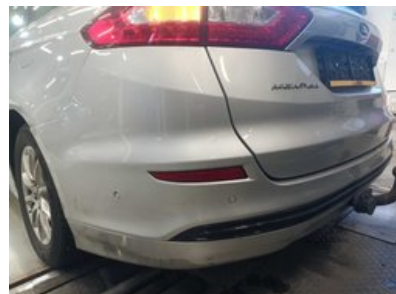
✓ **7. Rear:** Rear Bumper - Condition and Alignment

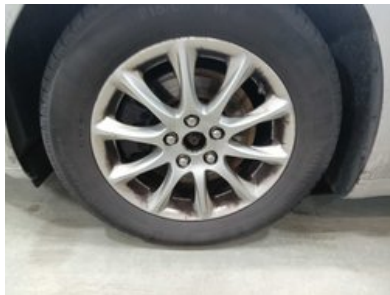
✓ **8. Side:** Wheels - Condition

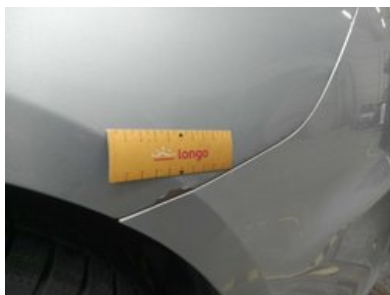
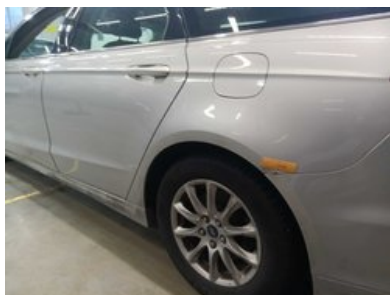
✓ **9. Side:** Left and Right Side - Visual Damage and Scratches

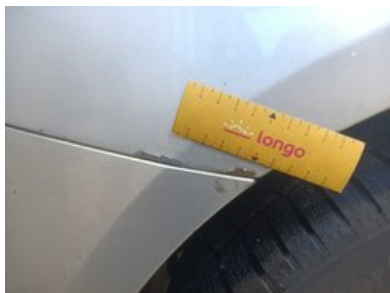
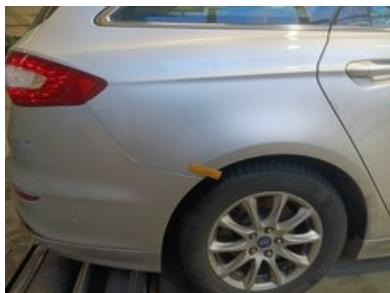
✓ **10. Side:** Left and Right Side - Visual Damage and Scratches

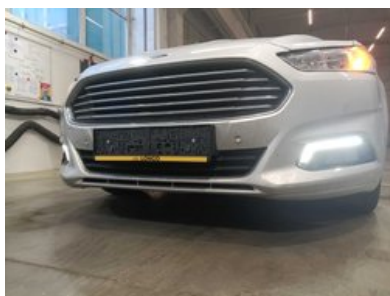
✓ **11. Lights:** Front Lights (City, Regular, Full Headlight, Fog, Indicator) - Basic Functioning, Damage, and Color

- ✓ 1. Fog Light Adjustment

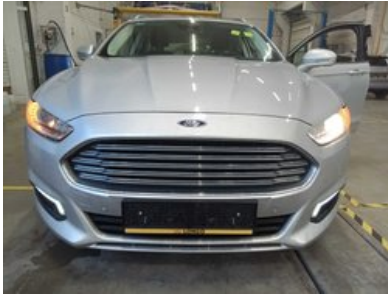
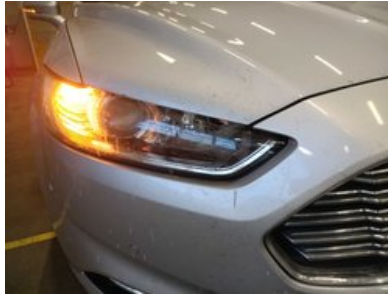
✓ **12. Lights:** Light Bulbs

- ✓ 1. Injection Pump
- ✓ 2. Engine Oil & Filter Change
- ✓ 3. Charge Battery
- ✓ 4. Change Bulb for Headlights
- ✓ 5. Change Bulb for License Plate Lights

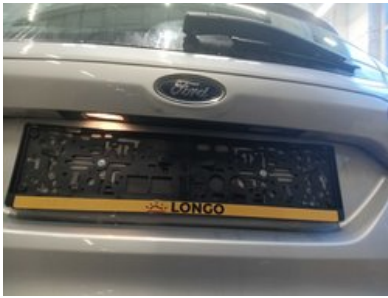
✓ **13. Lights:** Light Bulbs

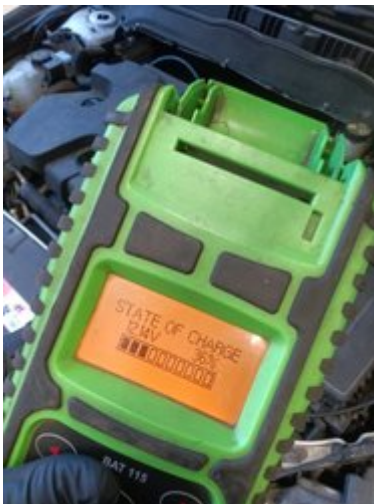
✓ **2. OTHER:** Charge Battery

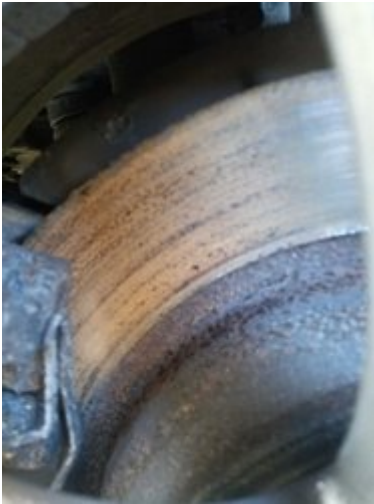
✓ **3. BRAKES:** Rear Brake Disc (Both) with Pads

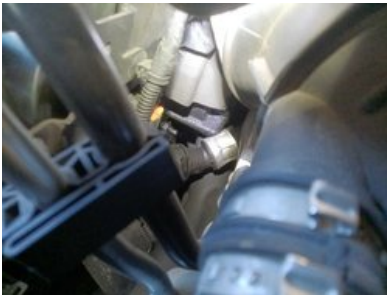
✓ **4. ENGINE MANAGEMENT - FUEL:** Injection Pump

- 1. Oil Filter (OP546/2)
- 2. OEM Fuel Pump Gasket (1892940)
- 3. OEM Gasket (2125417)
- 4. Fuel Pump Gasket (EL793480)
- 5. Oil Drain Plug (257.865.001)
- 6. Total Ineo First 0W30 208L 6.1L
