# Diagnosis report of 2017 HONDA CR-V Elegance Plus

Diagnosis report of

2017 HONDA CR-V Elegance Plus

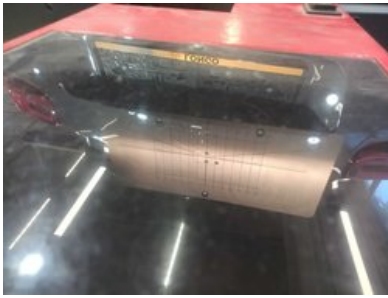
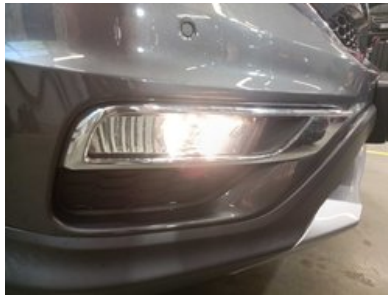
- ✓ **1. Lights:** Front Lights (City, Regular, Full Headlight, Fog, Indicator) - Basic Functioning, Damage, and Color

- ✓ 1. Change Front Fog Lights

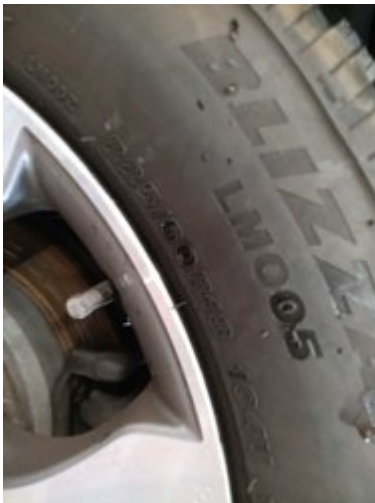
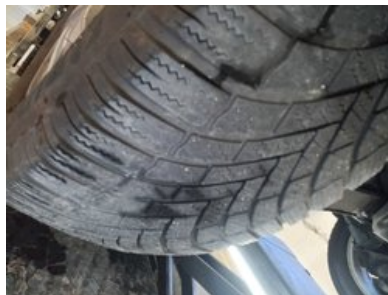
- ✓ **1. OTHER:** Change Tires

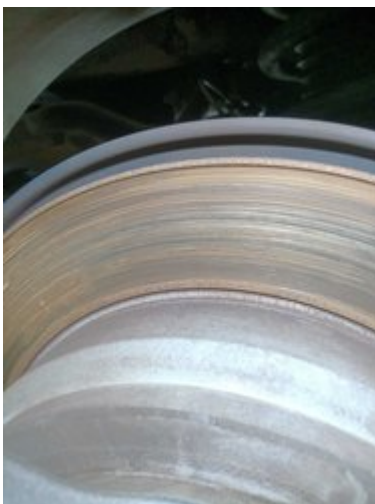
- ✓ **3. BRAKES:** Rear Brake Disc (Both)
