# Diagnosis report of 2017 TOYOTA C-HR Executive

# Preparation and repair report of 2017 TOYOTA C-HR Executive

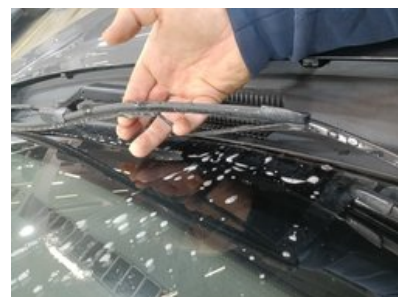
- ✔ 1. Front: Window Wiper Rubber and Handle (Front and Rear) - Condition

- ✓ 1. Change Front Wiper (Mechanical)
- ✓ 2. Engine Oil & Filter Change
- ✓ 3. Battery
- ✓ 4. System Evacuation/Recharging

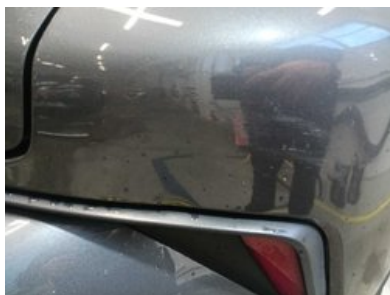
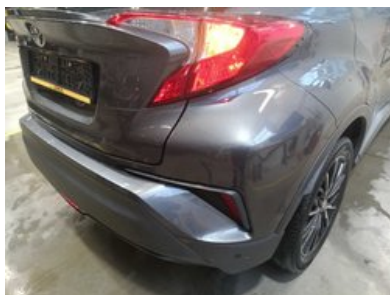
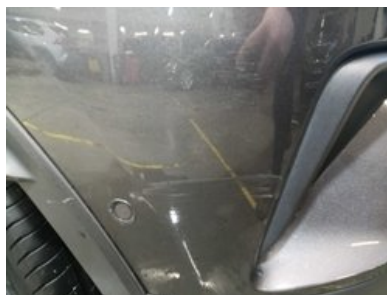
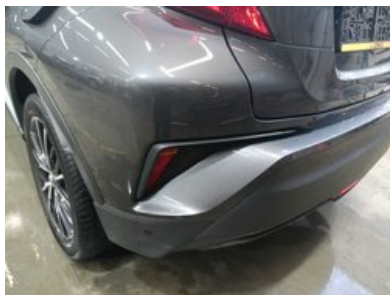
### ✓ 1. Rear: Rear Bumper - Condition and Alignment

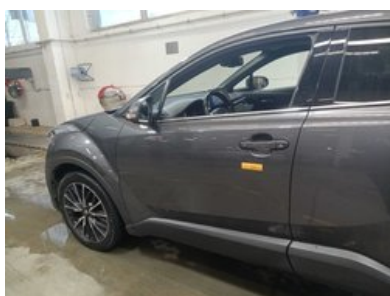
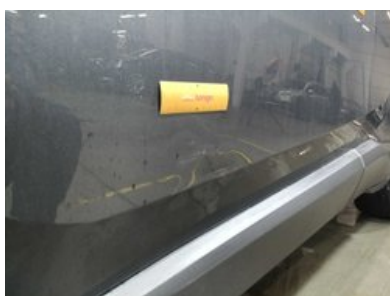
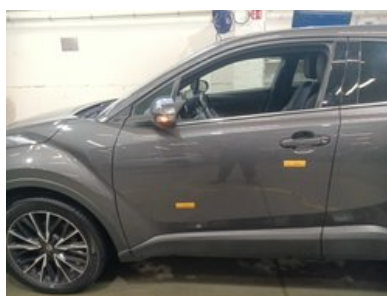
### ✓ 2. Side: Left and Right Side - Visual Damage and Scratches

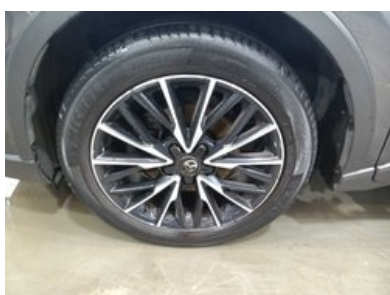
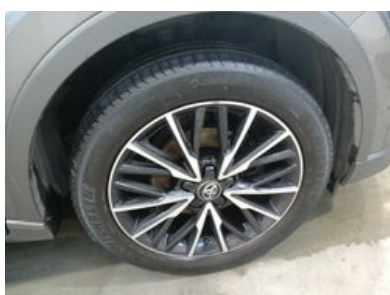
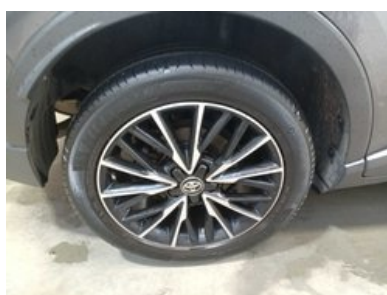
### ✓ 3. Side: Wheels - Condition

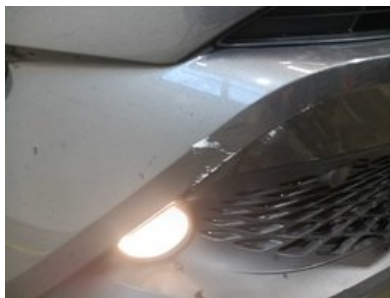
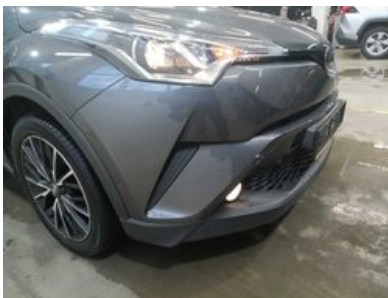
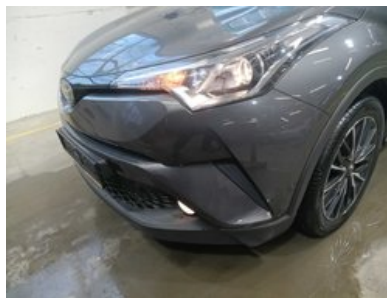
✔ **4. Front:** Front Bumper - Condition and Alignment

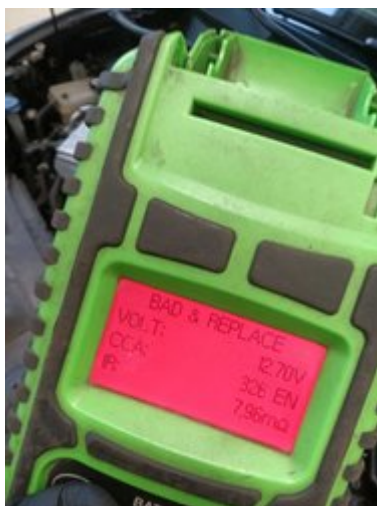
✔ **2. GENERAL ELECTRICS:** Battery

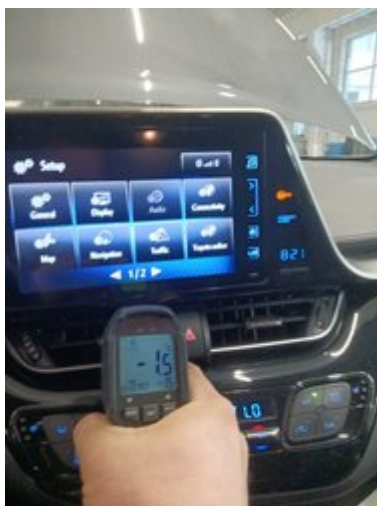
✓ 4. Air-Conditioning Measurement
