# Diagnosis report of 2015 CITROEN C4 CACTUS Business

During the comprehensive diagnosis conducted by Longo, 10 issues were identified in the vehicle.

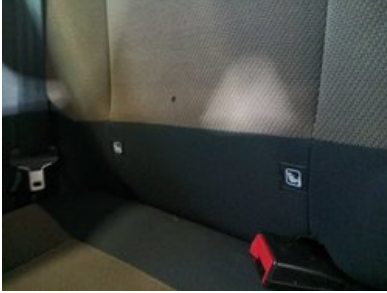
- ✓ **1. Seats:** All Seats - Condition

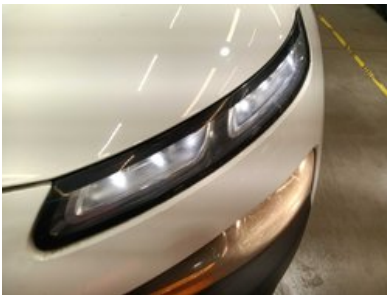
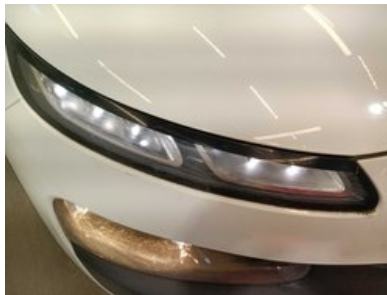
- ✓ **1. Other:** Additional Polishing Tasks

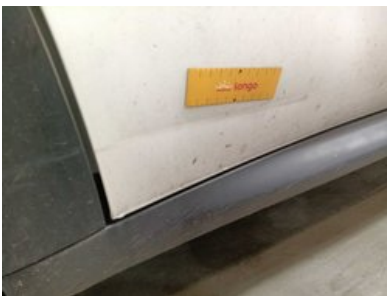
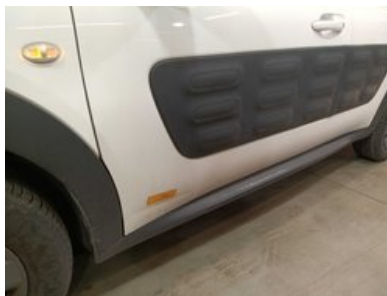
- ✓ **2. Side:** Left and Right Side - Visual Damage and Scratches

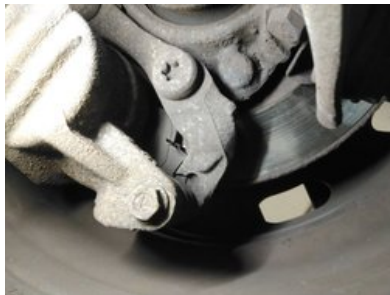
✓ **2. BRAKES:** Front Brake Discs Both with Pads

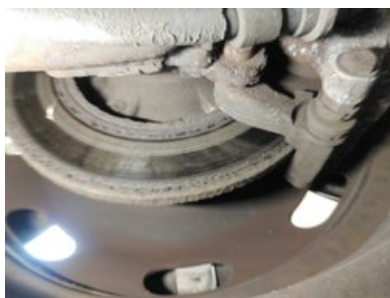
✓ **3. BRAKES:** Rear Brake Disc (Both) - Brake Pads Removed

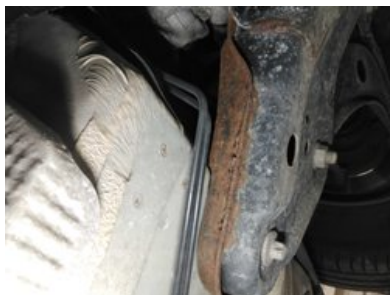
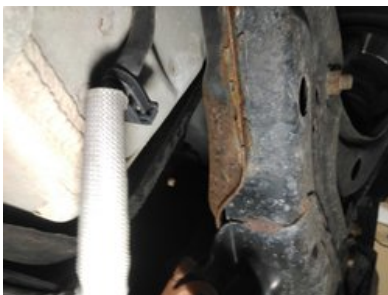
✓ **4. FINAL DRIVE, SHAFT & AXLES:** Front Axle - Complete

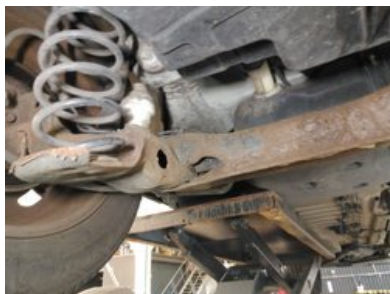
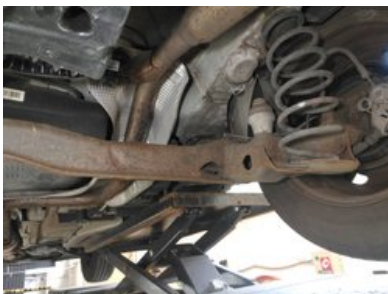
✓ **5. FINAL DRIVE, SHAFT & AXLES:** Rear Axle - Complete

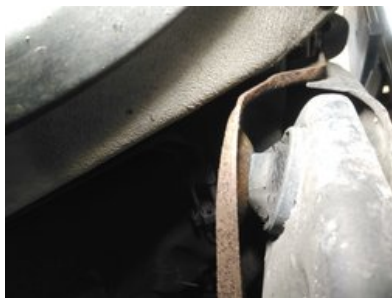
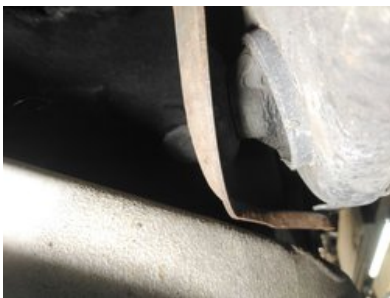
✓ **6. SUSPENSION:** Suspension Lower Arm Both

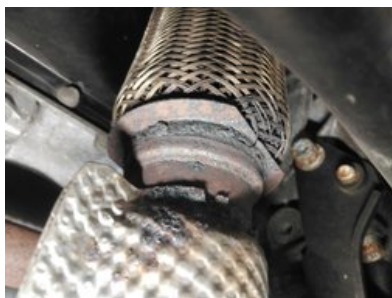
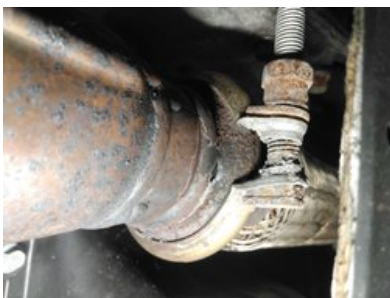
✓ **7. EXHAUST SYSTEM:** Pipe - Front/Downpipe
