# Diagnosis report of 2015 RENAULT CAPTUR Helly Hansen

# Preparation and repair report of 2015 RENAULT CAPTUR Helly Hansen

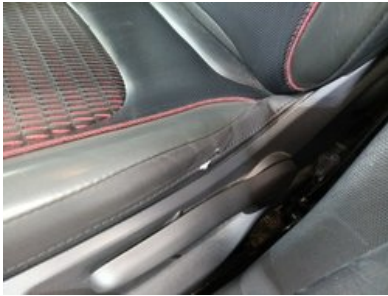
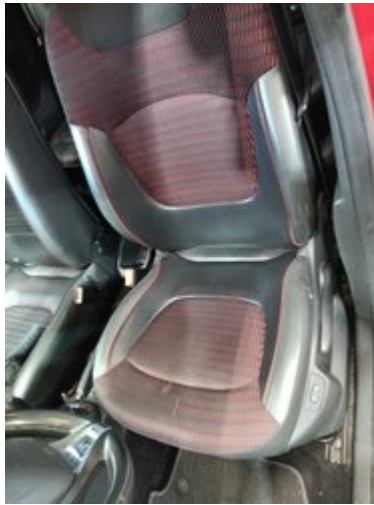
### ✓ 1. Seats: All Seats - Condition

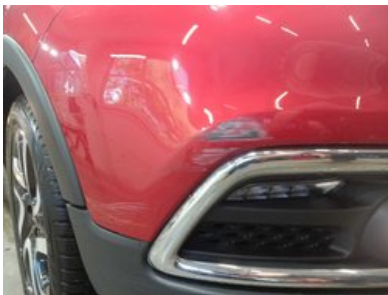
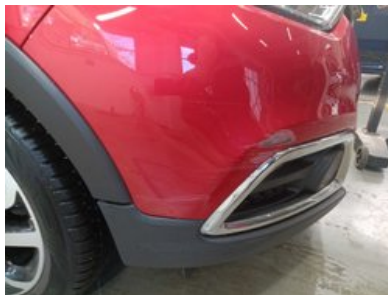
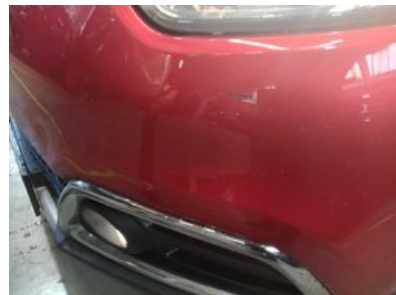
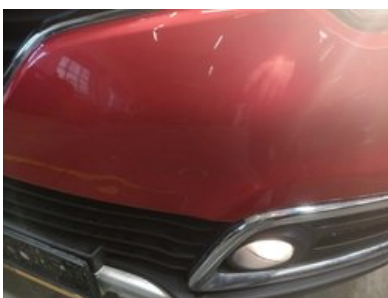
### ✓ 1. Front: Front Bumper - Condition and Alignment

- ✓ 1. Paint Front Bumper

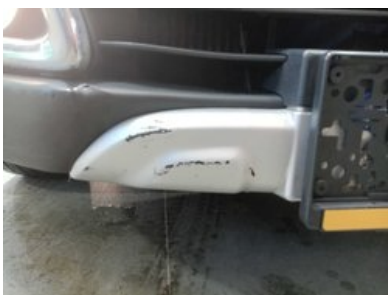
### ✓ 2. Front: Front Bumper - Condition and Alignment

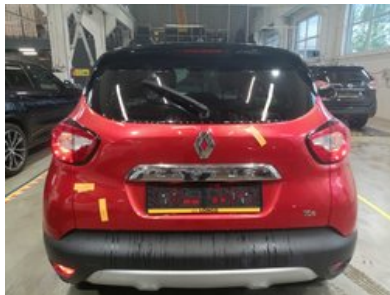
✓ **3. Rear:** Trunk - Visual Damage

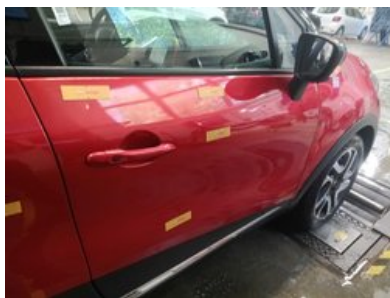
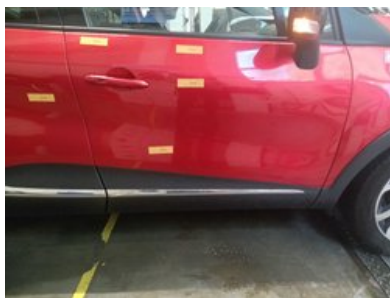
✓ **4. Side:** Left and Right Side - Visual Damage and Scratches

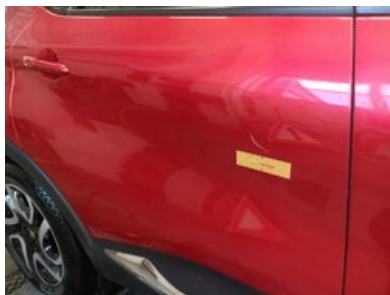
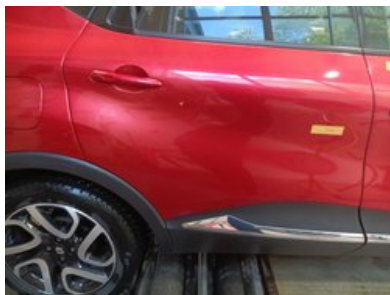
✓ **5. Side:** Left and Right Side - Visual Damage and Scratches

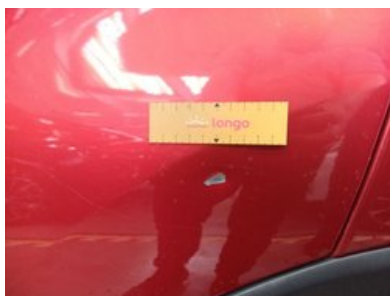
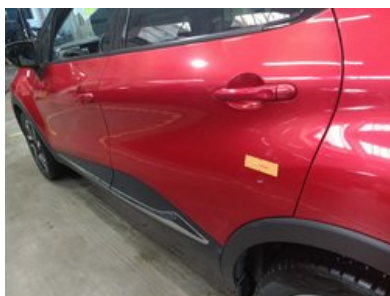
✓ **6. Side:** Left and Right Side - Visual Damage and Scratches

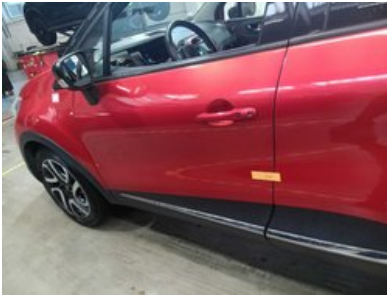
✔ **7. Side:** Left and Right Side - Visual Damage and Scratches

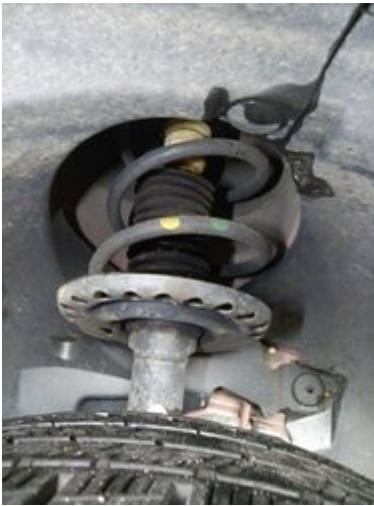
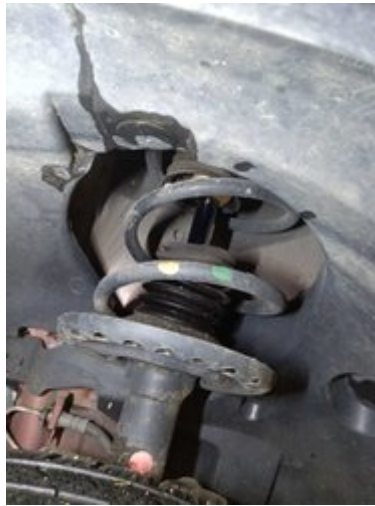
✔ **2. SUSPENSION:** Shock Absorber

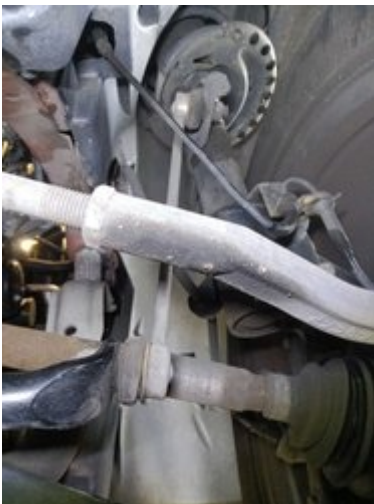
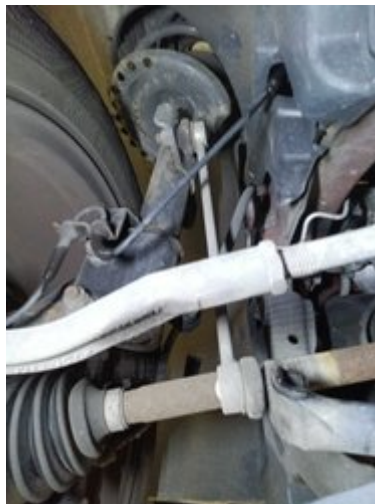
✔ **3. SUSPENSION:** Anti-Roll Bar Link, Outer, Both Sides

- ✓ 1. Engine Oil & Filter Change
- ✓ 2. System Evacuation/Recharging
- ✓ 3. Anti-Roll Bar Link - Outer (Both)

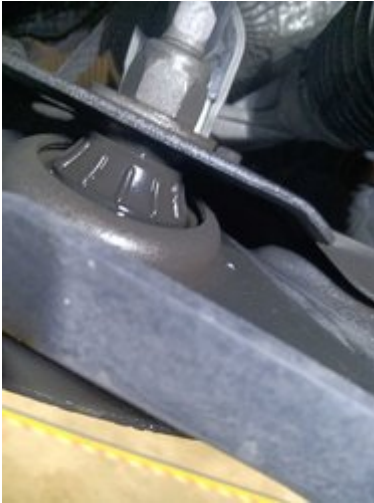
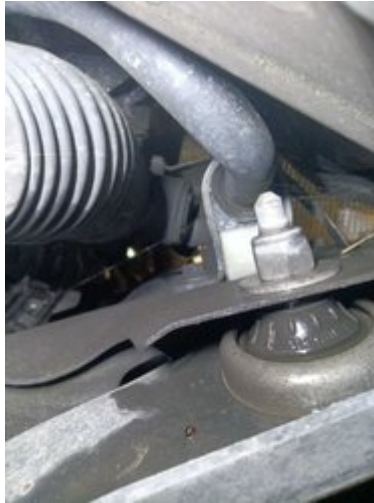
✓ **4. SUSPENSION:** Suspension Lower Arm Both

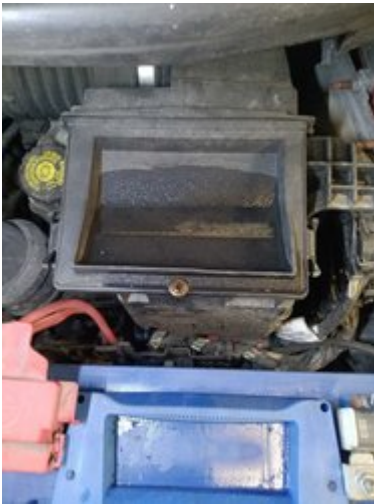
✓ **5. ENGINE MANAGEMENT - FUEL:** Air Filter Assembly

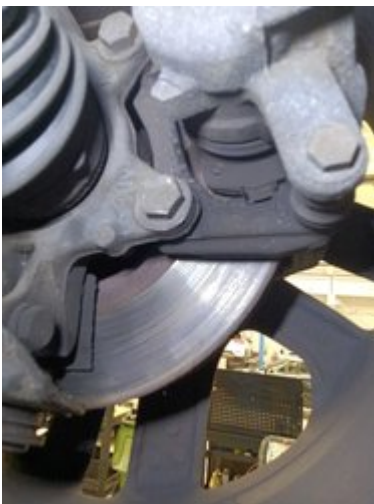
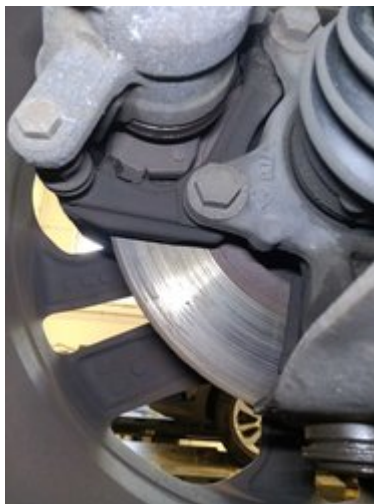
✓ **6. BRAKES:** Front Brake Discs Both with Pads

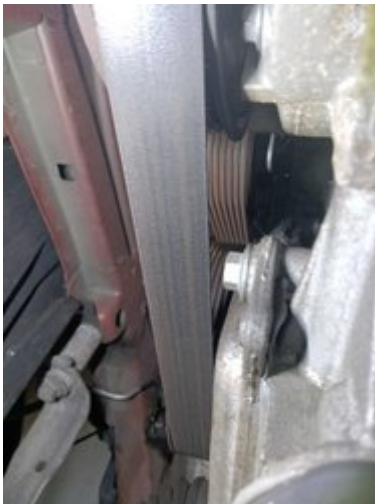
✓ **7. ENGINE:** Auxiliary Drive Belt
