# Diagnosis report of

## 2015 OPEL ASTRA Blitz

# Diagnosis report of 2015 OPEL ASTRA Blitz

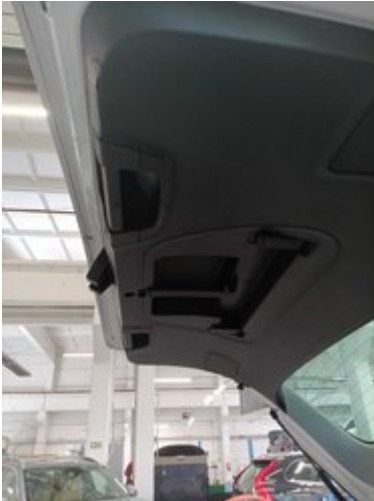
### ✓ 1. Inside: Trims - Condition

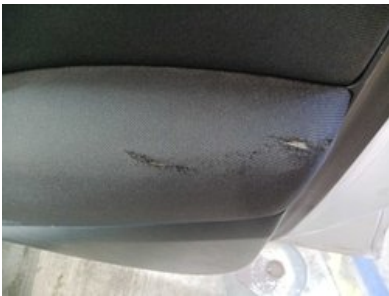
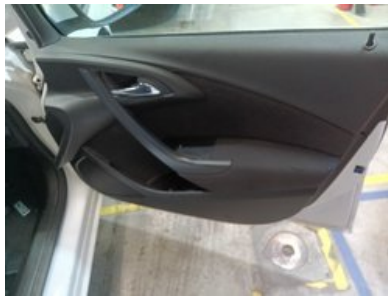
### ✓ 2. Doors: Trims - Condition

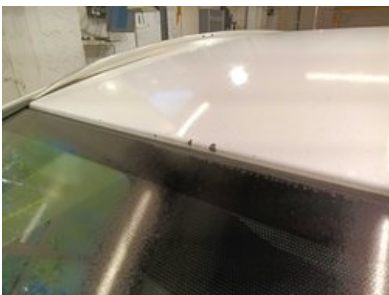
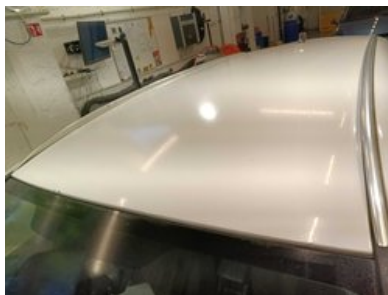
### ✓ 1. Other: Roof - Visual Damage (e.g., Hail Damage)

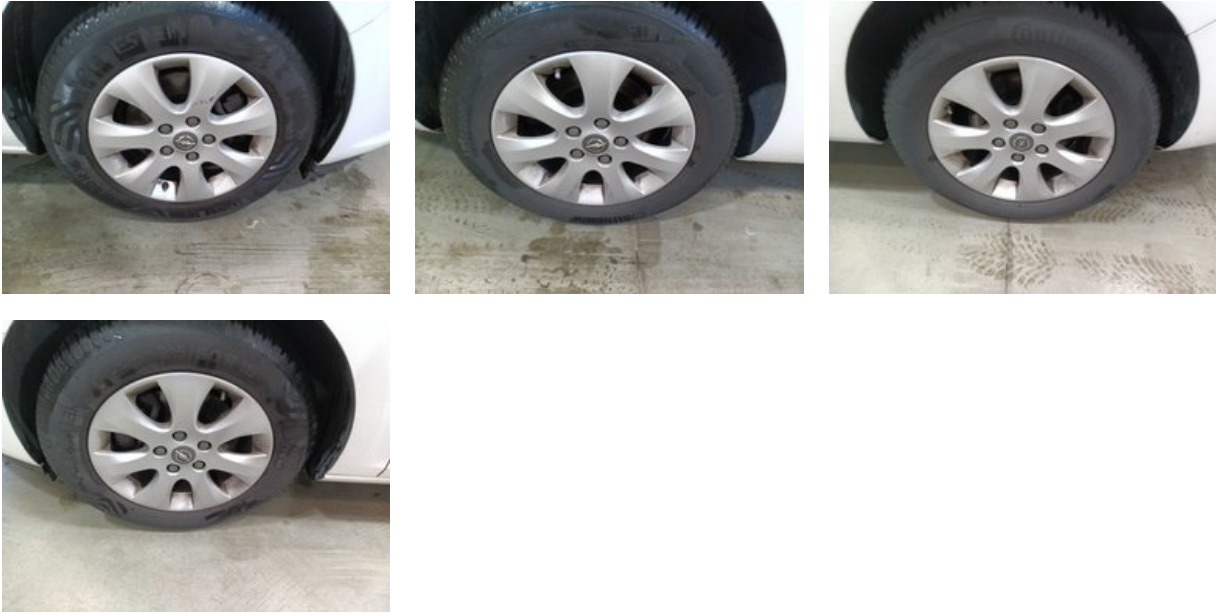
✓ **2. Side:** Wheels - Condition

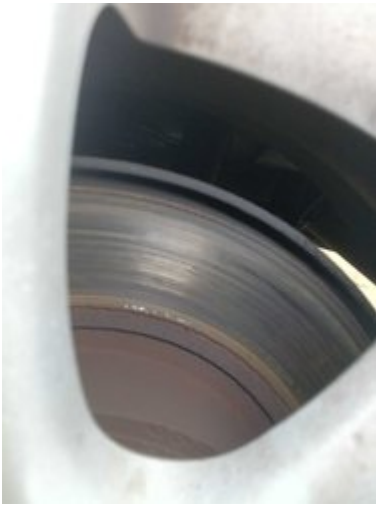
✓ **2. BRAKES:** Rear Brake Disc (Both)

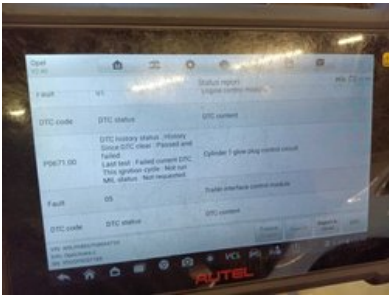
✓ **3. ENGINE:** Glow Plug

- ✓ 1. Engine Oil & Filter Change
- ✓ 2. Glow Plug
