# Diagnosis report of 2021 HYUNDAI TUCSON MHEV Ultimate

Diagnosis report of

2021 HYUNDAI TUCSON MHEV Ultimate

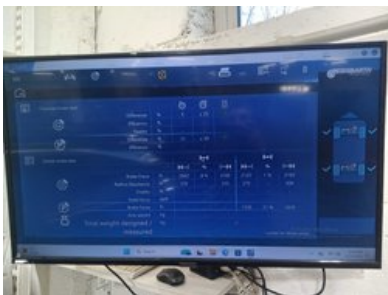
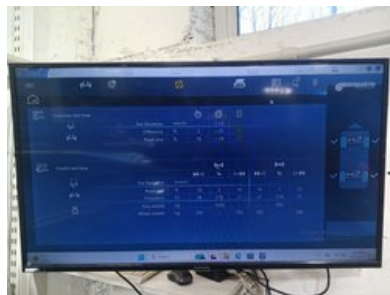
✓ **1. Brake Test Line Results**

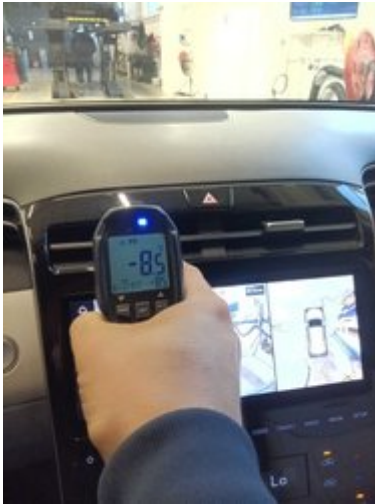
✓ 3. Air-Conditioning Measurement
