# Diagnosis report of 2015 MITSUBISHI OUTLANDER Executiv

Diagnosis report of

2015 MITSUBISHI OUTLANDER Executiv

Diagnosis details

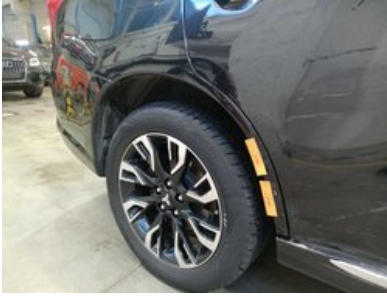
✓ **6. Side:** Left and Right Side - Visual Damage and Scratches

- ✓ 1. Paint Door
- ✓ 2. Paint Rear Fender
- ✓ 3. Paint Sill

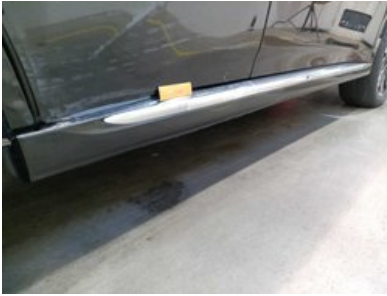
✓ **7. Side:** Left and Right Side - Visual Damage and Scratches

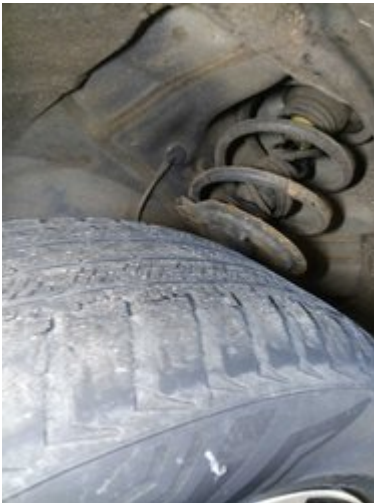
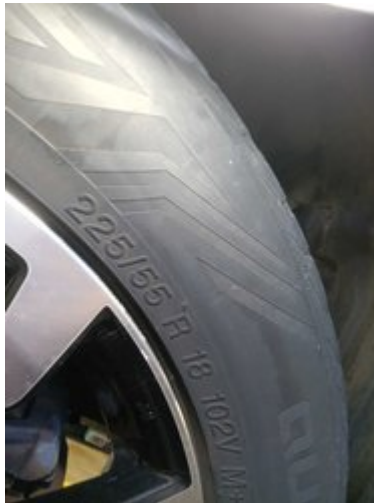
✓ **2. OTHER:** Change Tires

- ✓ 1. Front Wheel Alignment (Toe)
- ✓ 2. Change Tires
- ✓ 3. Track Rod End Joint (Both)
- ✓ 4. Engine Oil & Filter Change
