# Diagnosis report of 2014 PEUGEOT 308 Executive

# Preparation and repair report of 2014 PEUGEOT 308 Executive

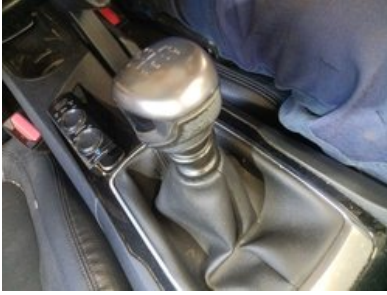
- ✓ **1. Inside:** Gear Shift Boot and Gear Shift Knob - Condition

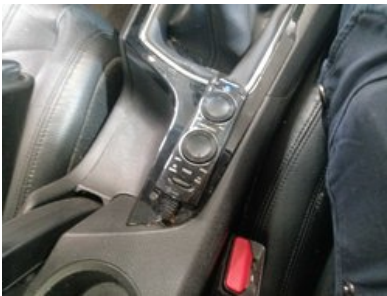
- 
- ✓ **3. Inside:** Accessories - Functioning and Condition

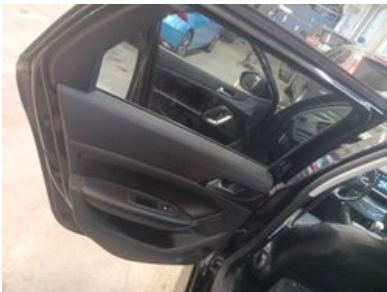
- 
- ✓ **4. Doors:** All Four Doors - Opening, Closing, and Handle Operation

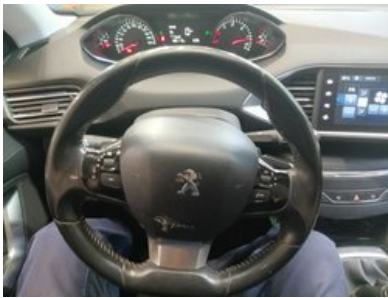
✓ **5. Front:** Steering Wheel - Condition

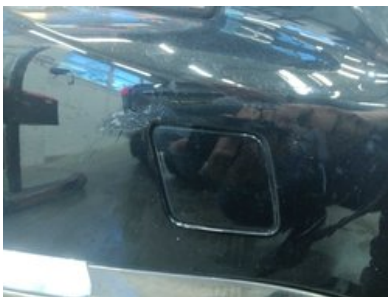
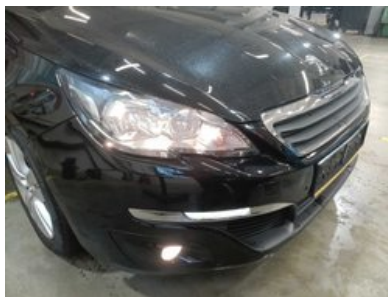
✓ **1. Front:** Front Bumper - Condition and Alignment

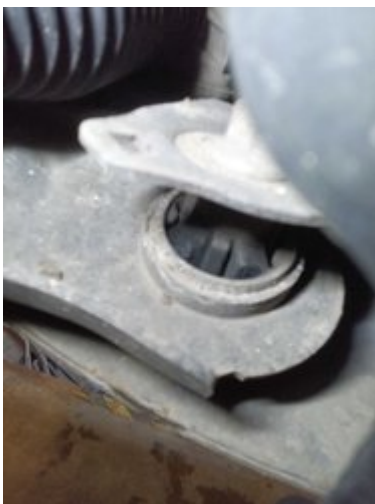
✓ **1. SUSPENSION:** Suspension Lower Arm Bushes Both

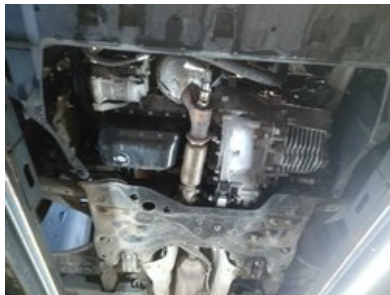
✓ **2. BODY - FRONT SECTION:** Engine Cover

- ✓ 1. Engine Cover
- ✓ 2. Change Tires

- 1. Engine Cover (PCT60018A)
- 2. LAUFENN 205/55R16 91T LW31 Winter (Žieminės padangos LAUFENN 20555 R16 91T LW31)

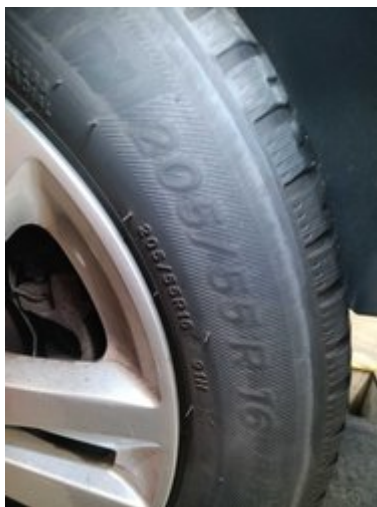
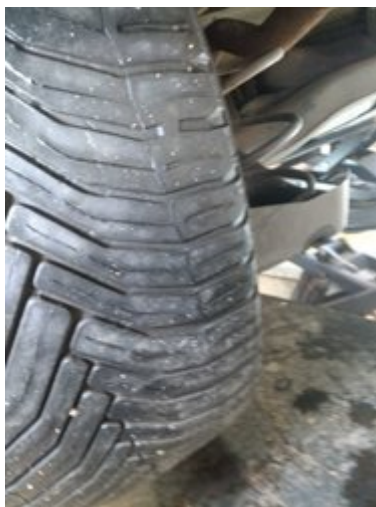
✓ **3. OTHER:** Change Tires
