# Diagnosis report of 2015 OPEL INSIGNIA Business+

# Preparation and repair report of 2015 OPEL INSIGNIA Business+

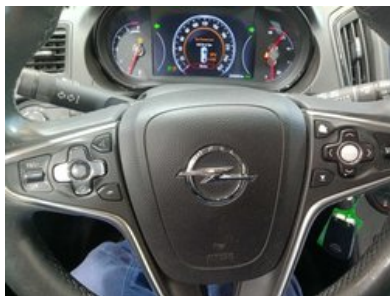
- ✓ **1. Front:** Steering Wheel - Operation of Controls/Buttons

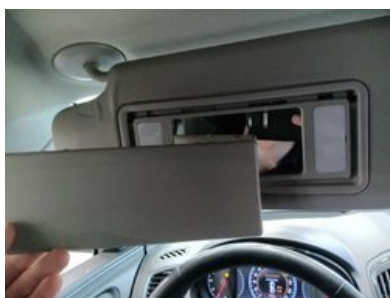
- 
- ✓ **2. Front:** Sun Visors - Operation and Condition

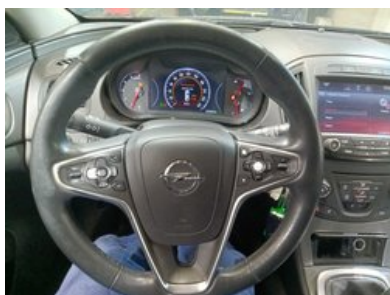
- 
- ✓ **3. Front:** Steering Wheel - Condition

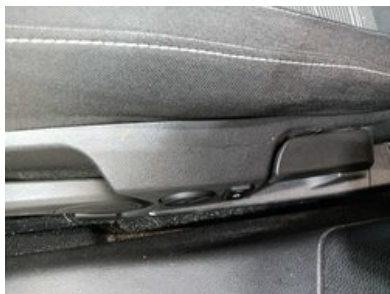
- 
- ✓ **4. Seats:** All Seats - Condition

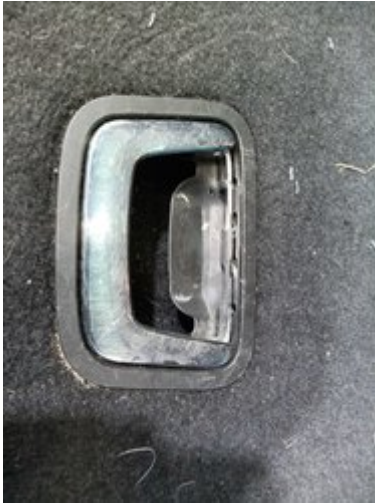
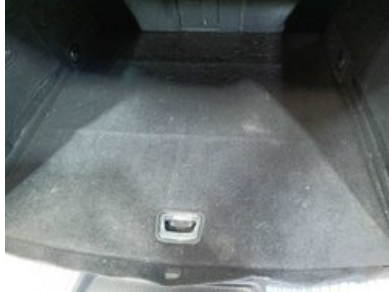
✓ **5. Inside:** Carpets - Condition

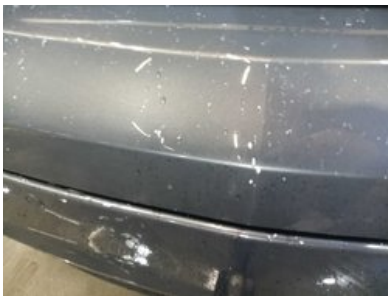
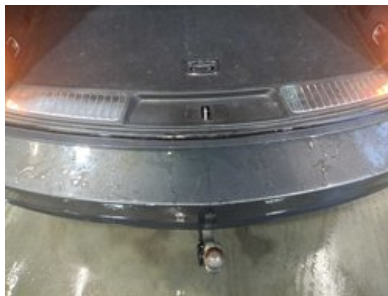
✓ **1. Rear:** Rear Bumper - Condition and Alignment

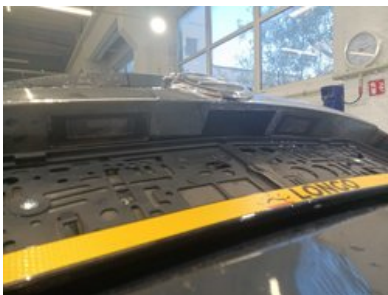
✓ **2. Lights:** Light Bulbs

- ✓ 1. Exhaust Gas Recirculation (EGR) Valve
- ✓ 2. Change Bulb for License Plate Lights
- ✓ 3. Engine Oil & Filter Change
- ✓ 4. Suspension Upper Arm (Both)

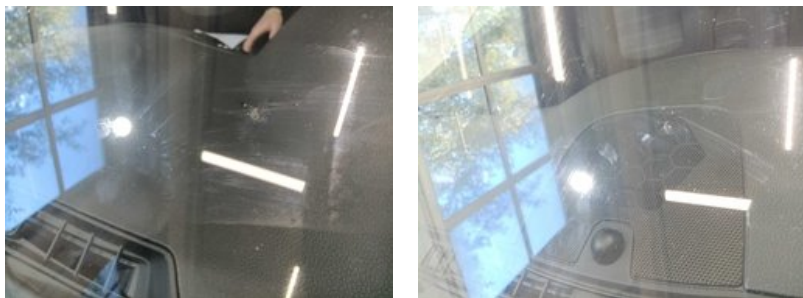
✔ **3. Front:** Windscreen Integrity - Free from MOT-Excluding Damage

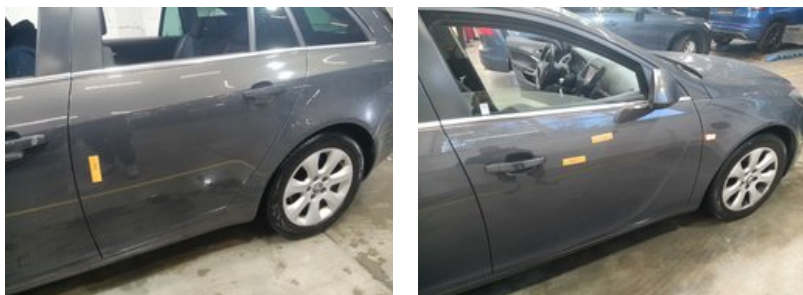
✔ **4. Side:** Left and Right Side - Visual Damage and Scratches

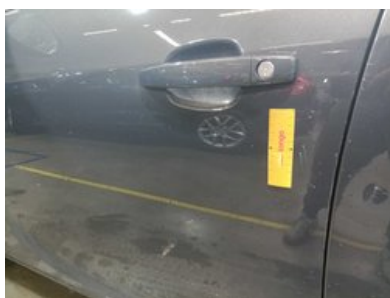
✔ **5. Side:** Left and Right Side - Visual Damage and Scratches

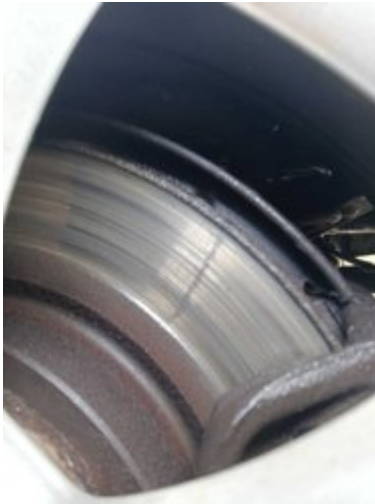
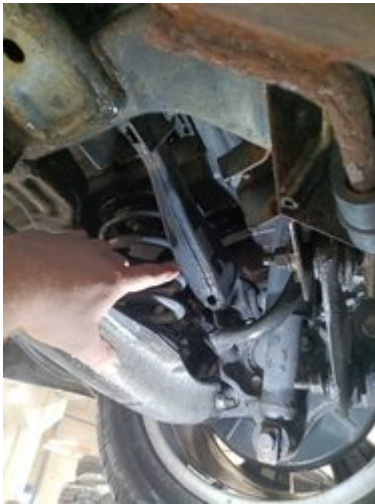
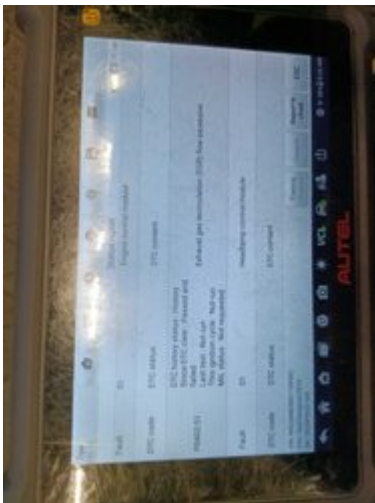
✔ **1. OTHER:** Engine Oil & Filter Change

- 1. Oil Filter (OE682/1)
- 2. Engine Oil 4.5L
- 3. Track Control Arm (OP-TC-15794)
- 4. Track Control Arm (OP-TC-15793)
- 5. Oil Drain Plug (359.300)
