# Diagnosis report of 2017 PEUGEOT 2008 GT-line

# Preparation and repair report of 2017 PEUGEOT 2008 GT-line

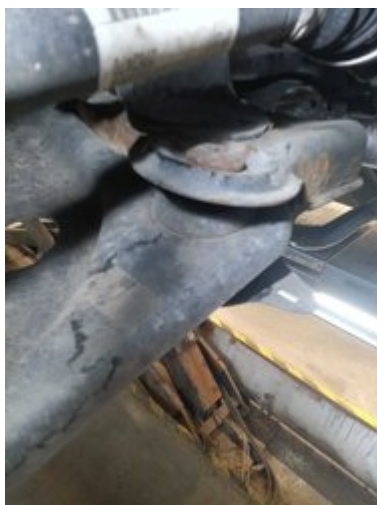
✓ **1. SUSPENSION:** Suspension Lower Arm Both

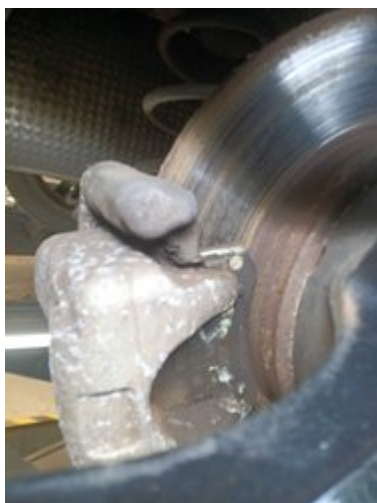
✓ **2. BRAKES:** Rear Brake Disc (Both)

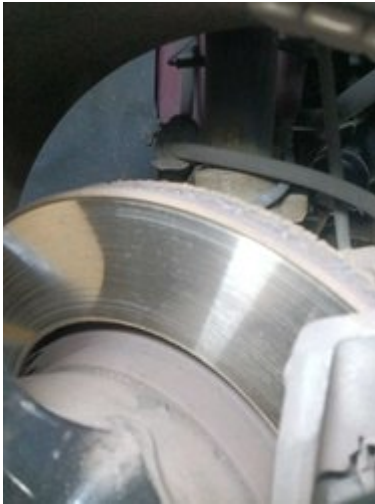
✓ **3. BRAKES:** Front Brake Discs Both

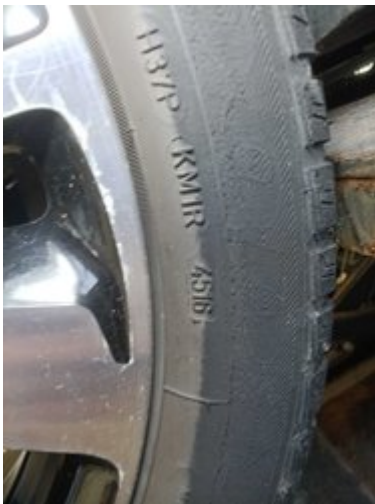
✓ **4. OTHER:** Change Tires

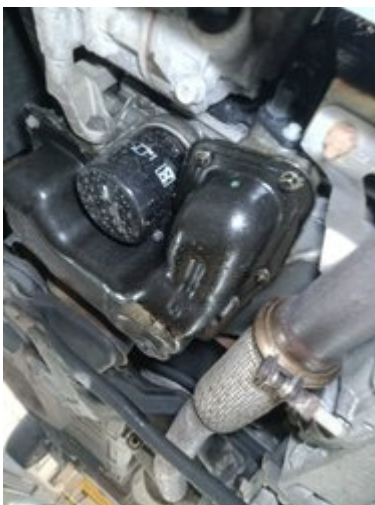
✓ **5. ENGINE:** Oil Pan - Lower

- ✓ 1. Oil Sump Pan - Lower
