# Diagnosis report of 2014 TOYOTA AURIS Aspiration

# Preparation and repair report of 2014 TOYOTA AURIS Aspiration

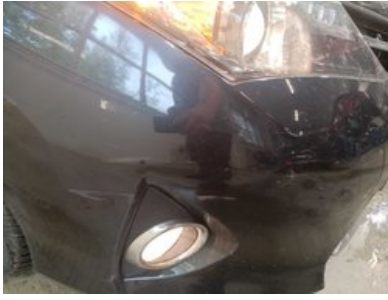
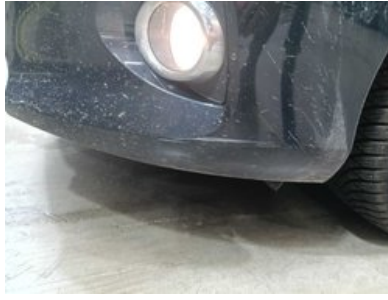
✔ **2. Front:** Front Bumper - Condition and Alignment

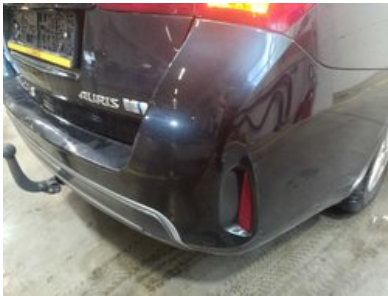
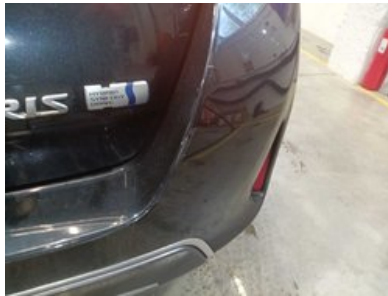
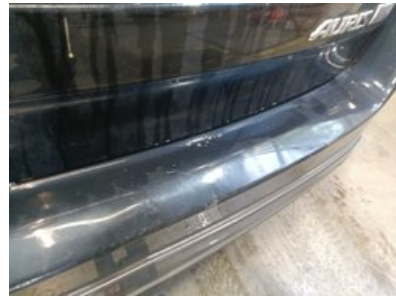
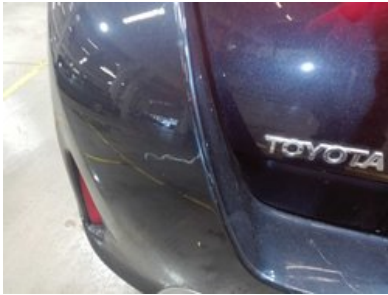
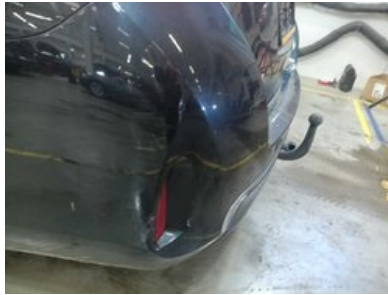
✔ **3. Rear:** Rear Bumper - Condition and Alignment

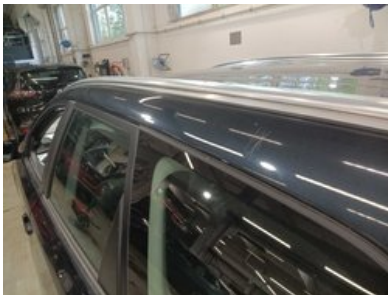
✔ **4. Side:** Left and Right Side - Visual Damage and Scratches

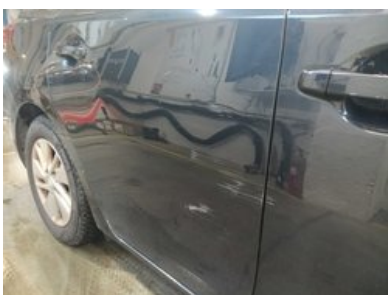
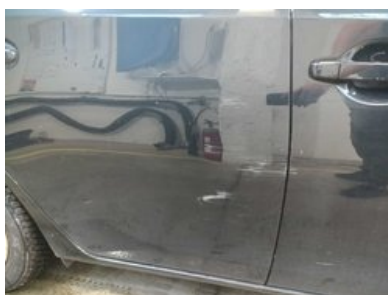
✔ **5. Other:** Additional Polishing Tasks

- ✓ 1. Body wet wash
- ✓ 2. Full interior deep clean using only hypoallergenic cleaning products
- ✓ 3. Post cleaning body polish
