# Diagnosis report of 2015 OPEL ZAFIRA TOURER Business+

## Diagnosis details

During the comprehensive diagnosis conducted by Longo, 13 issues were identified in the vehicle.

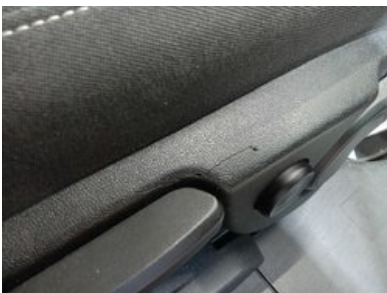
✓ **3. Seats:** All Seats - Condition

- ✓ 1. Change Seat Side Plastic

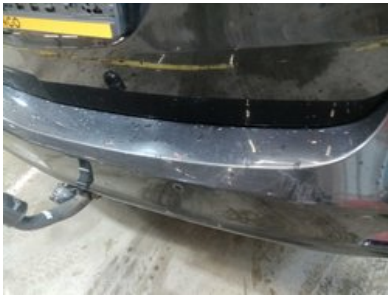
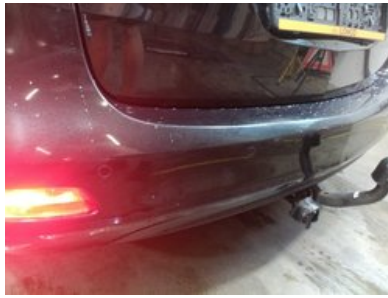
- ✓ **1. Rear:** Rear Bumper - Condition and Alignment

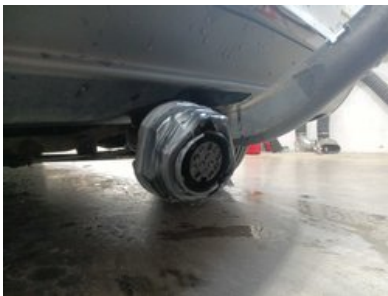
- ✓ **2. Rear:** Tow Hitch (Attachment, Removal Mechanism, External Light Connector, Connector Thickness)

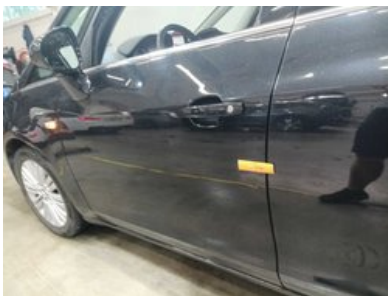
- ✓ **3. Side:** Left and Right Side - Visual Damage and Scratches

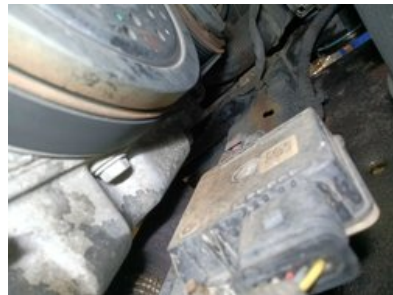
✓ **5. ENGINE:** Particulate Matter Sensor

- ✓ 1. Glow Plugs
- ✓ 2. Socket
- ✓ 3. Change Front Wiper (Mechanical)
- ✓ 4. Engine Oil & Filter Change
- ✓ 5. Front Brake Pads (All) — Wheels Removed
- ✓ 6. Particulate Matter Sensor

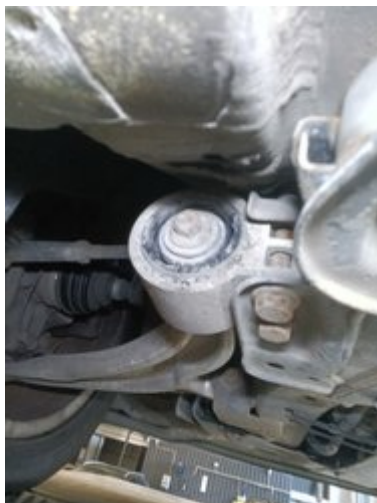
✓ **6. SUSPENSION:** Suspension Lower Arm Rear Both
