# Diagnosis report of 2014 TOYOTA AURIS Aspiration

# Preparation and repair report of 2014 TOYOTA AURIS Aspiration

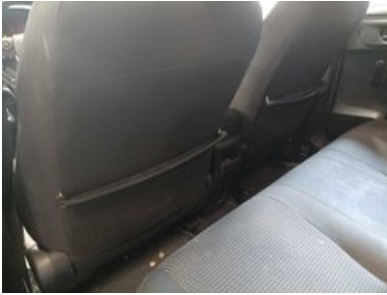
✓ **1. Seats:** All Seats - Condition

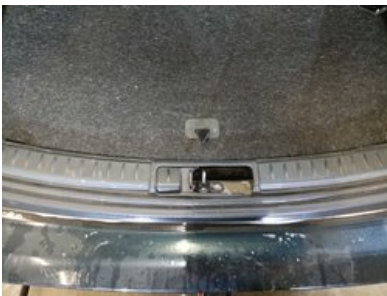
✓ **2. Inside:** Trims - Condition

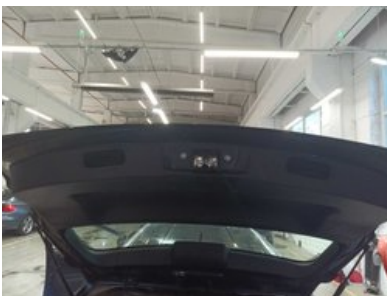
✓ **3. Inside:** Trims - Condition

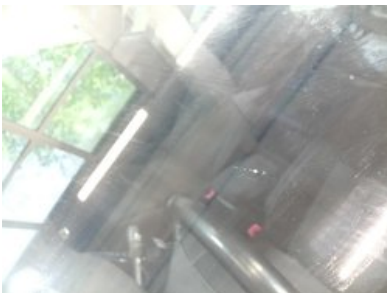
✓ **1. Front:** Windscreen Integrity - Free from MOT-Excluding Damage

- ✓ 1. Windshield Repair

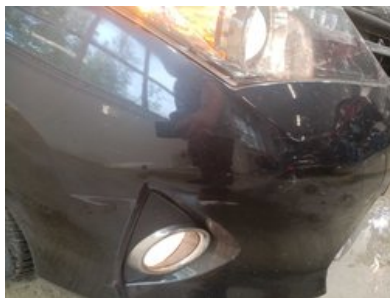
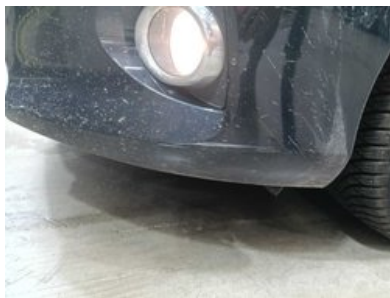
✔ **2. Front:** Front Bumper - Condition and Alignment

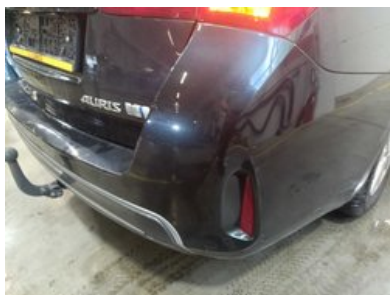
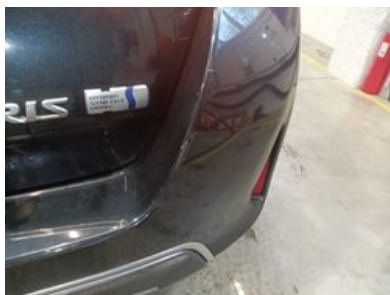
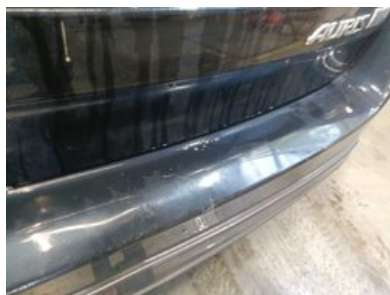
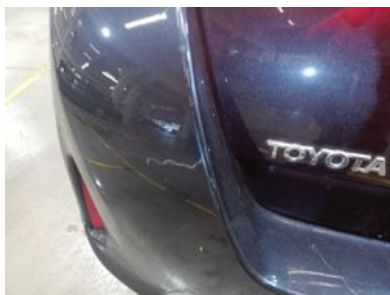
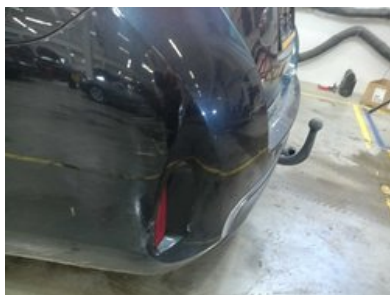
✔ **3. Rear:** Rear Bumper - Condition and Alignment

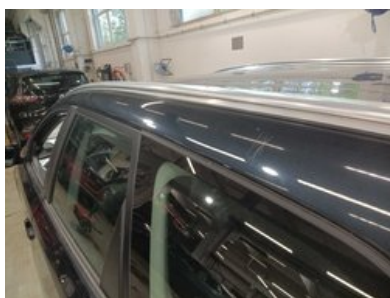
✔ **4. Side:** Left and Right Side - Visual Damage and Scratches

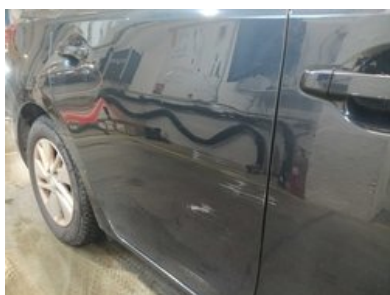
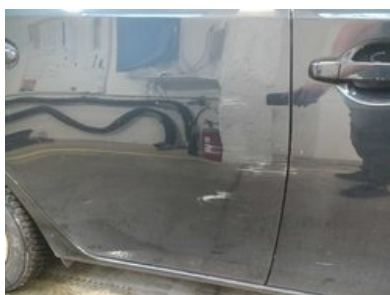
✔ **5. Other:** Additional Polishing Tasks

- ✓ 1. Body wet wash
- ✓ 2. Full interior deep clean using only hypoallergenic cleaning products
- ✓ 3. Post cleaning body polish

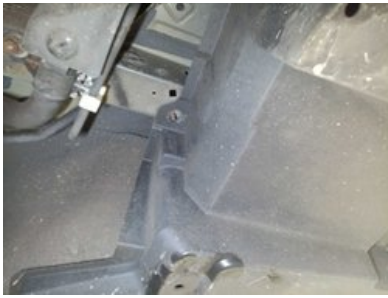
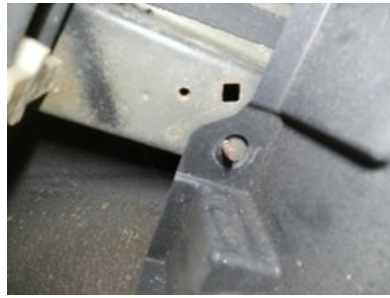
### ✓ 1. ENGINE: Missing screw

- ✓ 1. Other: Missing Screw

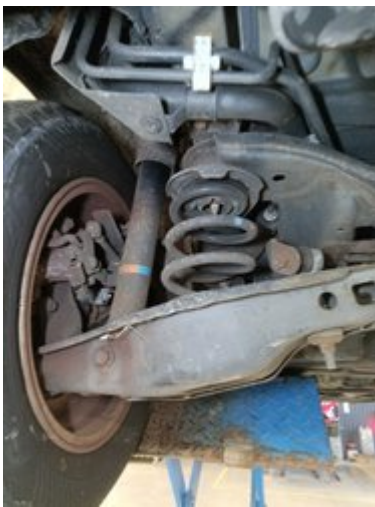
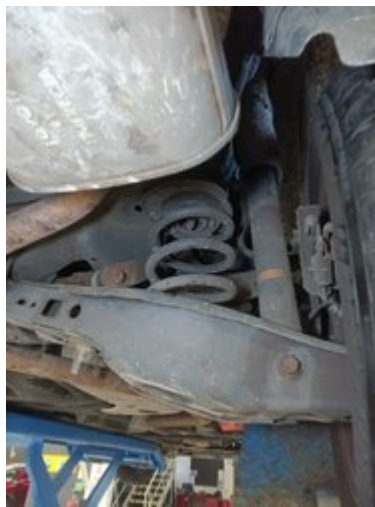
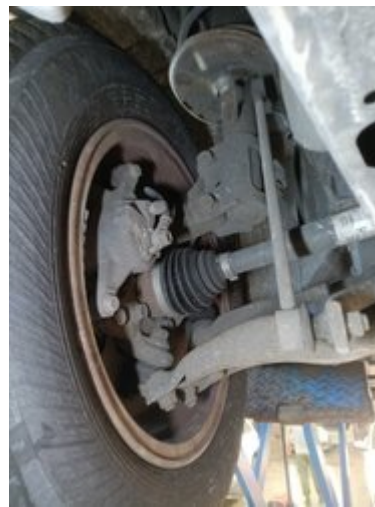
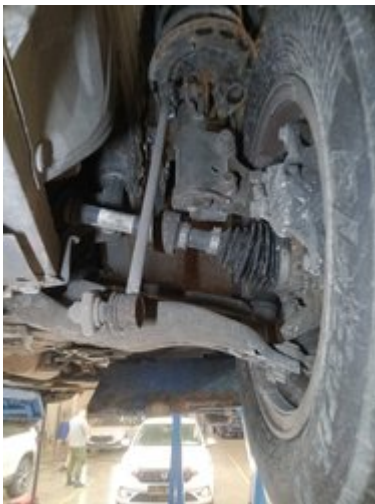
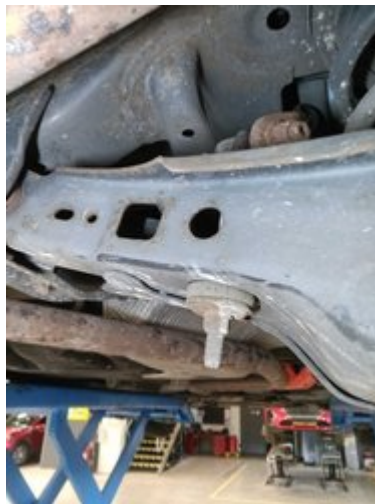
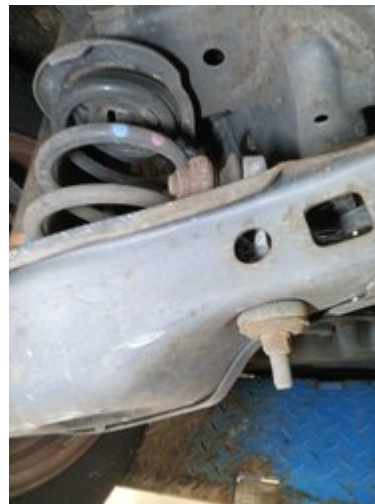
### ✓ 2. SUSPENSION: Suspension Condition
