# Diagnosis report of 2021 TOYOTA C-HR Executive

This vehicle has been inspected in accordance with the Longo 150-point checklist, covering the body exterior, interior, and mechanical condition. Based on the inspection performed and the information available at the time of assessment, no indications of involvement in major accidents were identified. Information regarding maintenance history and mandatory roadworthiness inspections is based on available documentation and records from the country of export. Please note that certain general wear and tear issues are considered acceptable and may not be repaired.

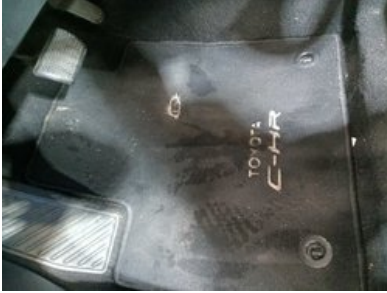
- ✓ **1. Inside:** Carpets - Condition

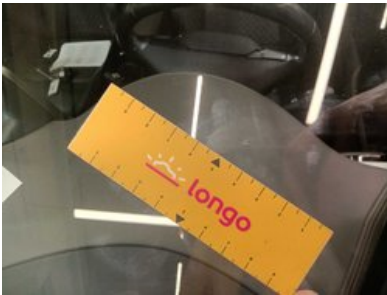
- ✓ **1. Front:** Windscreen Integrity - Free from MOT-Excluding Damage

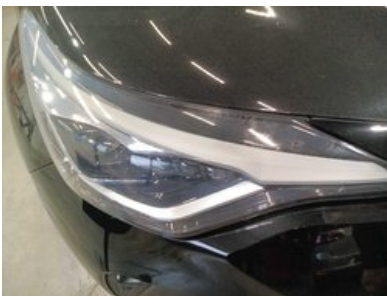
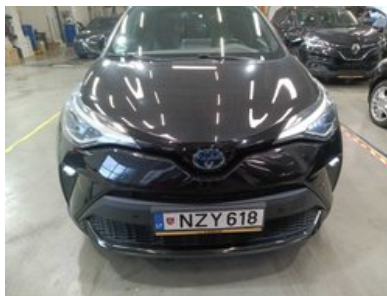
- ✓ **2. Lights:** Front Lights (City, Regular, Full Headlight, Fog, Indicator) - Basic Functioning, Damage, and Color

- ✓ 1. Change Headlights

- 1. Front Headlight (GOD33303)

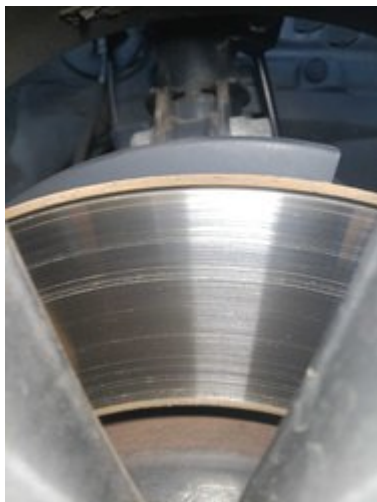
### ✓ 1. BRAKES: Front Brake Discs Both
