Diagnosis report of 2015 RENAULT CAPTUR Helly Hansen

Preparation and repair report of 2015 RENAULT CAPTUR Helly Hansen

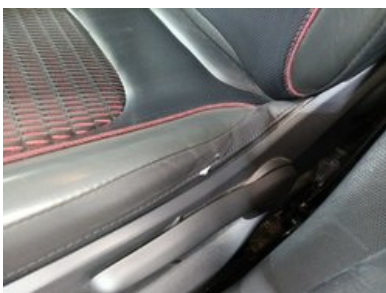
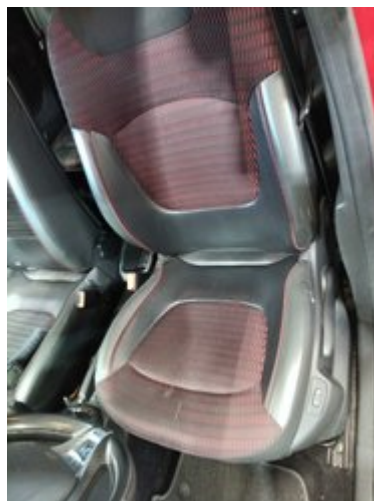
- ✔ **1. Seats:** All Seats - Condition

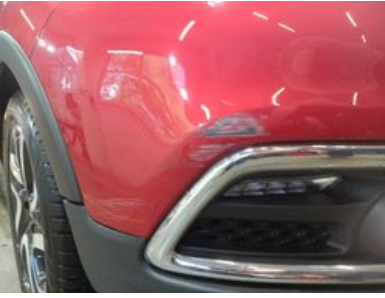
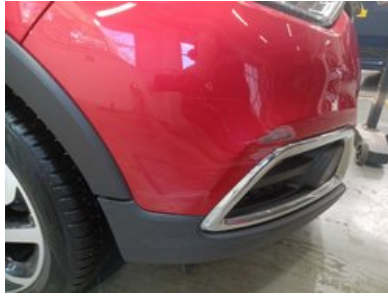
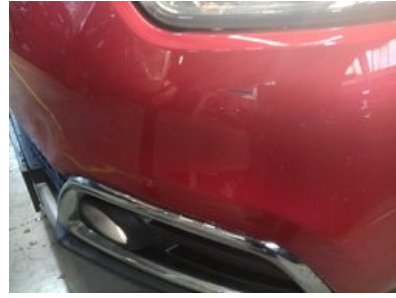
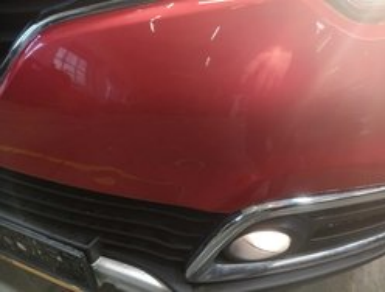
✓ 1. Front: Front Bumper - Condition and Alignment

- ✓ 1. Paint Front Bumper

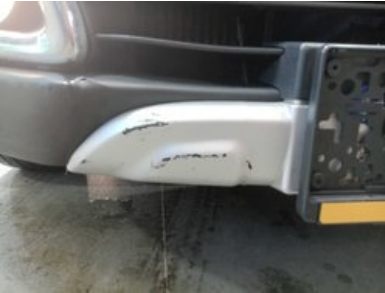
✓ 2. Front: Front Bumper - Condition and Alignment

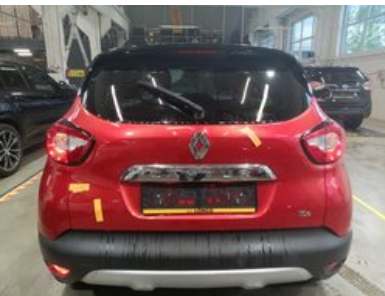
✓ 3. Rear: Trunk - Visual Damage

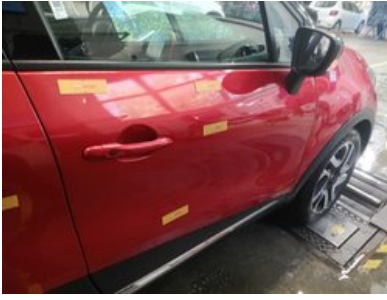
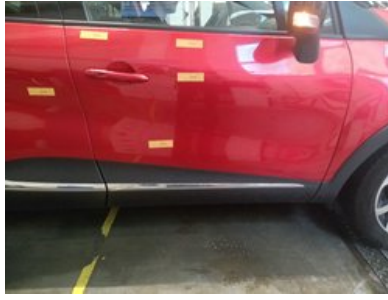
✔ **4. Side:** Left and Right Side - Visual Damage and Scratches

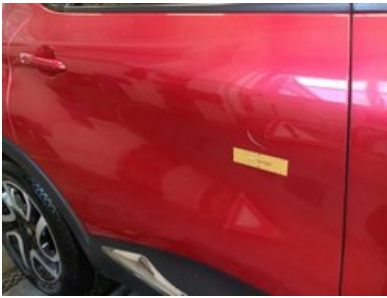
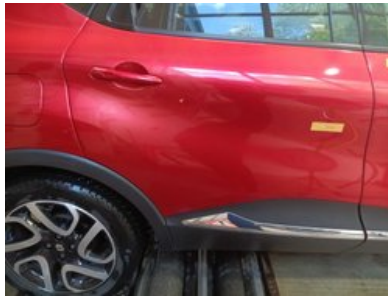
✔ **5. Side:** Left and Right Side - Visual Damage and Scratches

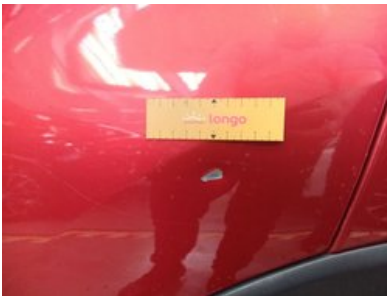
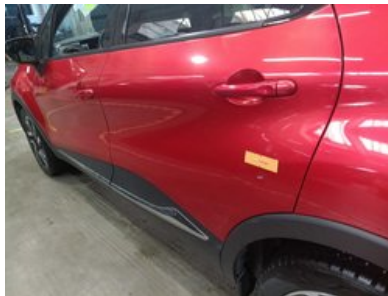
✔ **6. Side:** Left and Right Side - Visual Damage and Scratches

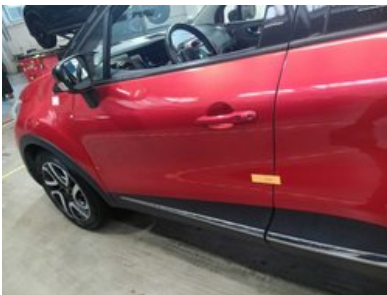
✔ **7. Side:** Left and Right Side - Visual Damage and Scratches

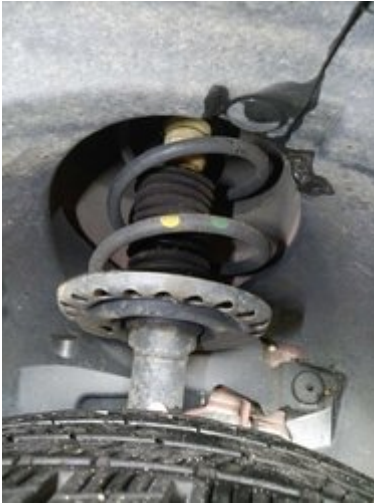
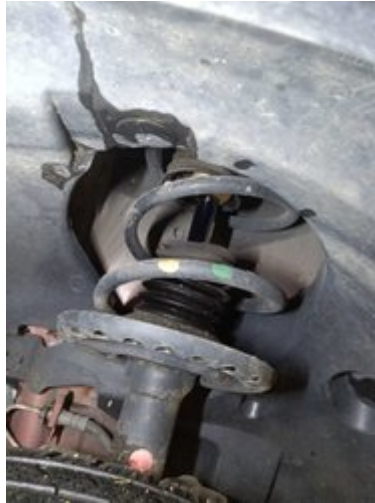
✔ **2. SUSPENSION:** Shock Absorber

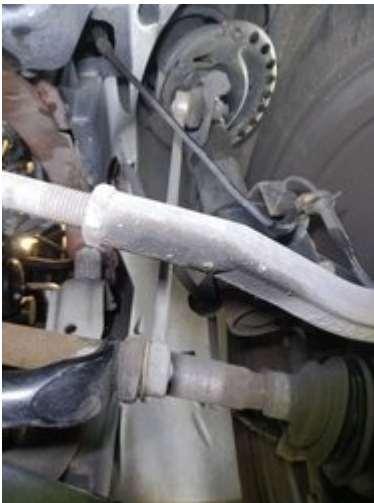
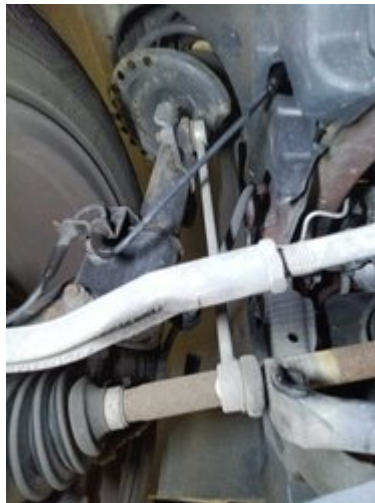
✔ **3. SUSPENSION:** Anti-Roll Bar Link, Outer, Both Sides

- ✓ 1. Engine Oil & Filter Change
- ✓ 2. System Evacuation/Recharging
- ✓ 3. Anti-Roll Bar Link - Outer (Both)

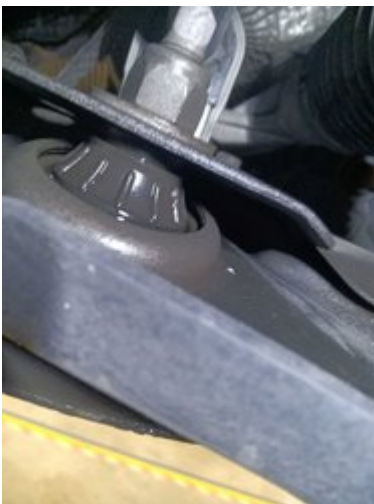
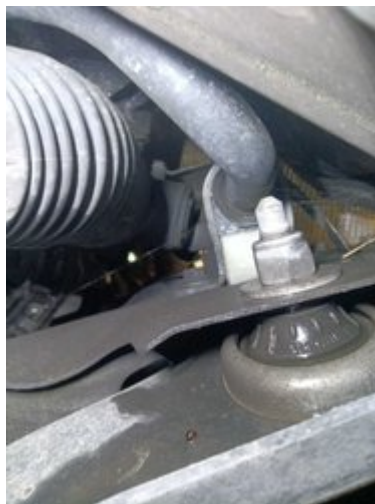
✔ **4. SUSPENSION:** Suspension Lower Arm Both

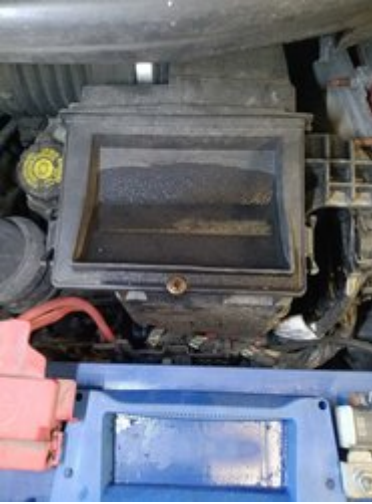
✓ **5. ENGINE MANAGEMENT - FUEL:** Air Filter Assembly

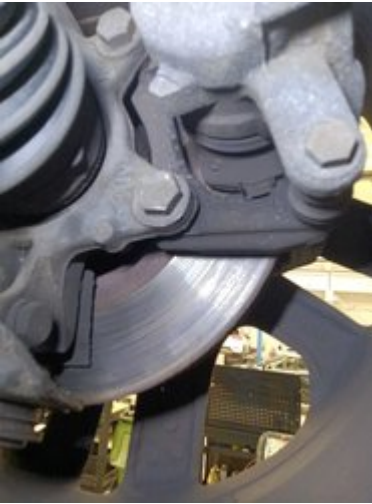
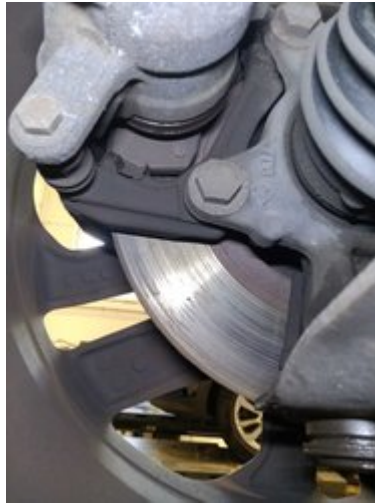
✓ **6. BRAKES:** Front Brake Discs Both with Pads

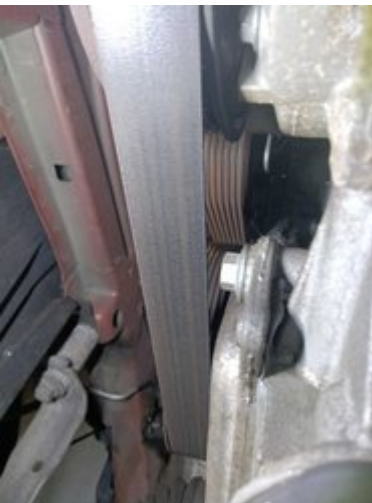
✓ **7. ENGINE:** Auxiliary Drive Belt
