Diagnosis report of 2015 RENAULT CLIO Night&Day

Preparation and repair report of 2015 RENAULT CLIO Night&Day

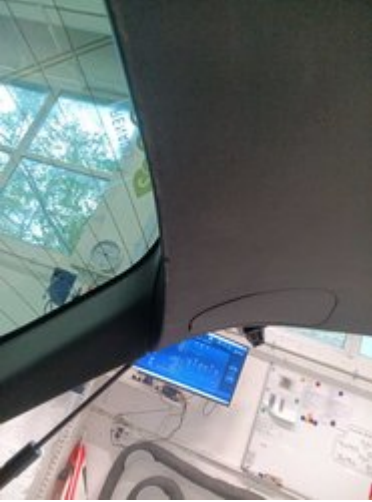
✓ **1. Inside:** Trims - Condition

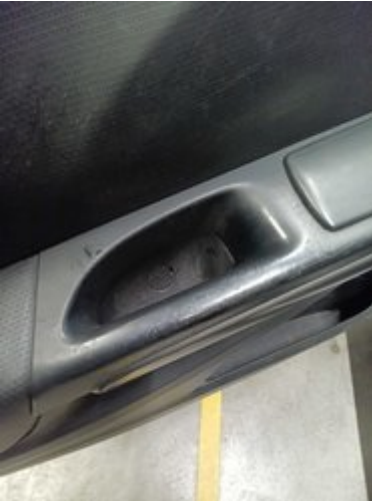
✓ **2. Doors:** Trims - Condition

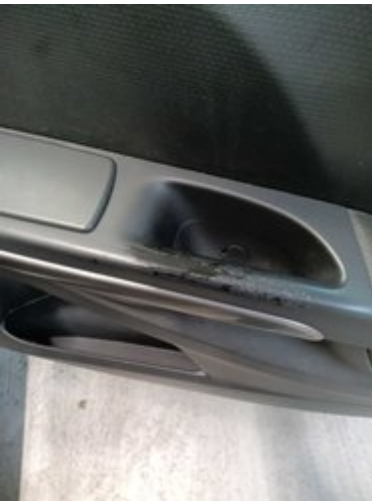
✓ **3. Doors:** Trims - Condition

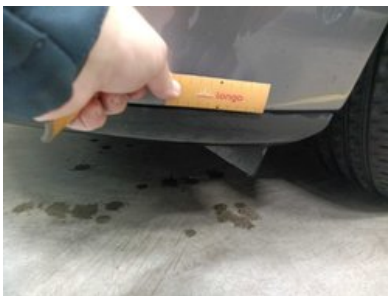
- ✓ **1. Front:** Front Bumper - Condition and Alignment

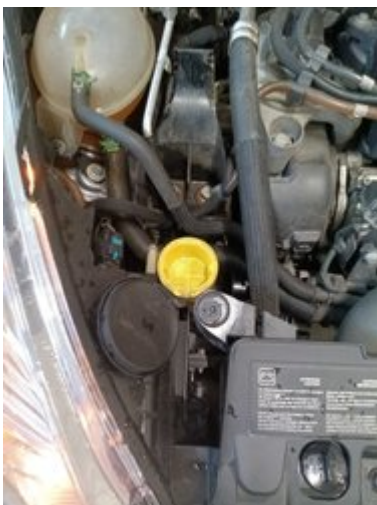
- ✓ **2. Front:** Window Washer Fluid Level (In Winter Also Winter-Adequate Fluid)

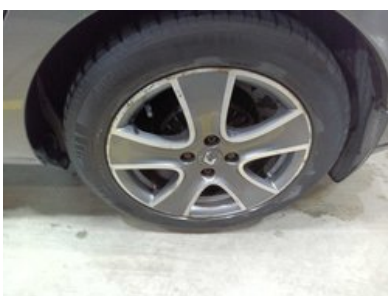
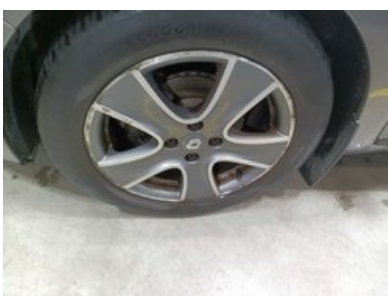
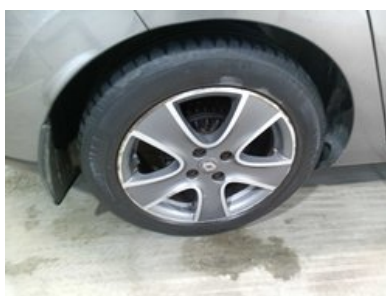
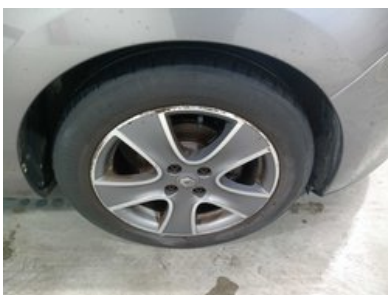
- ✓ **3. Side:** Wheels - Condition

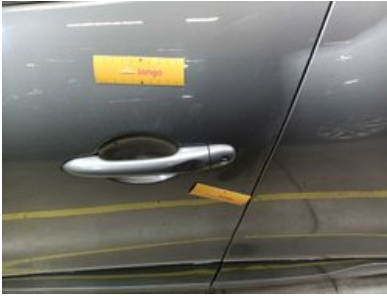
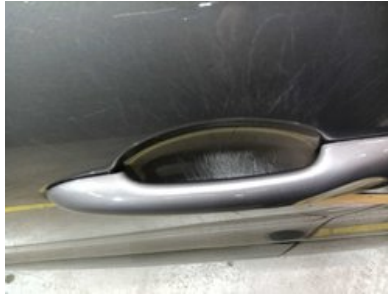
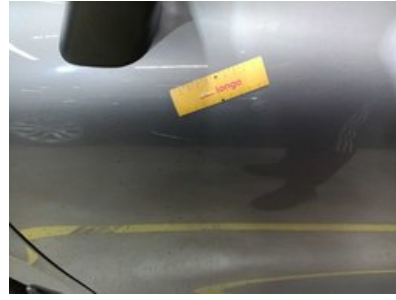
✔ **4. Side:** Left and Right Side - Visual Damage and Scratches

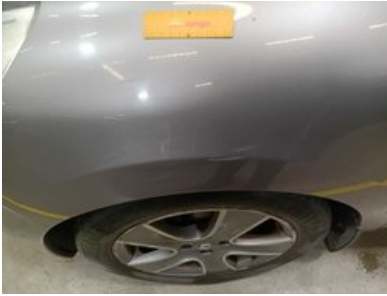
✔ **5. Side:** Left and Right Side - Visual Damage and Scratches

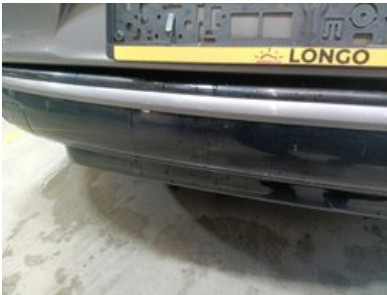
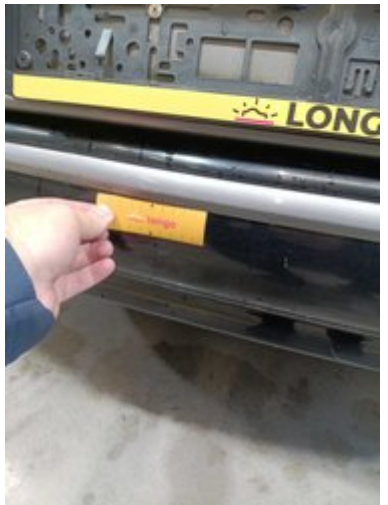
✔ **6. Rear:** Rear Bumper - Condition and Alignment

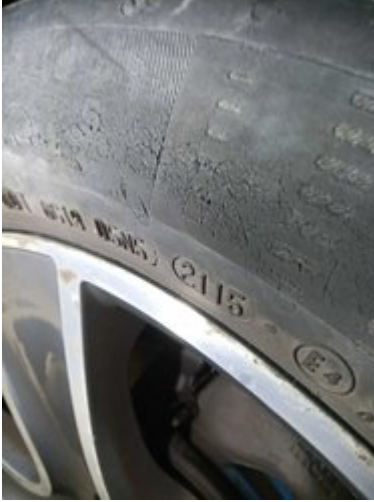
- ✔ **1. OTHER:** Change Tires

- ✓ 1. Engine Oil & Filter Change
- ✓ 2. Charge Battery
- ✓ 3. Change Tires
- ✓ 4. Rear Brake Shoes

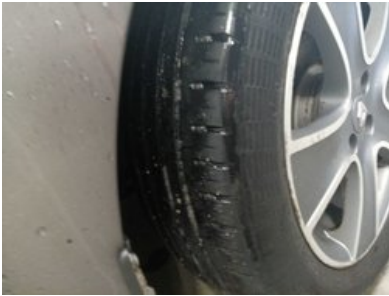
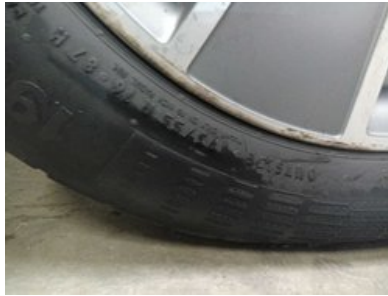
- ✔ **4. OTHER:** Change Tires

- 1. Oil Filter (OP643/5)
- 2. Engine Oil 4.8L
- 3. Oil Drain Plug (518.471.021)
- 4. Austone 195/55R16 91H Glacia Snow XL (EV Ready) 3PMSF (AS000688)
- 5. Rear Brake Pads (0986487754)

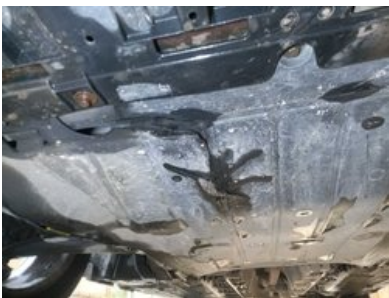
-
- ✔ **5. BODY - FRONT SECTION:** Damaged Engine Cover

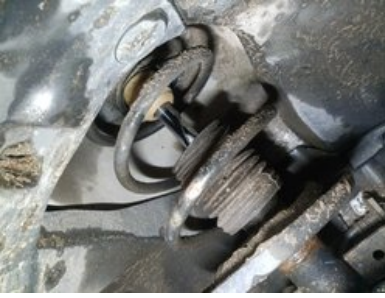
6. SUSPENSION: Strut Assembly (Both)

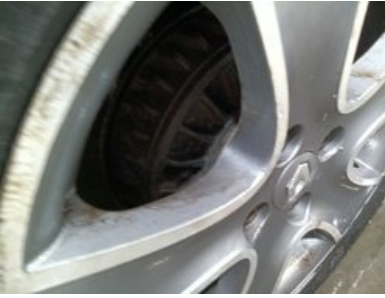
7. BRAKES: Rear Brake Shoes (All)
