# Diagnosis report of 2019 OPEL ASTRA 120 Year Edition

# Preparation and repair report of 2019 OPEL ASTRA 120 Year Edition

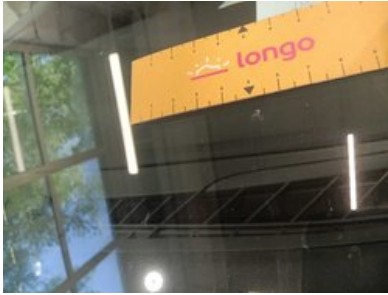
- ✓ **1. Front:** Windscreen Integrity - Free from MOT-Excluding Damage

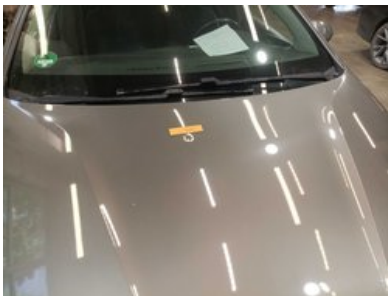
- ✓ **2. Front:** Hood - Visual Damage

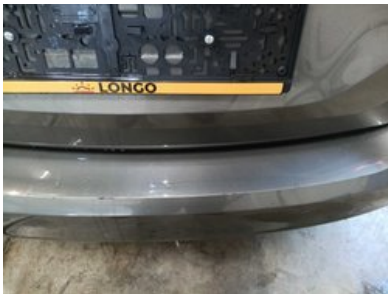
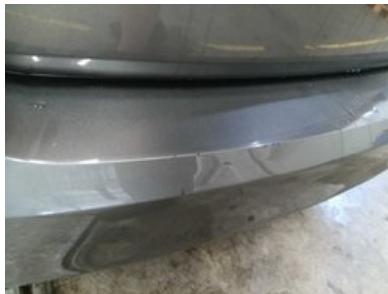
- ✓ **3. Rear:** Rear Bumper - Condition and Alignment

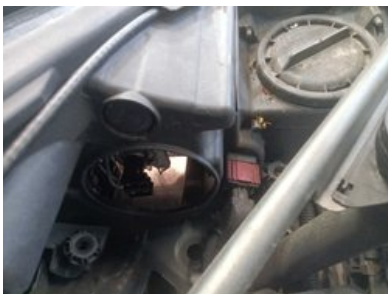
- ✓ **4. Lights:** Front Lights (City, Regular, Full Headlight, Fog, Indicator) - Basic Functioning, Damage, and Color

- ✓ 1. Driveshaft Joint - Outer Right
- ✓ 2. Change Light Covers
- ✓ 3. Change Tires

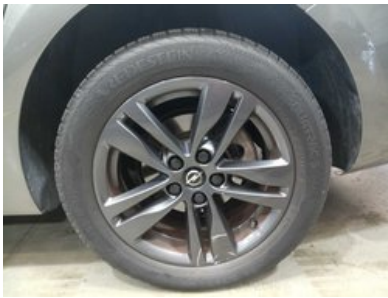
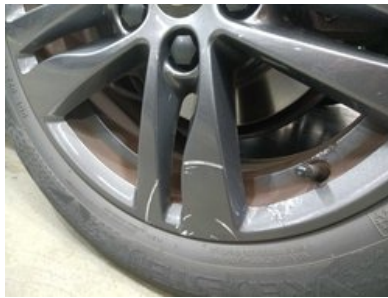
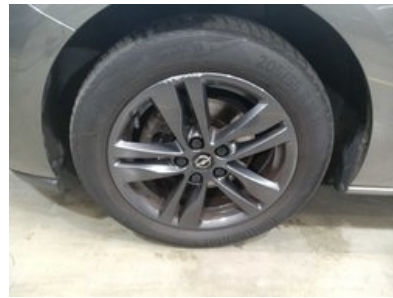
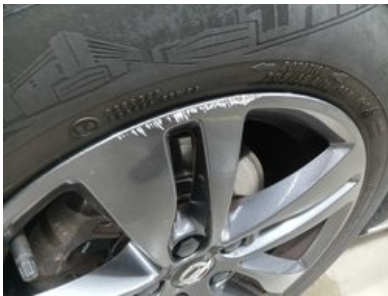
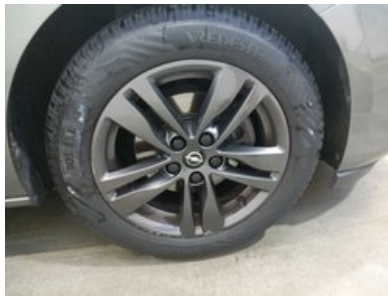
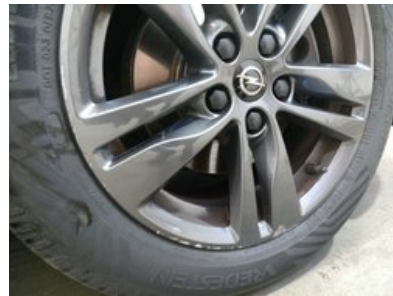
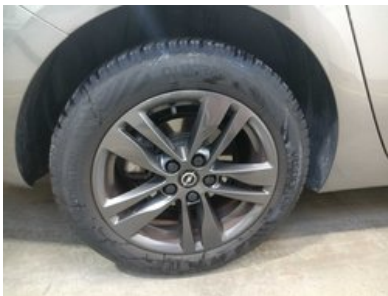
✓ **5. Side: Wheels - Condition**

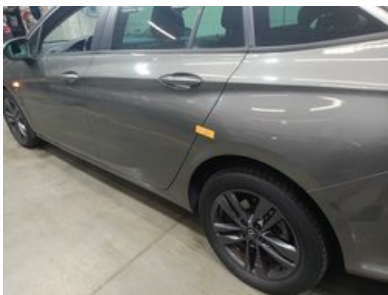
✓ **6. Side: Left and Right Side - Visual Damage and Scratches**

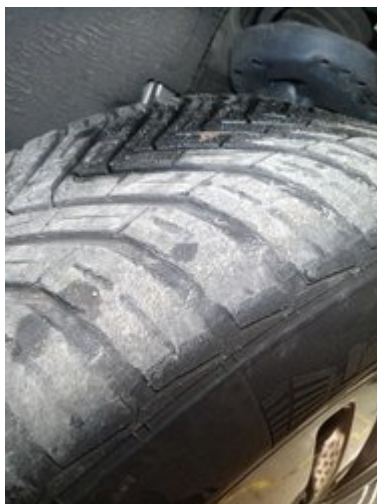
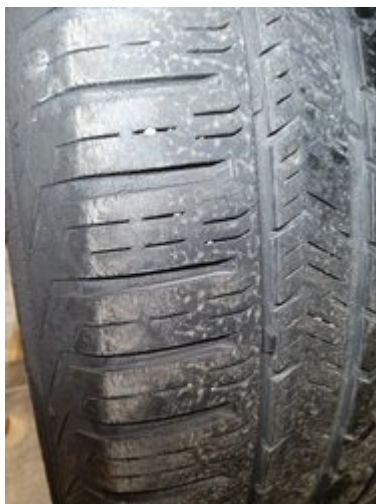
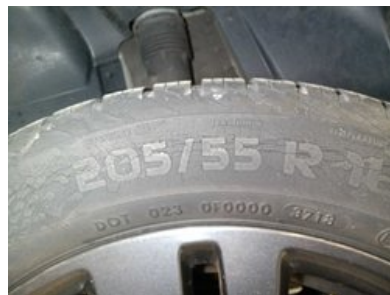
### ✓ 1. OTHER: Change Tires

- 1. Tyre Grenlander 205/55R16 91H Winter GL868 (GRN00113)
- 2. Headlamp Bulb Cover (13488984)
- 3. CV Joint Kit (190964)

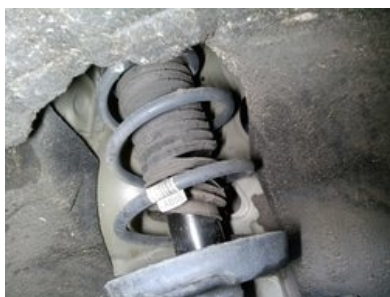
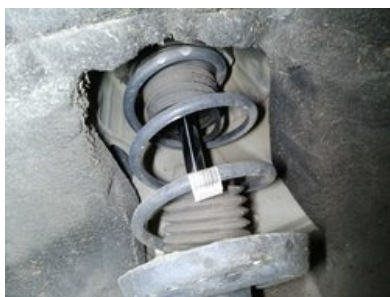
### ✓ 2. SUSPENSION: Shock Absorbers Dust Cover

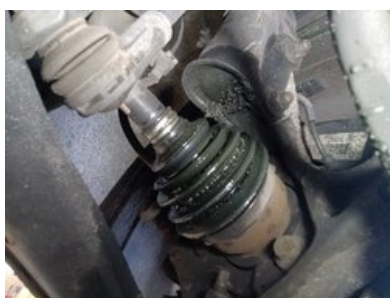
### ✓ 3. FINAL DRIVE, SHAFT & AXLES: Driveshaft Joint - Outer Right
