# Diagnosis report of 2019 PEUGEOT RIFTER Active

# Preparation and repair report of 2019 PEUGEOT RIFTER Active

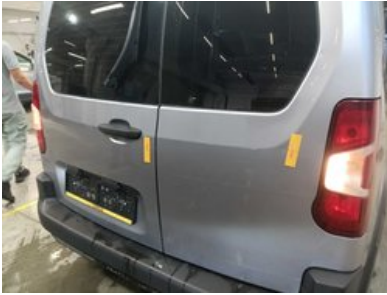
### ✓ 1. Rear: Trunk - Visual Damage

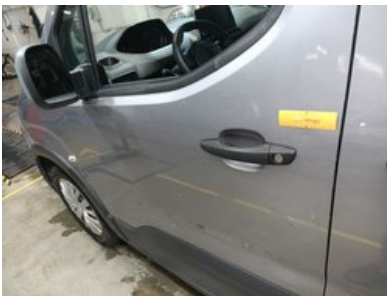
### ✓ 2. Side: Left and Right Side - Visual Damage and Scratches

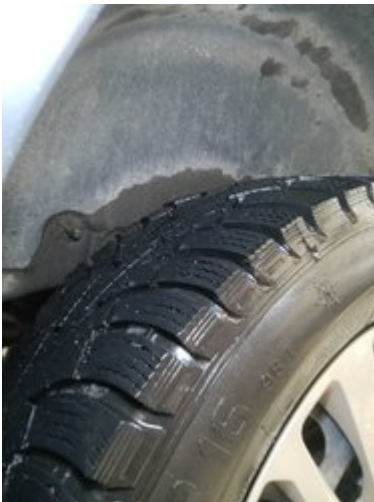
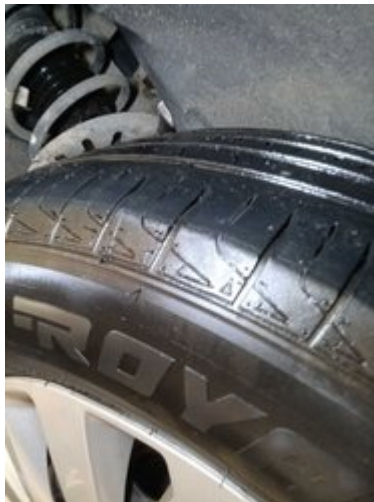
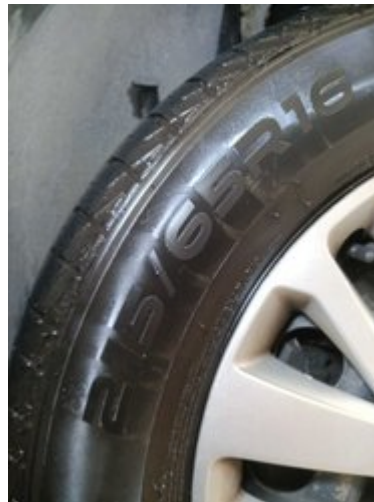
### ✓ 3. OTHER: Change Tires

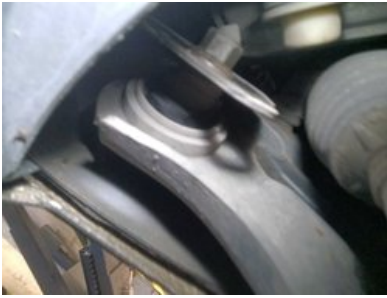
✓ **4. SUSPENSION:** Suspension Lower Arm Bushes Both

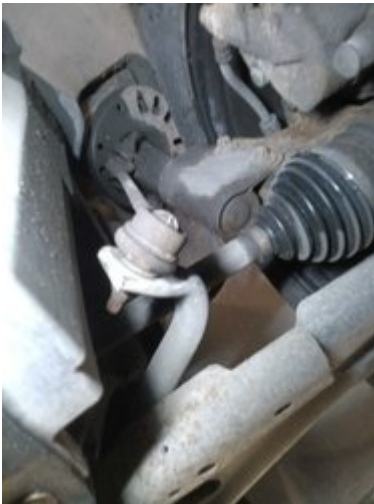
✓ **5. SUSPENSION:** Anti-Roll Bar Link, Outer

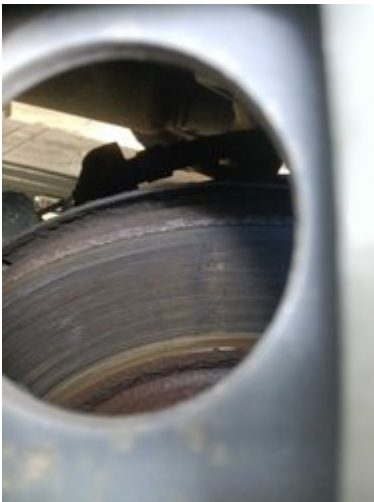
✓ **6. BRAKES:** Rear Brake Disc (Both)
