# Diagnosis report of 2016 HYUNDAI TUCSON Executive

## Diagnosis details

During the comprehensive diagnosis conducted by Longo, 10 issues were identified in the vehicle.

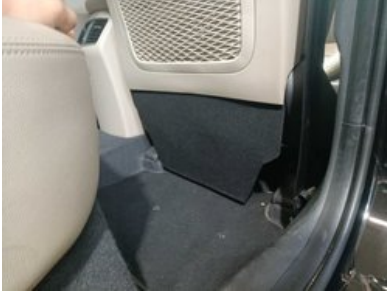
- ✓ **1. Seats:** All Seats - Condition

- ✓ 1. Change Lights on Car Side
- ✓ 2. Repair Seat

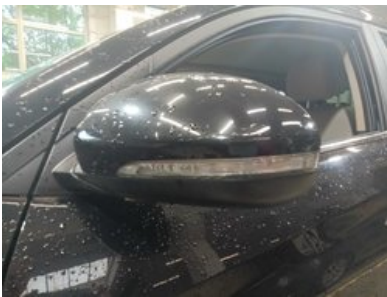
- ✓ **1. Lights:** Car Side Lights - Basic Functioning, Damage, and Color

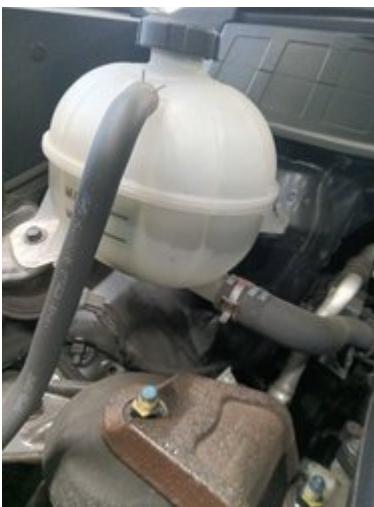
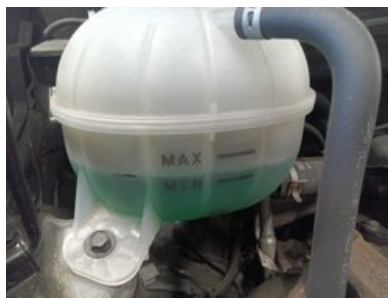
- ✓ **1. OTHER:** Coolant Refill

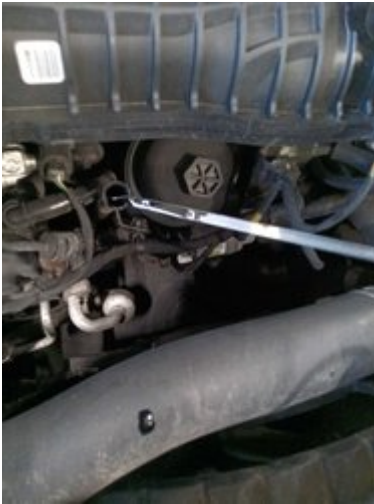
✓ **2. OTHER:** Engine Oil & Filter Change

- 1. Oil Filter (OE674/5)
- 2. Total Ineo First 0W30 208L 5.3L
- 3. Oil Drain Plug (EL726760)
- 4. Tire MAXTREK 245/45R19 102W MAXIMUS M2 XL Summer (MXT00525)
- 5. Front Door Electric Wing Mirror Tucson TL (AYI2784)
- 6. Exhaust Pressure Sensor (NTK77304)

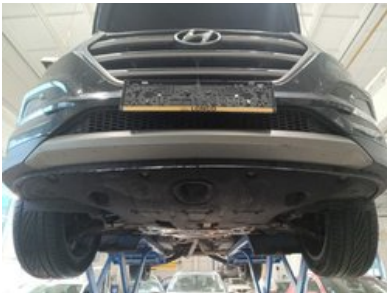
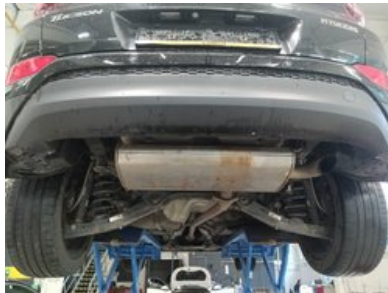
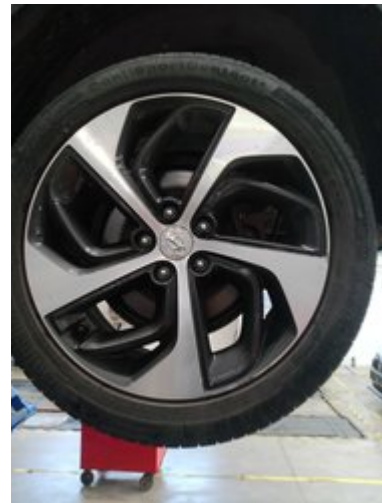
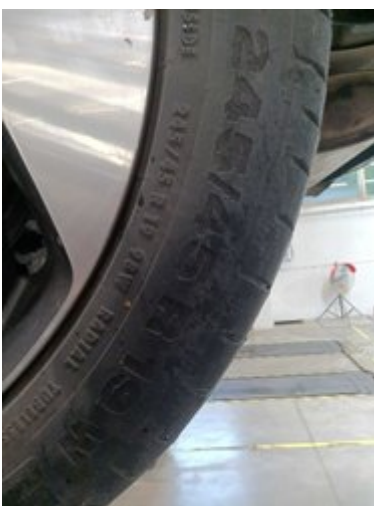
✓ **3. OTHER:** Change Tires

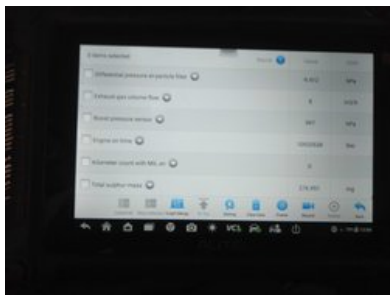
✓ **4. OTHER:** DPF Filter Regeneration/Cleaning

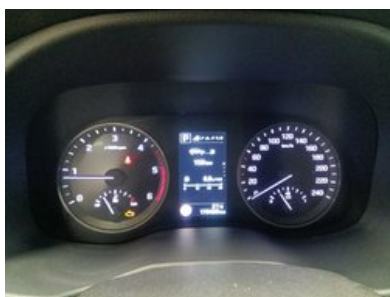
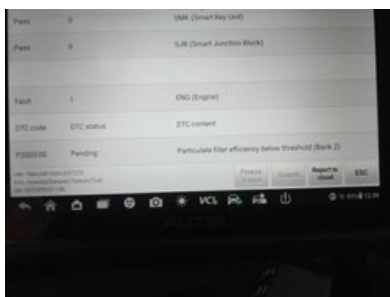
✓ **5. OTHER:** Check Failures

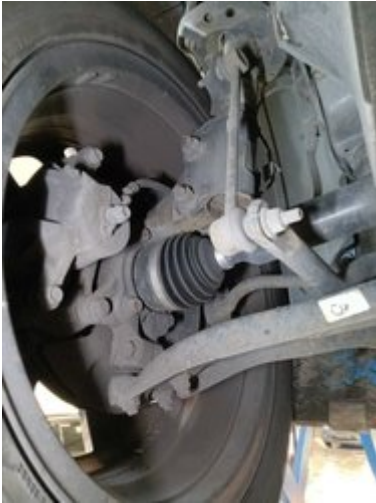
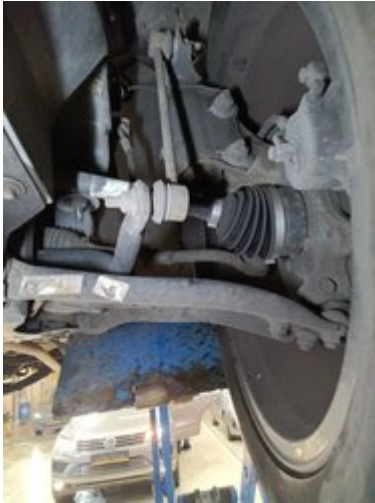
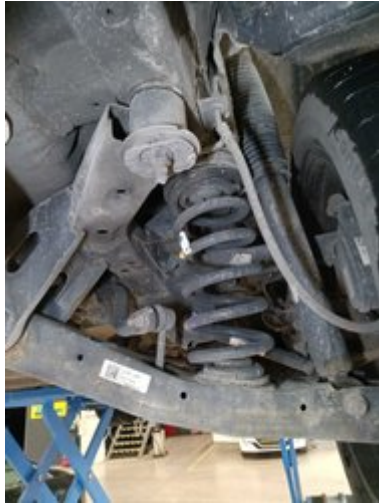
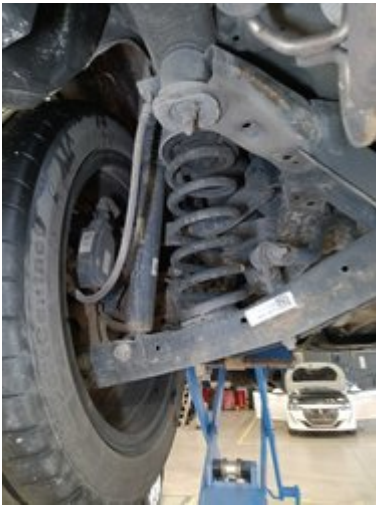
7. **SUSPENSION:** Suspension Condition
