# Diagnosis report of 2014 TOYOTA AURIS Aspiration

# Preparation and repair report of 2014 TOYOTA AURIS Aspiration

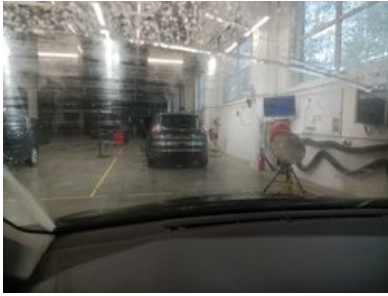
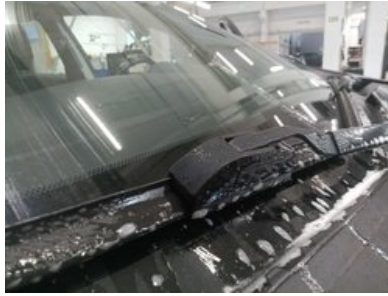
- ✓ **1. Front:** Window Wiper Rubber and Handle (Front and Rear) - Condition

- ✓ 1. System Evacuation/Recharging
- ✓ 2. Charge Battery
- ✓ 3. Change Bulb for Headlights
- ✓ 4. Change Front Wiper (Mechanical)
- ✓ 5. Strut Top Mounting (Both)
- ✓ 6. Anti-Roll Bar
- ✓ 7. Engine Oil & Filter Change
- ✓ 8. Shock Absorbers (Pair)

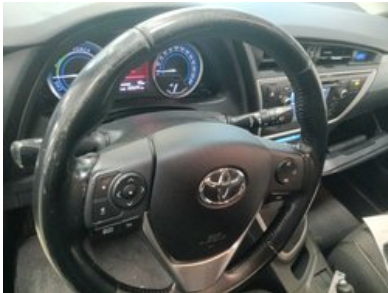
- ✓ **2. Front:** Steering Wheel - Condition

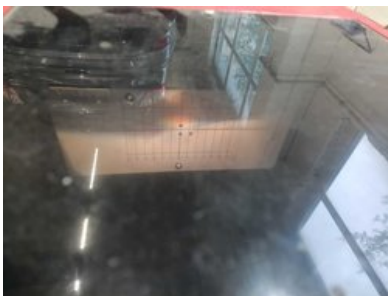
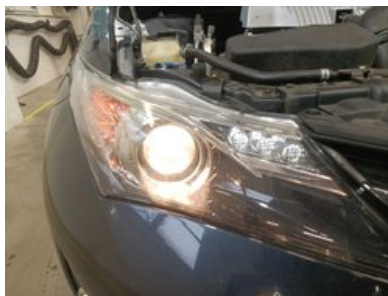
- ✓ **1. Lights:** Light Bulbs

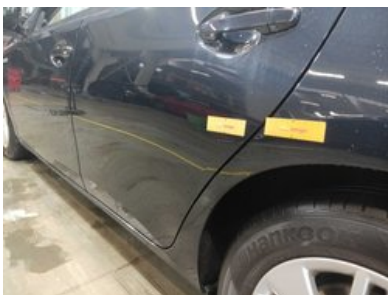
- ✓ **2. Other:** Additional Polishing Tasks

- ✓ 1. Body wet wash
- ✓ 2. Full interior deep clean using only hypoallergenic cleaning products
- ✓ 3. Post cleaning body polish

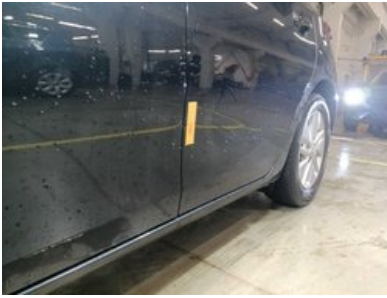
✓ **3. Side:** Left and Right Side - Visual Damage and Scratches

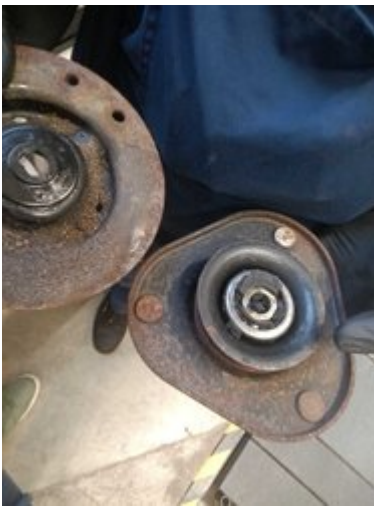
✓ **1. SUSPENSION:** Strut Top Mounting (Both)

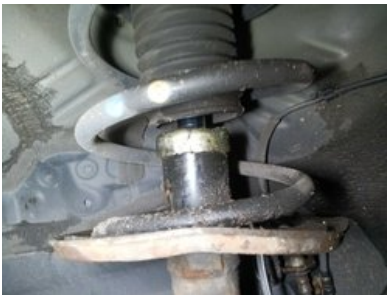
✓ **2. SUSPENSION:** Shock Absorbers (Pair)

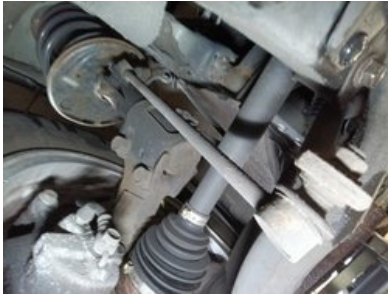
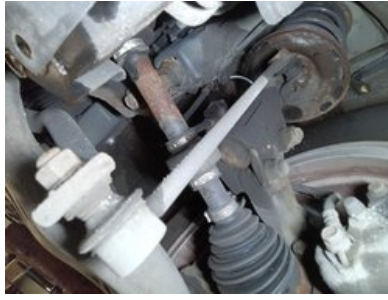
✓ **3. SUSPENSION:** Anti-Roll Bar

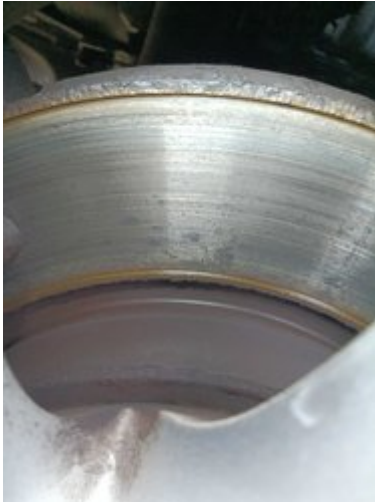
✓ **4. BRAKES:** Rear Brake Disc (Both)

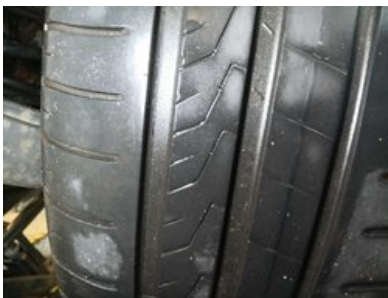
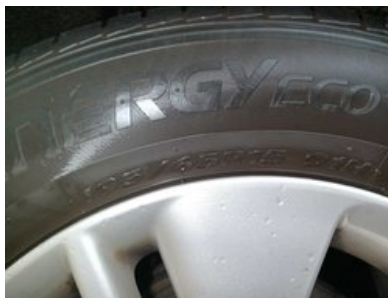
✓ **5. OTHER:** Change Tires

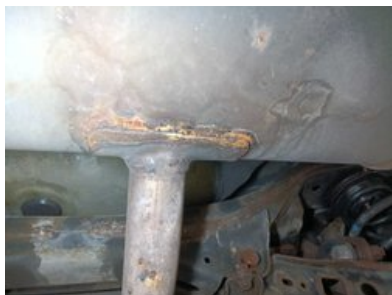
✓ **8. EXHAUST SYSTEM:** Pipe - Rear/Tail/Silencer
