# Diagnosis report of 2015 TOYOTA AURIS Executive

# Preparation and repair report of 2015 TOYOTA AURIS Executive

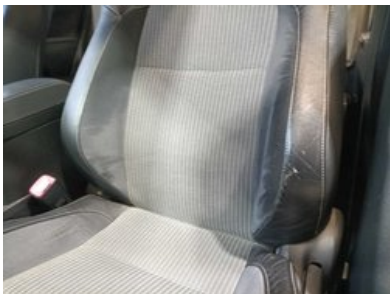
✔ **1. Seats:** All Seats - Condition

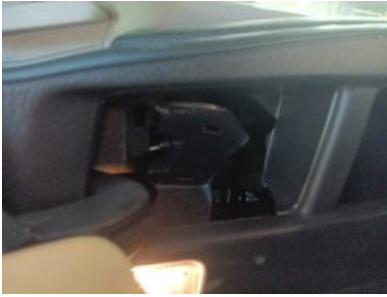
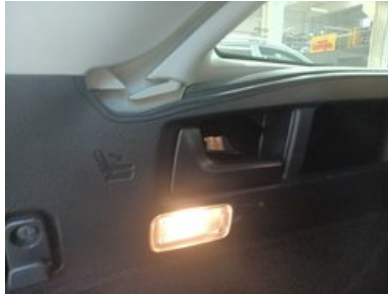
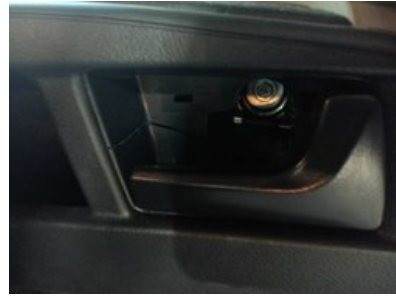
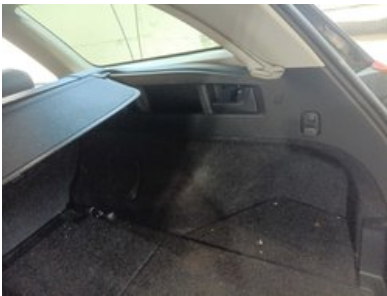
✓ **2. Seats:** Seat Adjustment Mechanisms - Functioning

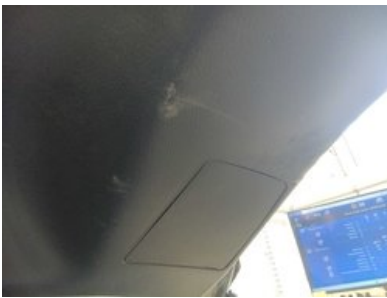
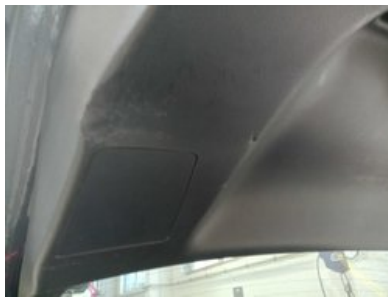
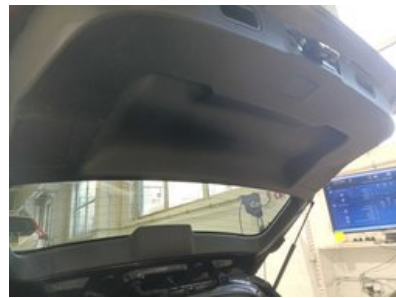
✓ **3. Inside:** Trims - Condition

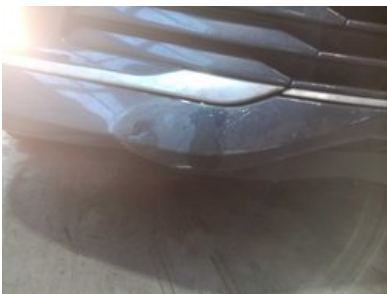
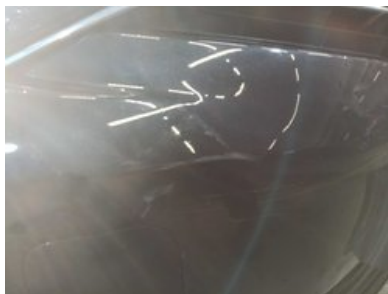
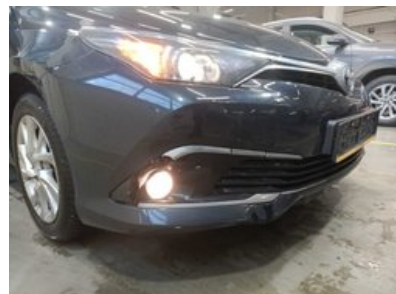
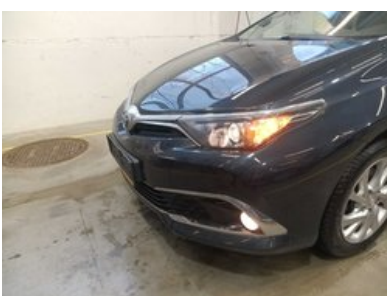
✓ **1. Front:** Front Bumper - Condition and Alignment

- ✓ 1. Other: Trim Around Right Fog Light with Chrome

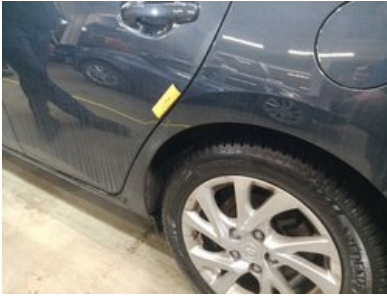
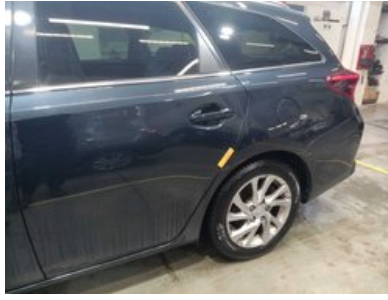
✓ **2. Side:** Left and Right Side - Visual Damage and Scratches

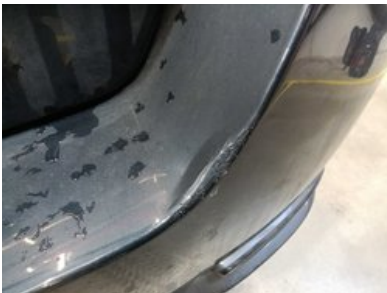
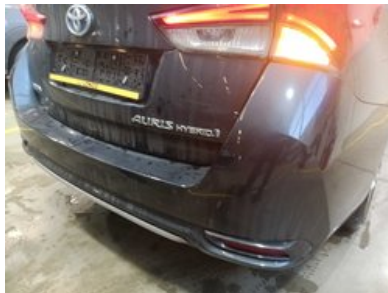
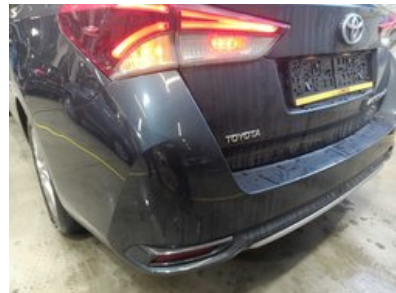
✓ **4. Rear:** Rear Bumper - Condition and Alignment

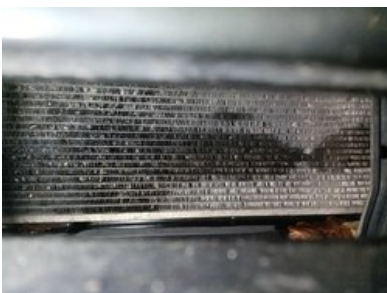
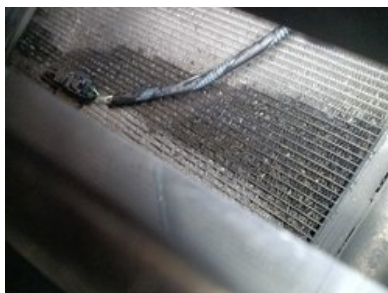
✓ **4. AIR CONDITIONING AND HEATING:** Condenser

- ✓ 1. Condenser
- ✓ 2. Engine Oil & Filter Change
- ✓ 3. Charge Battery
- ✓ 4. System Evacuation/Recharging
