# Diagnosis report of 2018 PEUGEOT 5008 Allure

## Diagnosis details

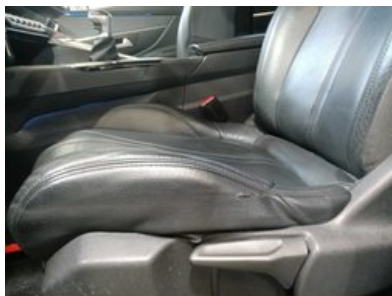
### ✓ 1. Seats: All Seats - Condition

- ✓ 1. Repair Seat

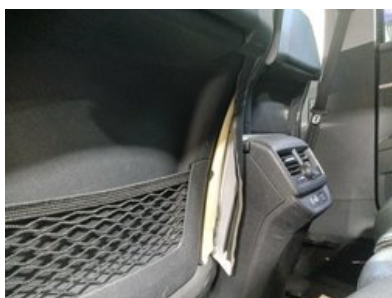
### ✓ 2. Seats: All Seats - Condition

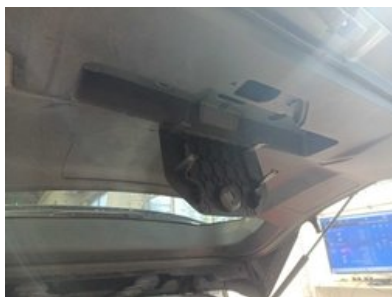
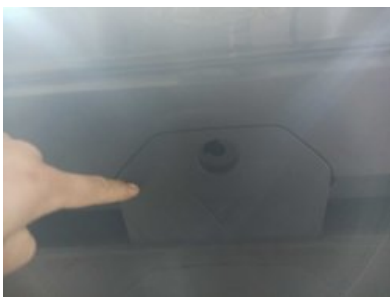
### ✓ 3. Inside: Trims - Condition

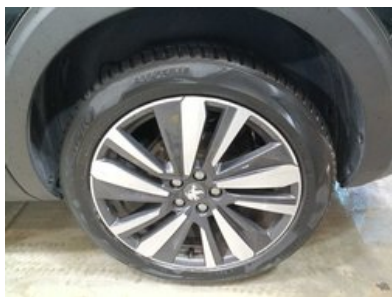
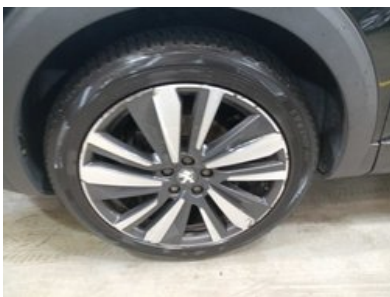
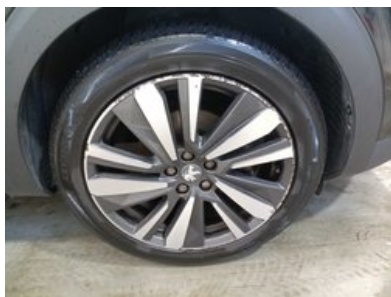
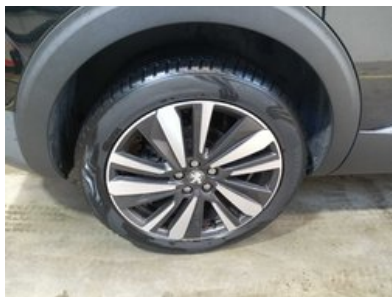
### ✓ 1. Side: Wheels - Condition

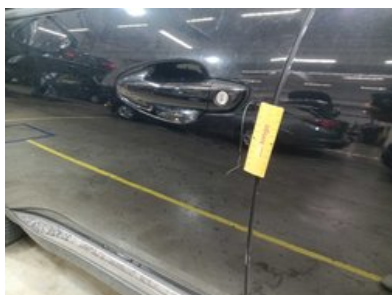
### ✓ 2. Side: Left and Right Side - Visual Damage and Scratches
