# Diagnosis report of 2019 PEUGEOT 2008 GT-Line

# Preparation and repair report of 2019 PEUGEOT 2008 GT-Line

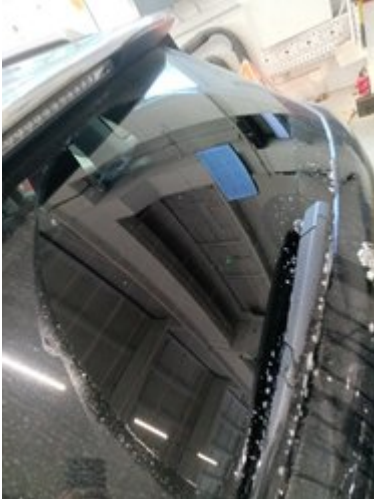
- ✓ **1. Front:** Window Wiper Rubber and Handle (Front and Rear) - Condition

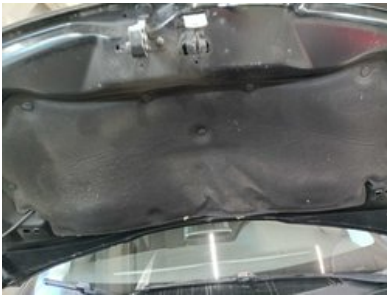
- ✓ **1. Front:** Hood Sound Insulation - Condition

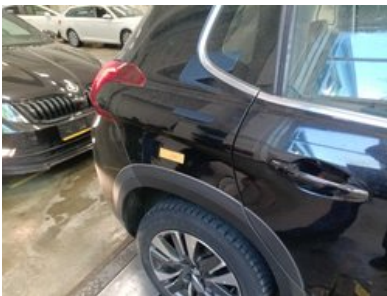
- 
- ✓ **2. Side:** Left and Right Side - Visual Damage and Scratches

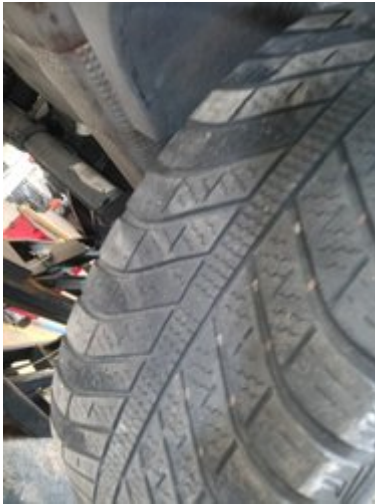
✓ **2. OTHER:** Change Tires

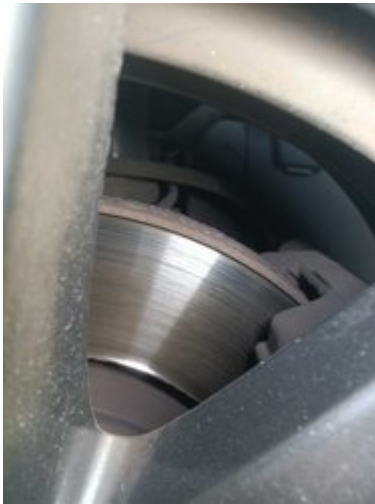
✓ **3. BRAKES:** Front Brake Discs Both with Pads
