# Diagnosis report of 2018 SKODA FABIA Monte Carlo

# Preparation and repair report of 2018 SKODA FABIA Monte Carlo

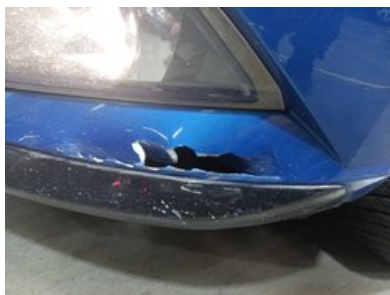
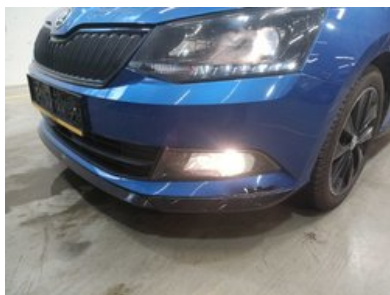
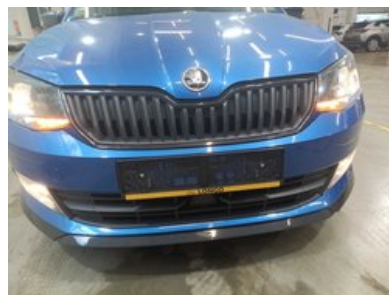
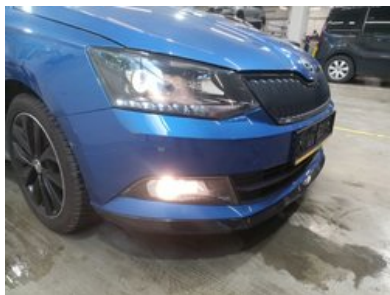
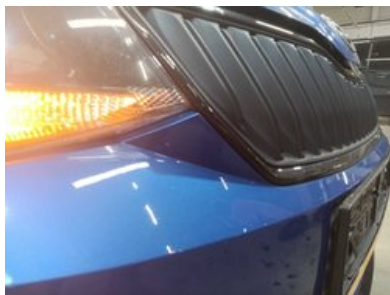
### ✔ 1. Front: Front Bumper - Condition and Alignment

- ✓ 1. Paint Rear Fender
- ✓ 2. Paint Sill
- ✓ 3. Paint Front Bumper
- ✓ 4. Paint Door

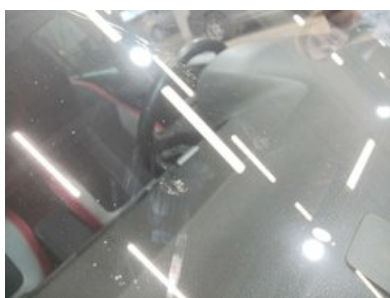
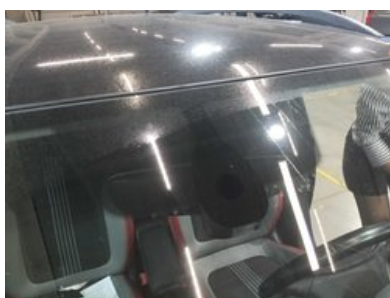
### ✔ 2. Front: Windscreen Integrity - Free from MOT-Excluding Damage

- ✓ 1. Change Lights on Car Side
- ✓ 2. Windshield Replacement
- ✓ 3. Headlamp Alignment

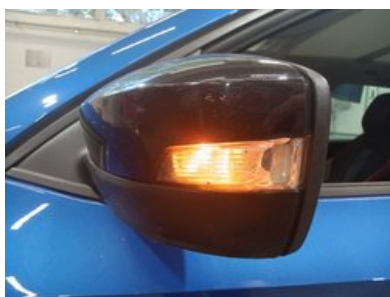
### ✔ 3. Lights: Car Side Lights - Basic Functioning, Damage, and Color

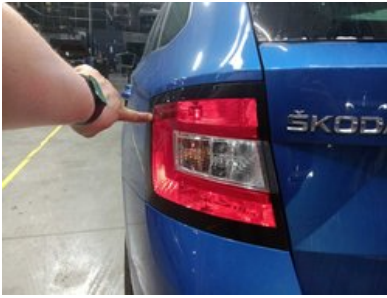
✓ **4. Lights:** Light Bulbs

- ✓ 1. Engine Oil & Filter Change
- ✓ 2. Shock Absorber
- ✓ 3. Change Bulb for Rear Lights
- ✓ 4. Strut Assembly

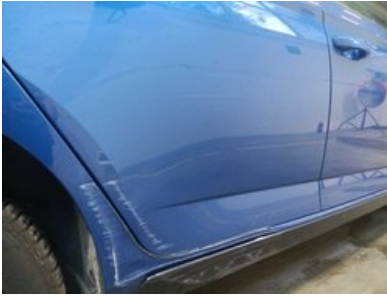
✓ **5. Side:** Left and Right Side - Visual Damage and Scratches

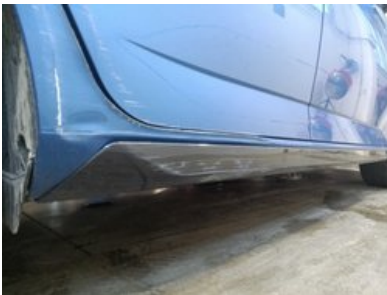
✓ **6. Side:** Left and Right Side - Visual Damage and Scratches

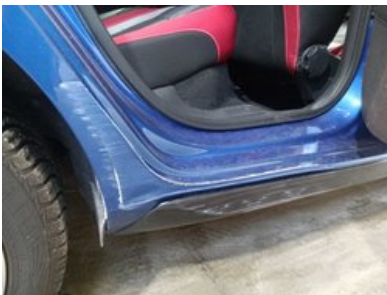
✓ **7. Side:** Left and Right Side - Visual Damage and Scratches

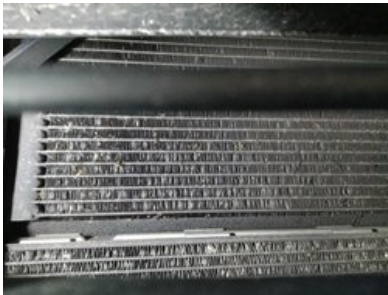
### ✓ 1. AIR CONDITIONING AND HEATING: Condenser

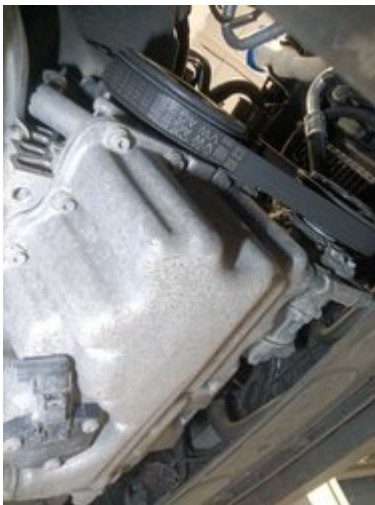
### ✓ 2. ENGINE: Engine Condition

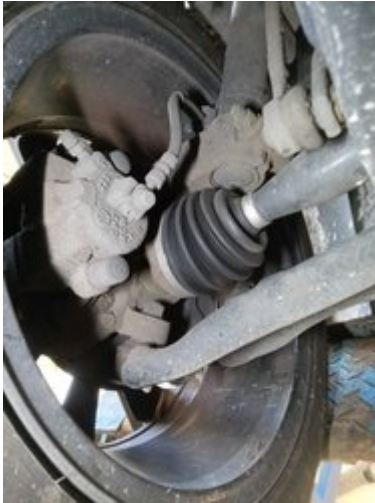
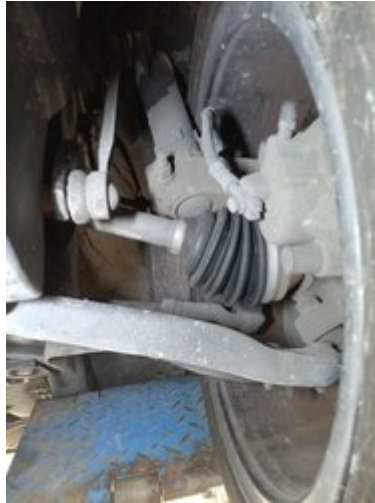
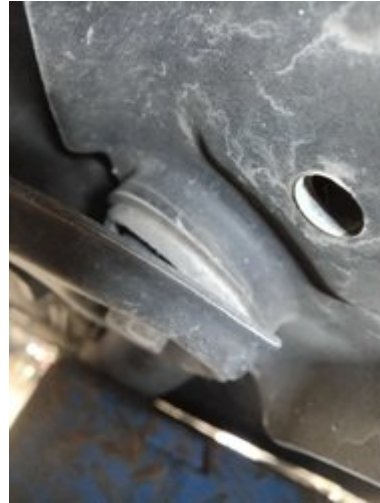
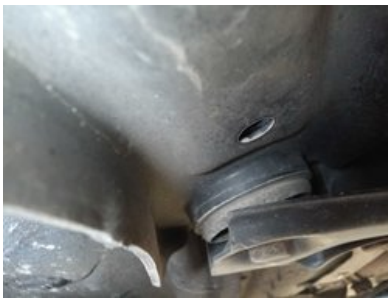
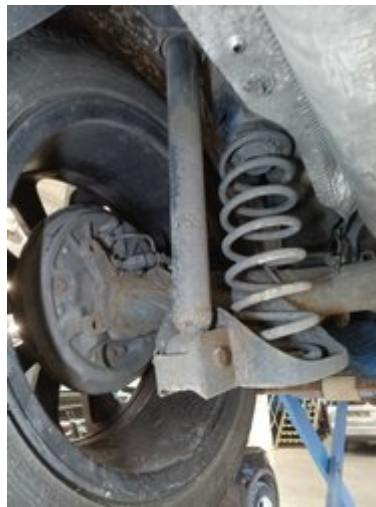
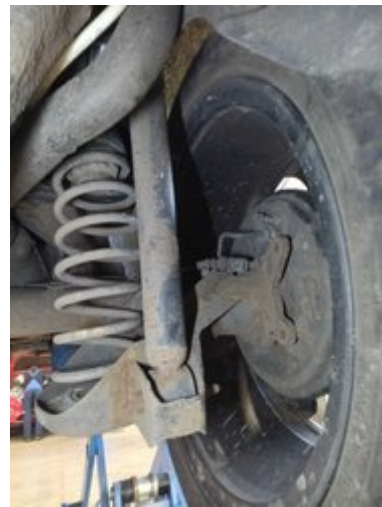
✓ **3. SUSPENSION:** Suspension Condition

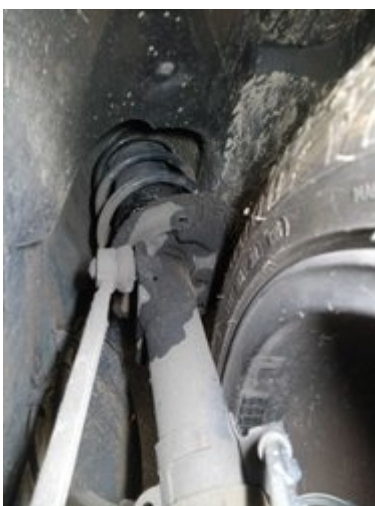
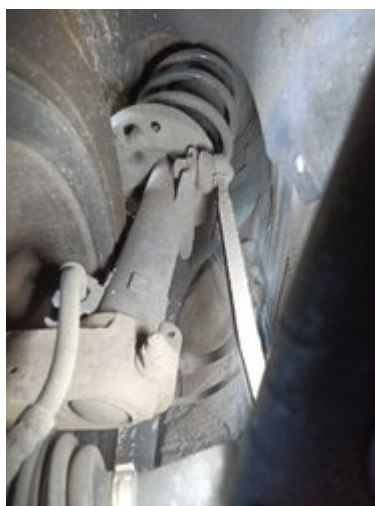
✓ **4. SUSPENSION:** Shock Absorber

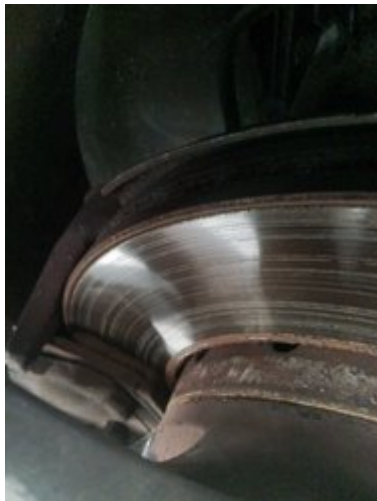
## ✓ 7. BRAKES: Brakes Condition
