# Diagnosis report of 2019 OPEL GRANDLAND X Business Executive

Diagnosis report of

2019 OPEL GRANDLAND X Business Executive

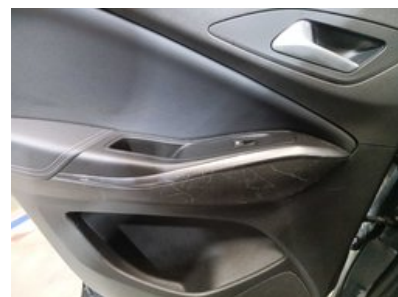
- ✔ 1. Doors: Trims - Condition

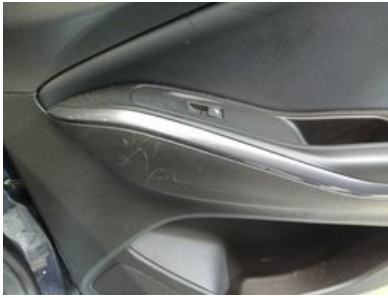
✓ **2. Doors:** Trims - Condition

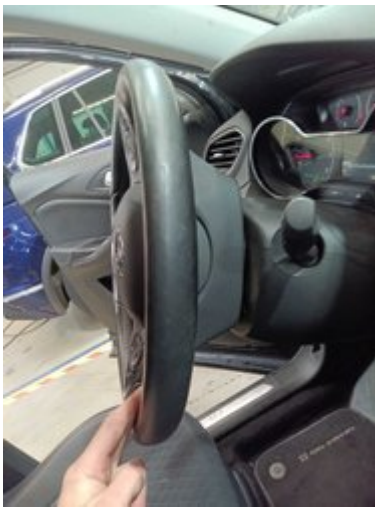
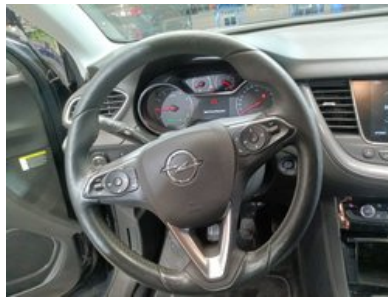
✓ **3. Front:** Steering Wheel - Condition

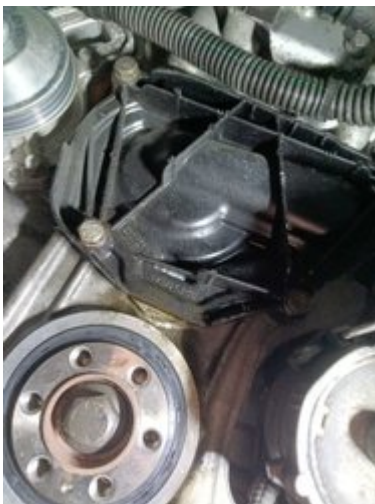
✓ **1. OTHER:**

- ✓ 1. Timing Belt Tensioner Cover Gasket
- ✓ 2. Spark Plugs

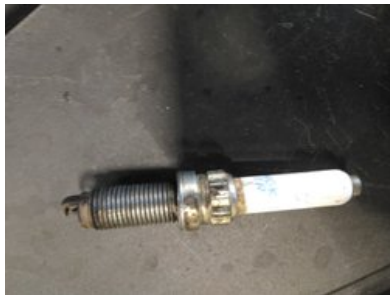
## ✓ 2. OTHER: Spark Plugs
