# Diagnosis report of 2017 PEUGEOT 2008 GT-line

During the comprehensive diagnosis conducted by Longo, 9 issues were identified in the vehicle.

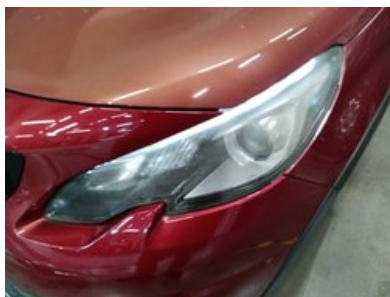
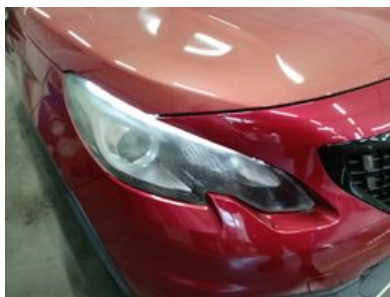
### ✓ 1. Other: Additional Polishing Tasks

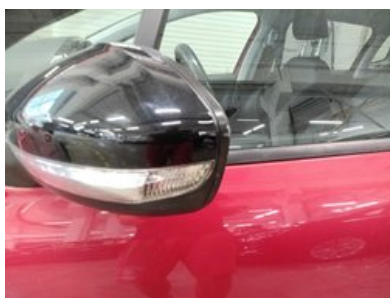
### ✓ 2. Side: Exterior Mirrors - Mirror Integrity and Car Attachment

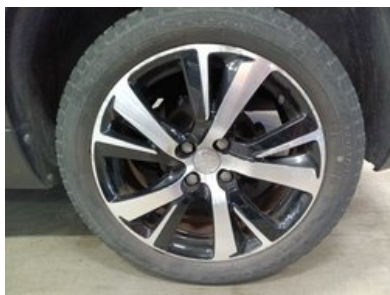
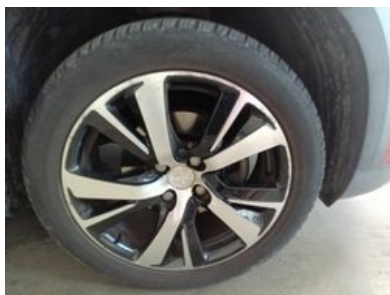
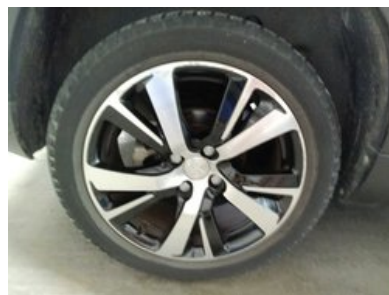
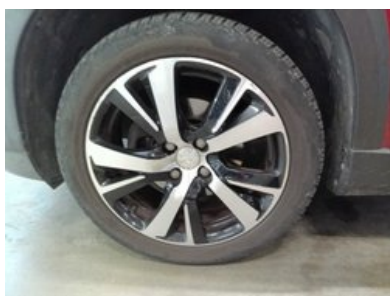
### ✓ 3. Side: Wheels - Condition

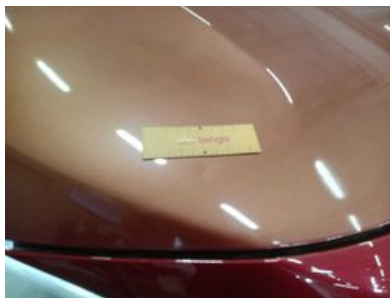
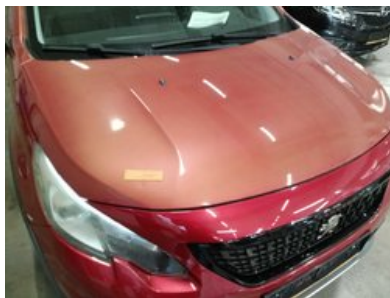
✓ **4. Front: Hood - Visual Damage**

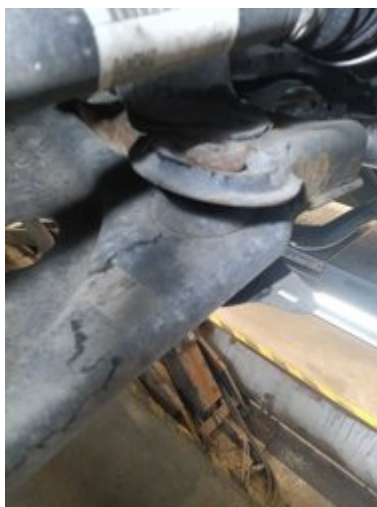
✓ **1. SUSPENSION:** Suspension Lower Arm Both

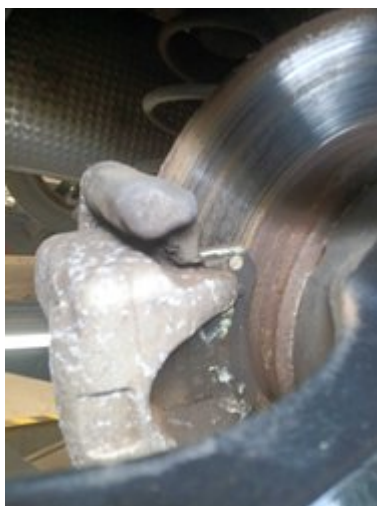
✓ **2. BRAKES:** Rear Brake Disc (Both)

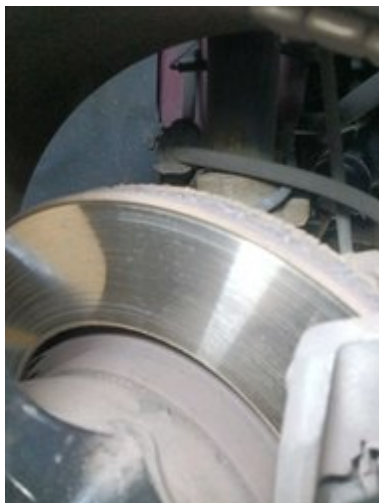
✓ **3. BRAKES:** Front Brake Discs Both

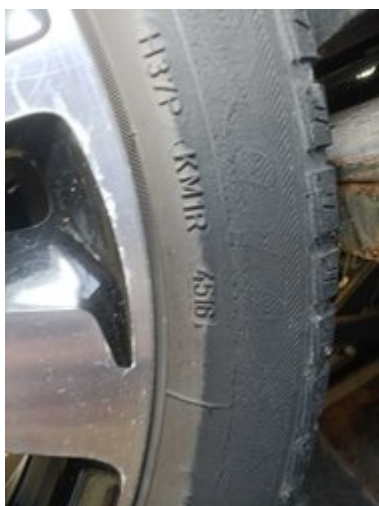
✓ **4. OTHER:** Change Tires

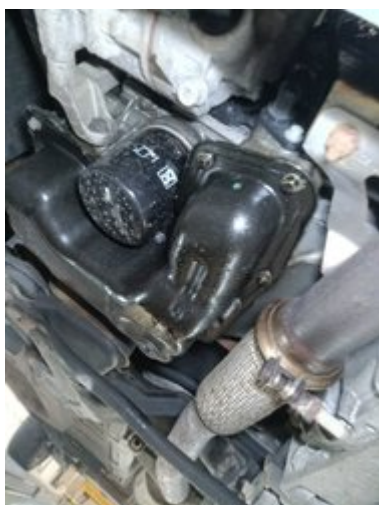
✓ **5. ENGINE:** Oil Pan - Lower

- ✓ 1. Oil Sump Pan - Lower
