# Diagnosis report of 2016 PEUGEOT 2008 Active

Color: Grey	CO <sub>2</sub> NEDC Emission: 103 g/km
Fuel type: Petrol	
Body type: SUV	Gross Vehicle Weight (GVW): 1655 kg
Number of doors: 5	Engine size: 1.20 l
Number of seats: 5	Cylinders: 3
Mileage: 153 385 km	Power: 81 kw
VIN Code: VF3CUHNZ6GY116927	Fuel consumption: 4.40 l/100km
Gearbox: Manual	Tire size: 195/60 - 16"
Drive type: Front-Wheel Drive	Longo Stock ID: N289454

During the comprehensive diagnosis conducted by Longo, 11 issues were identified in the vehicle.

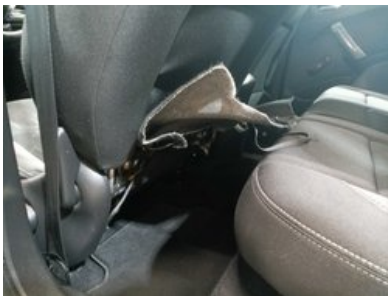
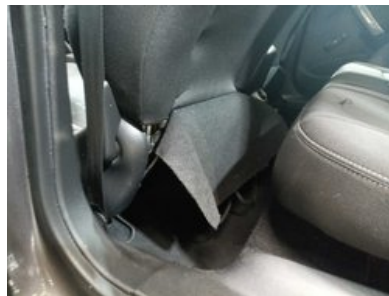
✔ **1. Seats:** All Seats - Condition

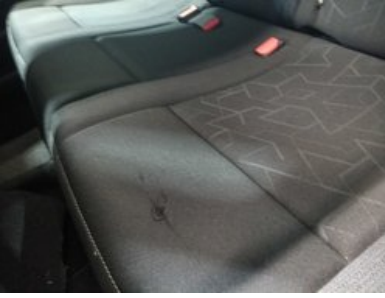
✔ **2. Seats:** All Seats - Condition

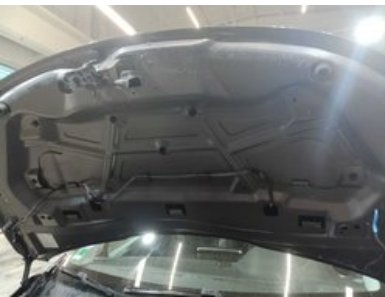
✔ **1. Front:** Hood Sound Insulation - Condition

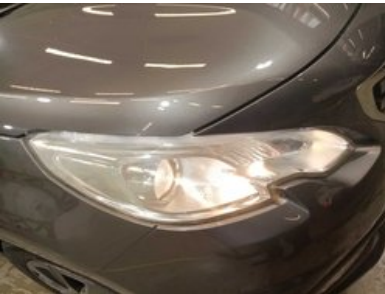
✔ **2. Other:** Additional Polishing Tasks

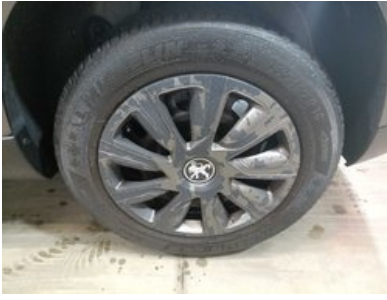
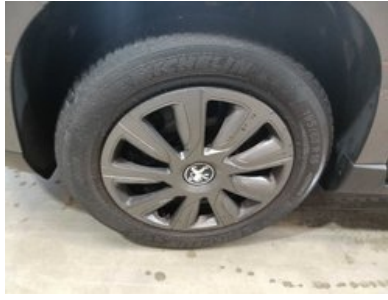
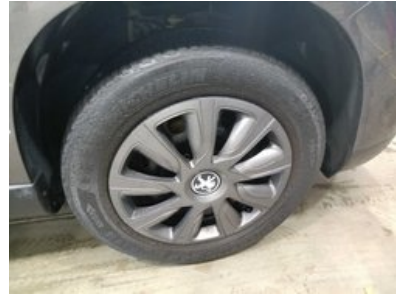
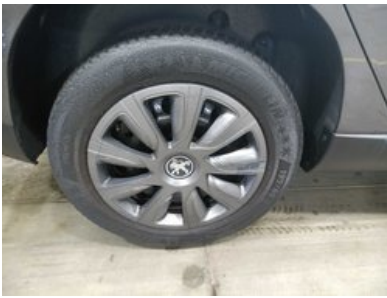
✓ **3. Side:** Wheels - Condition

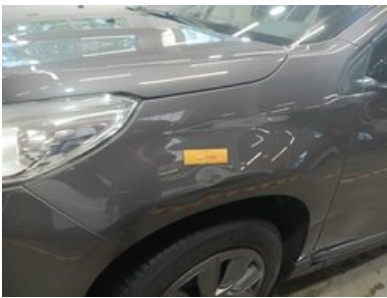
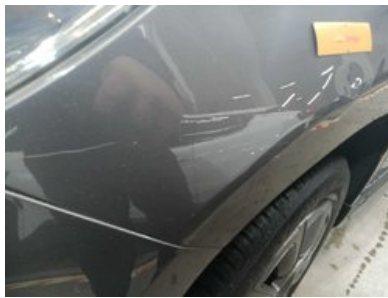
✓ **4. Side:** Left and Right Side - Visual Damage and Scratches
