# Diagnosis report of 2021 TOYOTA COROLLA Business Plus

# Preparation and repair report of 2021 TOYOTA COROLLA Business Plus

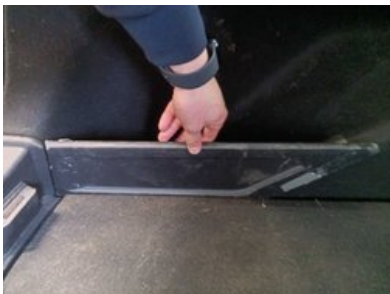
- ✔ 1. Inside: Trims - Condition

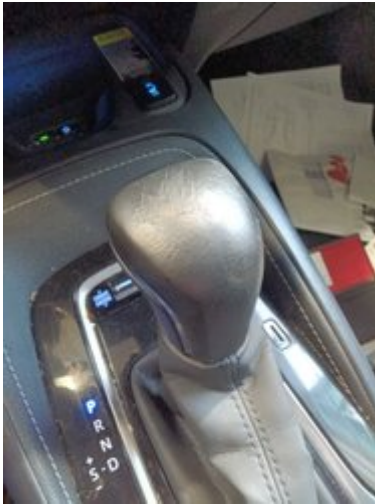
✓ **2. Inside:** Gear Shift Boot and Gear Shift Knob - Condition

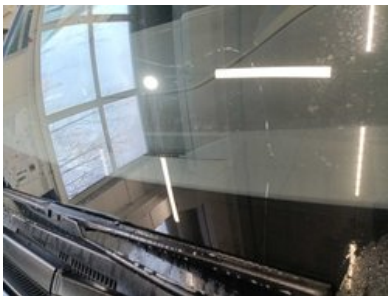
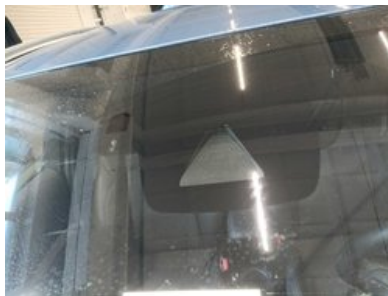
✓ **1. Front:** Windscreen Integrity - Free from MOT-Excluding Damage

- ✓ 1. Windshield Replacement

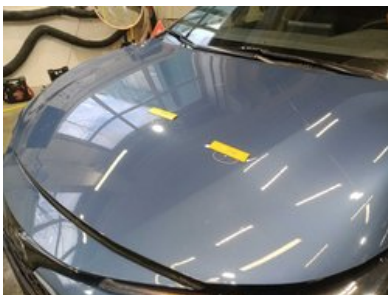
✓ **2. Front:** Hood - Visual Damage

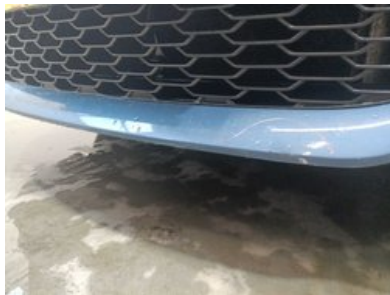
✓ **3. Front:** Front Bumper - Condition and Alignment

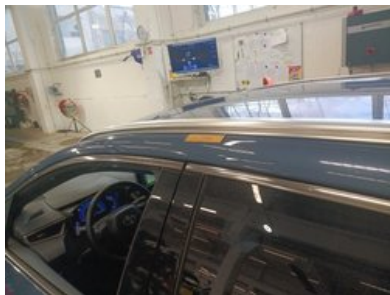
✓ **4. Side:** Left and Right Side - Visual Damage and Scratches

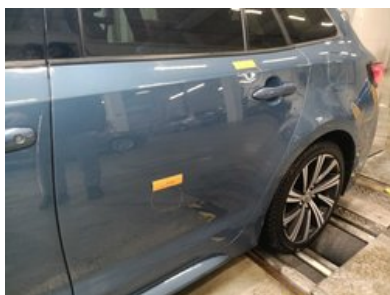
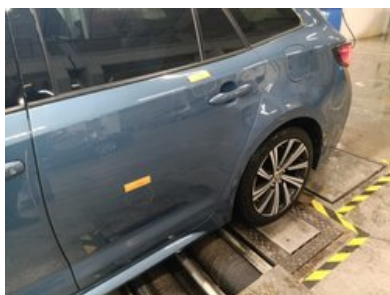
✓ **5. Side:** Left and Right Side - Visual Damage and Scratches

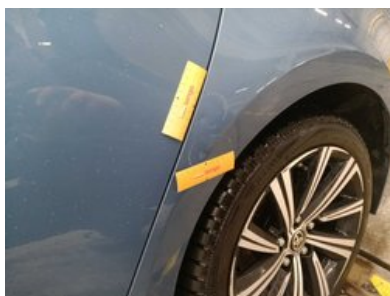
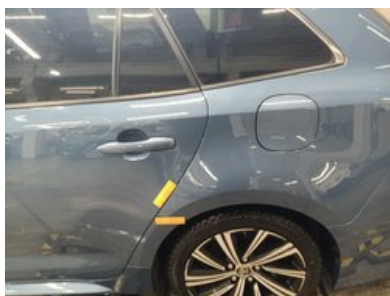
✓ **6. Side:** Left and Right Side - Visual Damage and Scratches

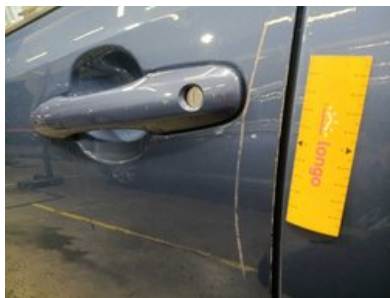
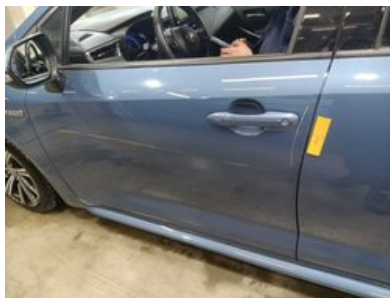
✔ **7. Side:** Left and Right Side - Visual Damage and Scratches

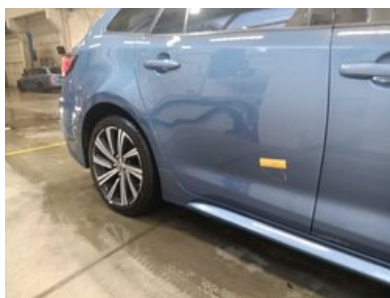
✔ **8. Side:** Left and Right Side - Visual Damage and Scratches

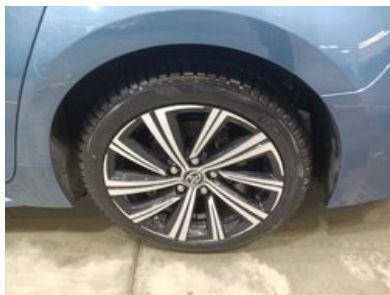
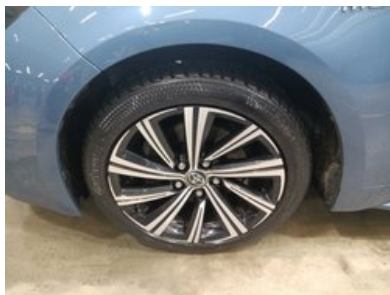
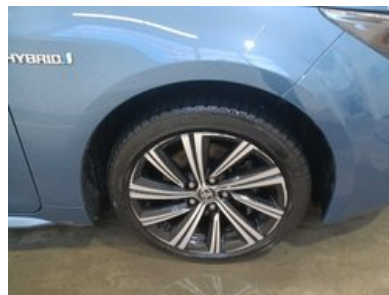
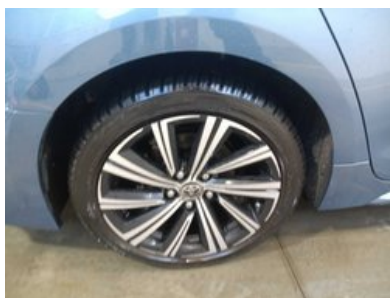
✔ **9. Side:** Wheels - Condition

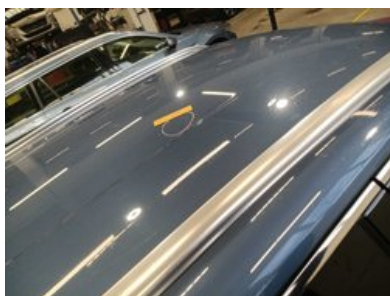
✔ **10. Other:** Roof - Visual Damage (e.g., Hail Damage)

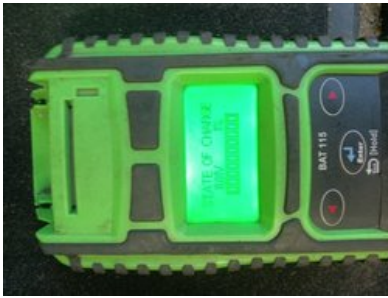
✓ **2. OTHER:** Charge Battery

- ✓ 1. Charge Battery
- ✓ 2. Engine Oil & Filter Change

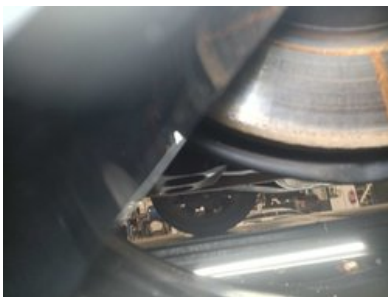
✓ **3. BRAKES:** Rear Brake Disc (Both)

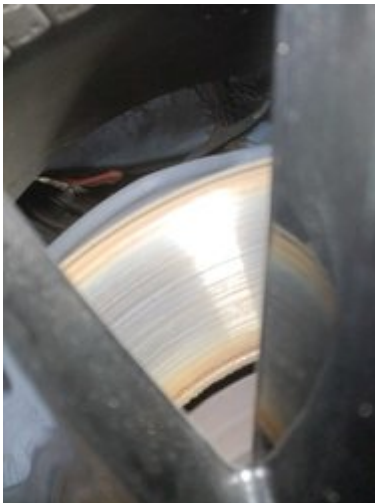
✓ **4. BRAKES:** Front Brake Discs Both
