# Diagnosis report of 2018 PEUGEOT 3008 Allure

During the comprehensive diagnosis conducted by Longo, 8 issues were identified in the vehicle.

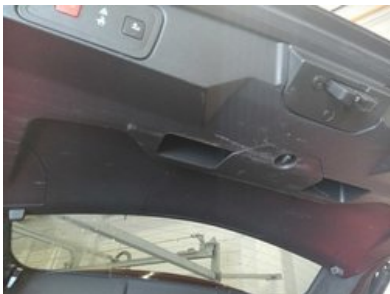
### ✔ 1. Inside: Trims - Condition

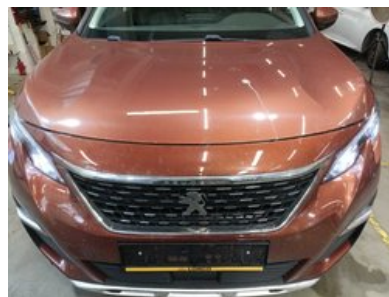
### ✓ 1. Side: Body Panel Geometry

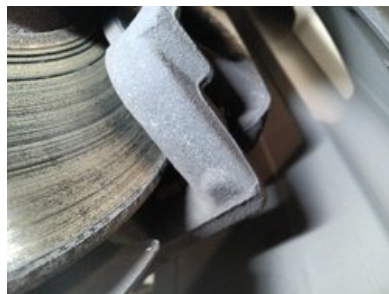
### ✓ 3. BRAKES: Brakes Condition

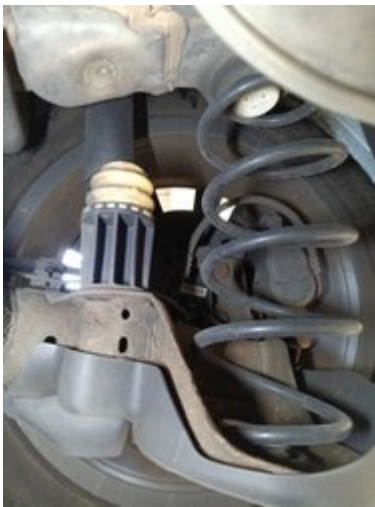
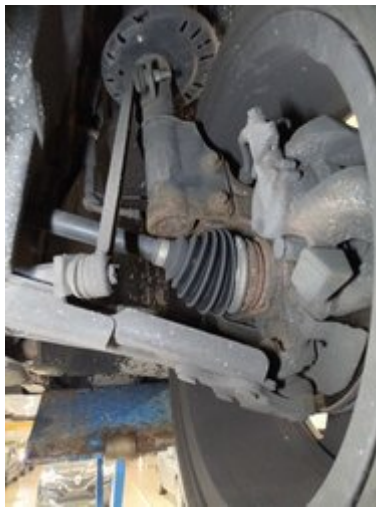
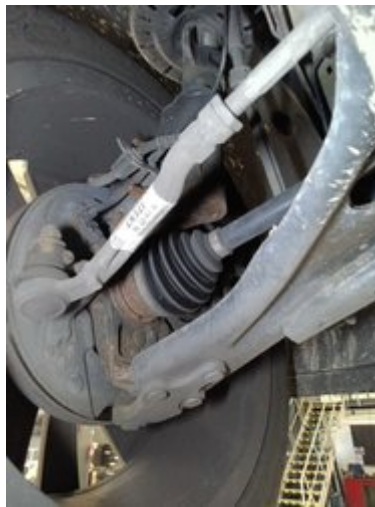
✓ **4. SUSPENSION:** Suspension Condition
