Diagnosis report of 2014 PEUGEOT 3008 Allure

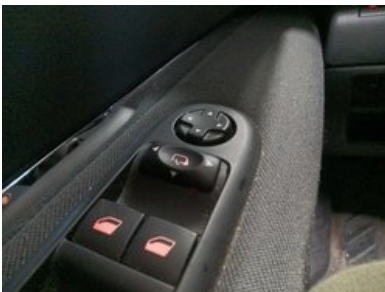
- ✔ **1. Doors:** Exterior Side Mirrors - Electronic Controls, Folding, and Adjustment

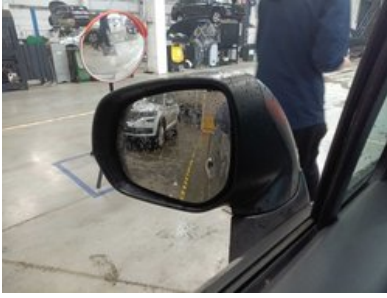
✔ **2. Doors:** Exterior Side Mirrors - Electronic Controls, Folding, and Adjustment

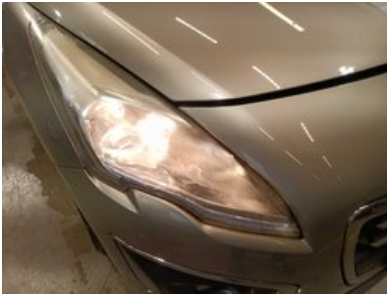
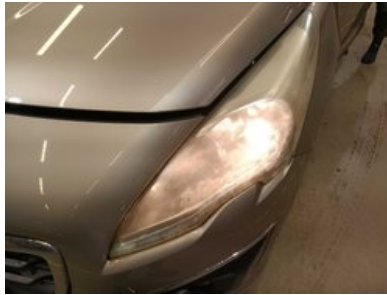
✔ **1. Other:** Additional Polishing Tasks

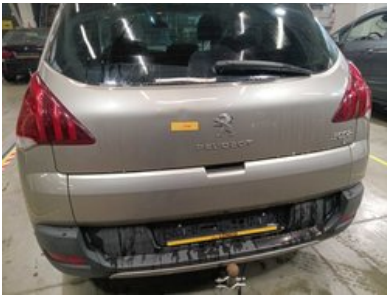
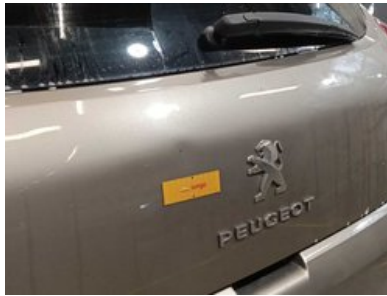
✔ **2. Rear:** Trunk - Visual Damage

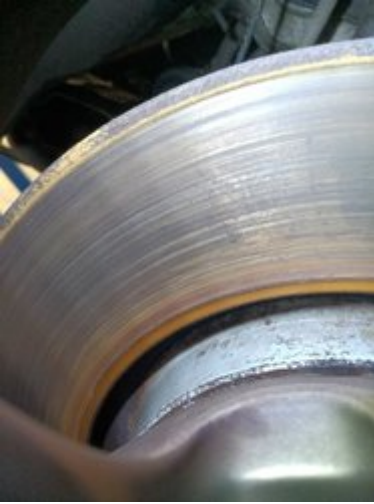
✔ **3. OTHER:** Front Brake Discs Including Pads

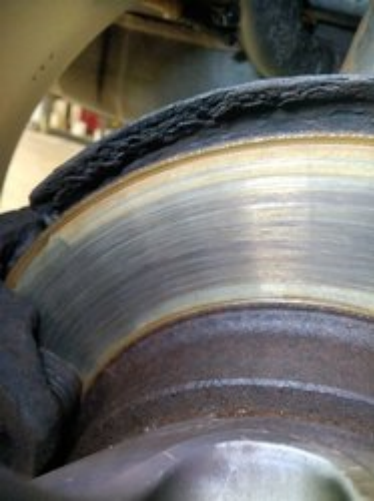
✔ **4. OTHER:** Rear Brake Discs Including Pads
