# Diagnosis report of 2021 MAZDA CX-5 Comfort

| VIN Code: JMZKF6W7A90165971 | Fuel consumption: 6.60 l/100km |

During the comprehensive diagnosis conducted by Longo, 6 issues were identified in the vehicle.

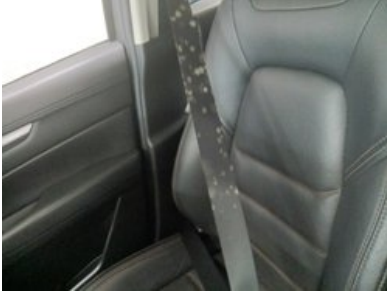
### ✓ 1. Inside: Additional Cleaning Tasks

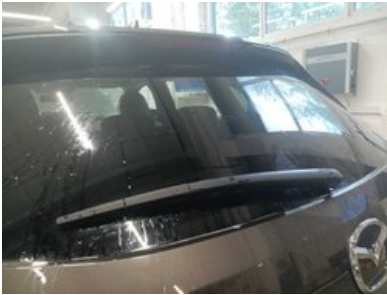
### ✓ 2. Front: Window Wiper Rubber and Handle (Front and Rear) - Condition

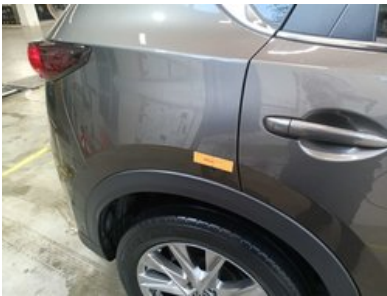
### ✓ 1. Side: Left and Right Side - Visual Damage and Scratches

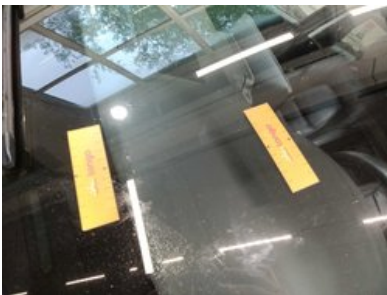
### ✓ 2. Front: Windscreen Integrity - Free from MOT-Excluding Damage

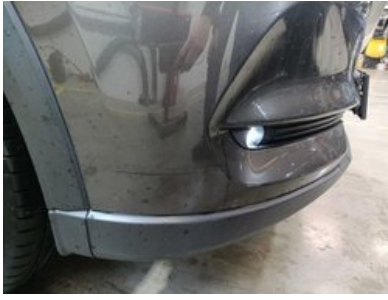
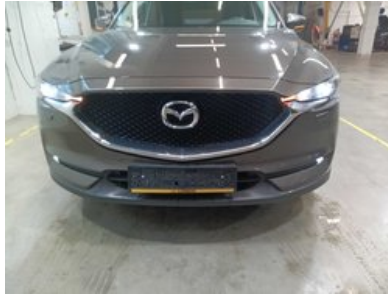
✓ **3. Front:** Front Bumper - Condition and Alignment
